Erosion Control Plan

**Short term measures to remedy adverse effects of the unlawful dam
construction at 17/232 Redford Farm**

Prepared by Dr. Jackie Dabrowski of Confluent Environmental (Pty) Ltd

August 2021

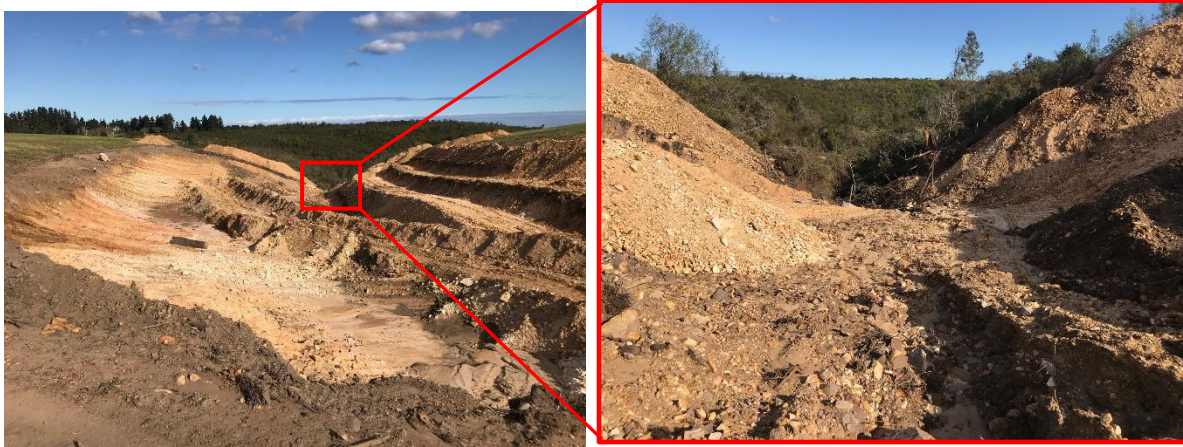
The first site visit was conducted on 17 June 2021. During the site visit it was noted that extensive excavation for the dam had been conducted on steep slopes the valley and included topsoil, subsoils, and underlying rock (Figure 1). The total area cleared of vegetation where earth-moving and excavation took place was 1.17 ha. No dam wall had been constructed and the topsoil removed in the process is currently stockpiled elsewhere on the farm. Remaining soils are piled at various points in the dam and terraces have been excavated along the valley sides.

The dam is located towards the top of the catchment and very little runoff is expected from surrounding areas. This aspect reduces the expected flows through the original watercourse and off the slopes. However, the sheer volume and area of soil disturbance, along with the steep gradient of the slopes exacerbates the erosion risk substantially.

Figure 1. Photos of the excavated dam area and enlargement of the 'outflow' leading to the watercourse below.

It is therefore recommended that erosion control measures be focussed on the bed of the original watercourse through a series of hay bale check dams. These are relatively cost-effective and easy to install. At least one check dam should be installed under supervision of an Environmental Control Officer (ECO) or an Aquatic Specialist. This should be the lowest check dam as it is the most important intervention. Supervision must also cover the on-site location of additional sites for each of the upstream check dams. A theoretical layout of the location of each check dam is provided in Figure 3.

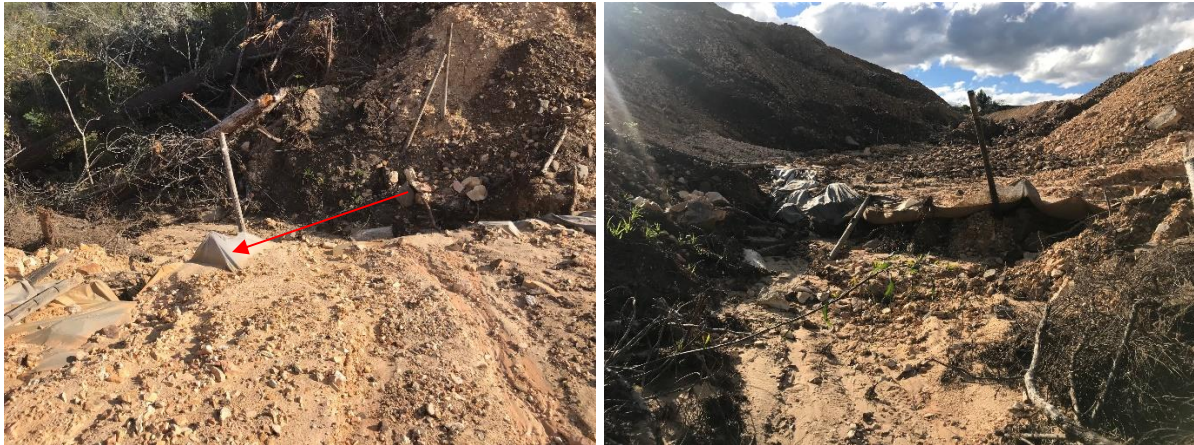
At the time of the first site visit, a silt fence was observed which had been erected by the earthmoving contractor at the outflow of the dam. The silt fence had been overwhelmed by sediment which filled the fence making it lie flat with no further function (Figure 2). The length of the watercourse below the dam was walked to determine the extent to which sedimentation had occurred at that time. This is easily determined because the subsoils washing down are a much lighter colour than the original stream bed. A GPS point was taken at this point, which measured 25 m downstream of the outflow, which is still on the land-owner's property.

Figure 2. Photo showing the overwhelmed silt fence (indicated by red arrow) from the upstream (left) and downstream (right) perspective.
