## **APPENDIX D: SITE PHOTOGRAPHS**

## **Groot Dam (Construction):**

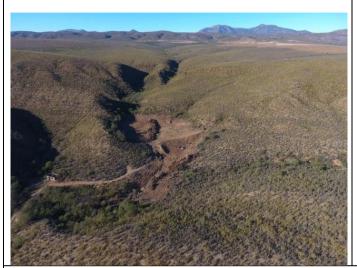
1. Aerial view of Groot Dam.

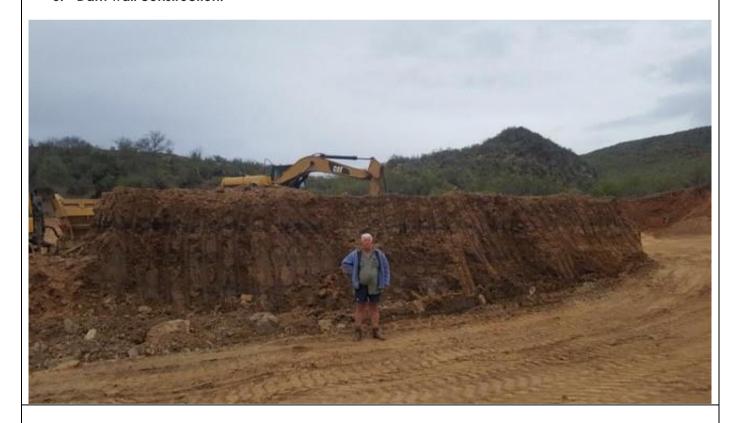
3. Dam wall construction.

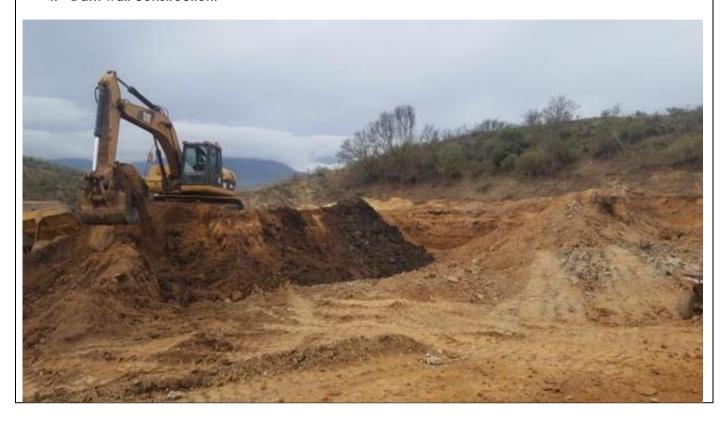
4. Dam wall construction.

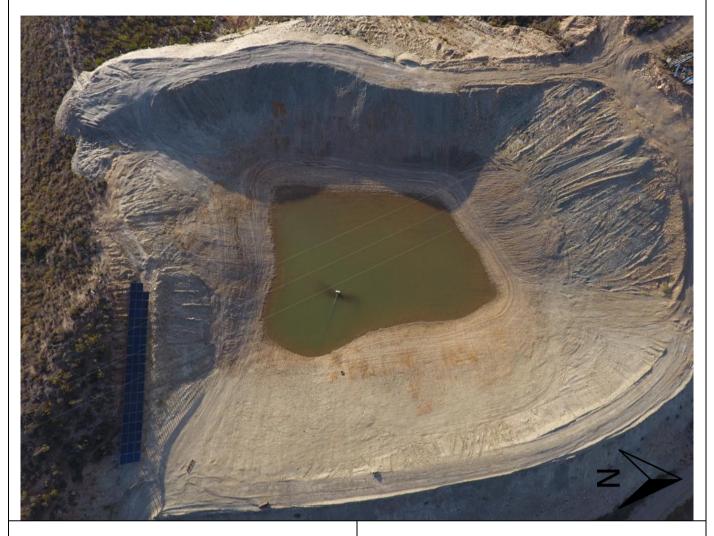
1. Aerial view of Kop Dam.
