## Memo

| <b>Copy to:</b> | Mr Godwyn Smith (GG&G) | <b>Project #:</b> | 624065 |
| <b>Subject:</b> | <b>Outeniqua Game Farm Irrigation Dam Wall<br/>Geotechnical Desk Study &amp; Site Walkover</b> | | |

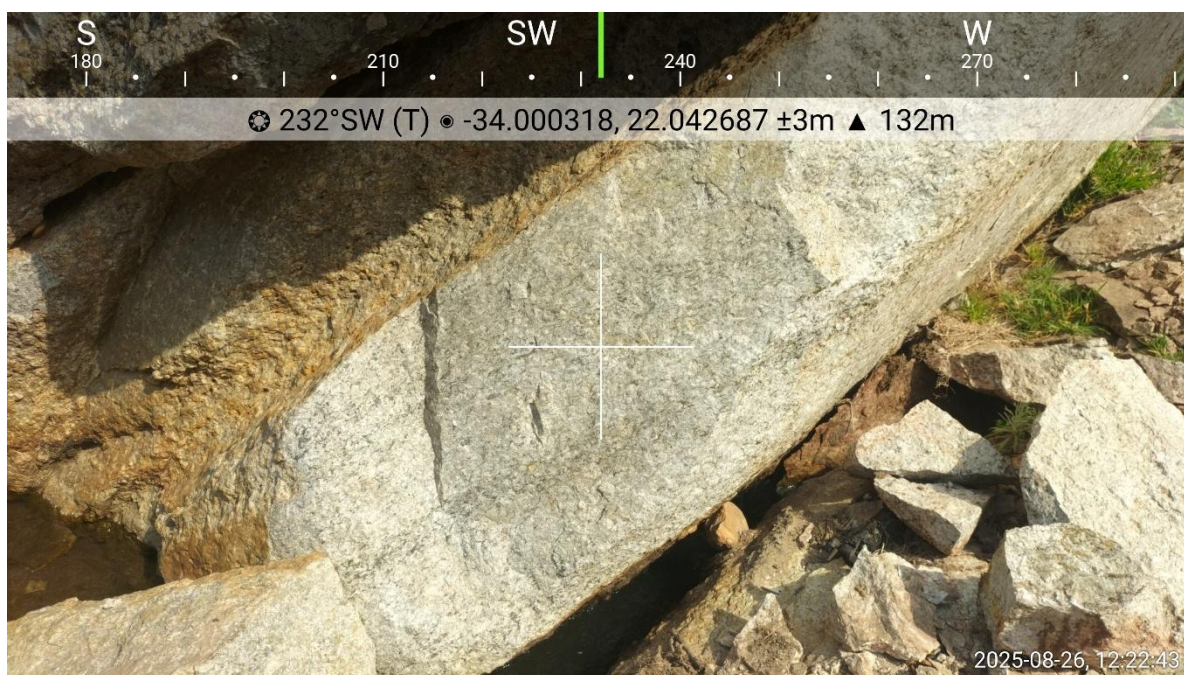
Where exposed, the granite is typically slightly weathered, coarse-grained with gneissic banding (Figure 4-2) with an estimated unconfined compressive strength of at least *hard rock* based on industry-accepted field estimation techniques.

The orientation of the banding dips towards the southwest at a steep angle; based on a dip and dip direction measurement ( $45^{\circ}/201^{\circ}$ ) collected at Option 2. This is like the orientation provided in Brink (1981)<sup>3</sup> for a case study for a large road cutting located 1.0 km east of the Great Brak River, or ~18.9 km southeast of the proposed dam sites, which potentially indicates a degree of 'regional uniformity'.

**Figure 4-2: Gneissic banding (darker band below the centre cross)**

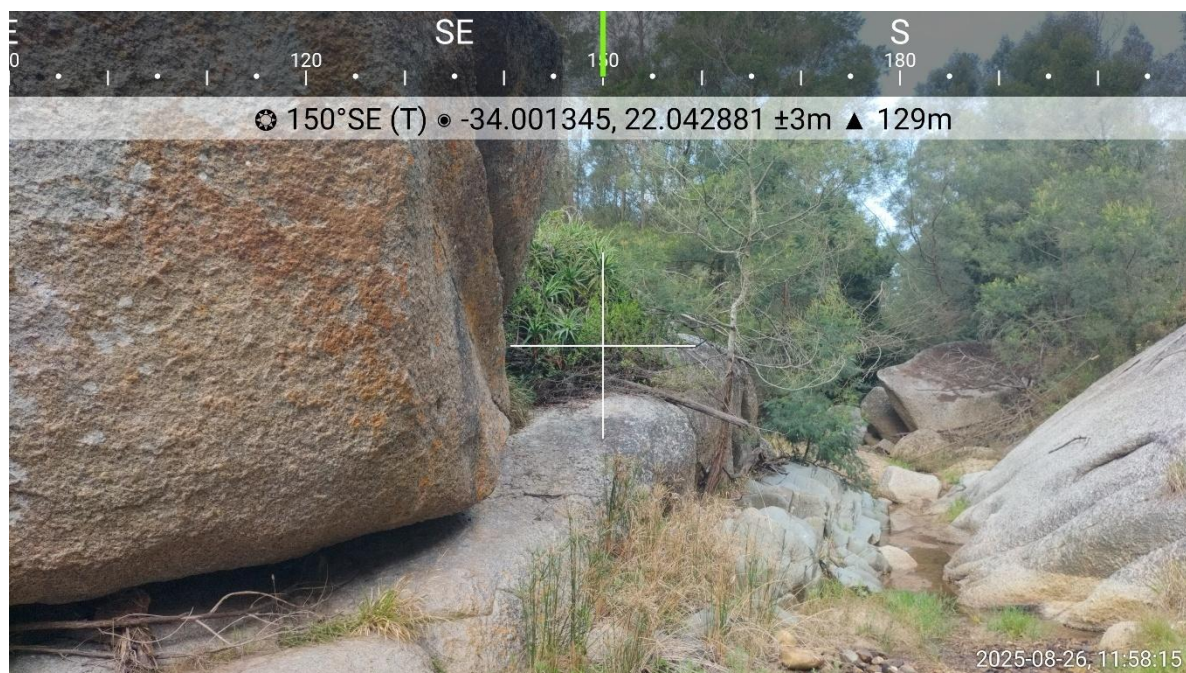
Most of the plutons have been intruded by younger dykes and veinlets of microgranite, aplite and quartz porphyry, often containing abundant concentrations of the mineral tourmaline. The rock type observed at Option 2 and Option 3 (appeared to be in a slightly more weathered state compared to Option 2) resembles 'aplite' which is described as *a uniformly fine-grained (with crystals that are generally not visible to the naked eye [aphanitic]), pale-coloured intrusive igneous rock, often found as small, often thin, bodies, sometimes called 'lenses', that intrude into or are contained within larger igneous intrusions like those of the Cape Granite Suite. The intrusion has a near-vertical to vertical orientation and moderately jointed* (Figure 4-3). The image is captured looking south of southeast

indicating that the dyke dips towards the north of northwest. The estimated hardness is the same as the granite i.e. at least hard rock.

**Figure 4-3: Near-vertically dipping, light bluish grey 'aplite' dyke within granite gneiss (bottom right quadrant).**

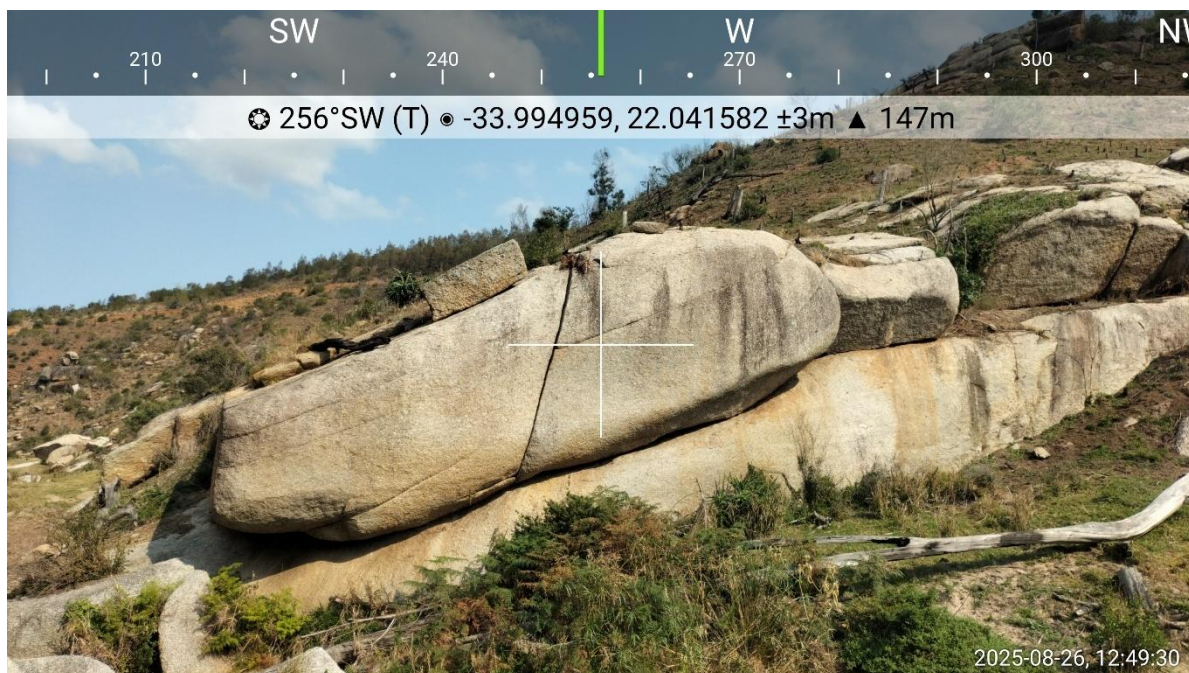
Discontinuous<sup>4</sup> foliation joints are present though this characteristic should be regarded as an underestimate (Figure 5-1).

Clayey and/or crushed rock gouge is present at the cutting though not observed at the dam site options. It is postulated that this material has been washed away by the river leaving behind the large, open joints as indicated in Figure 5-1 of the right-hand abutment at Option 3.

**Figure 5-1: Large, open discontinuities and smaller, discontinuous discontinuities exposed at the right-hand abutment at Option 3.**
