## Coastal Stability Assessment at Featherbed Nature Reserve

By Inanda Port and Coastal Engineers (Pty) Ltd

For Phambi Properties (Pty) (Ltd)

Document No: 04125-IND-M-RPT  
Revision : A

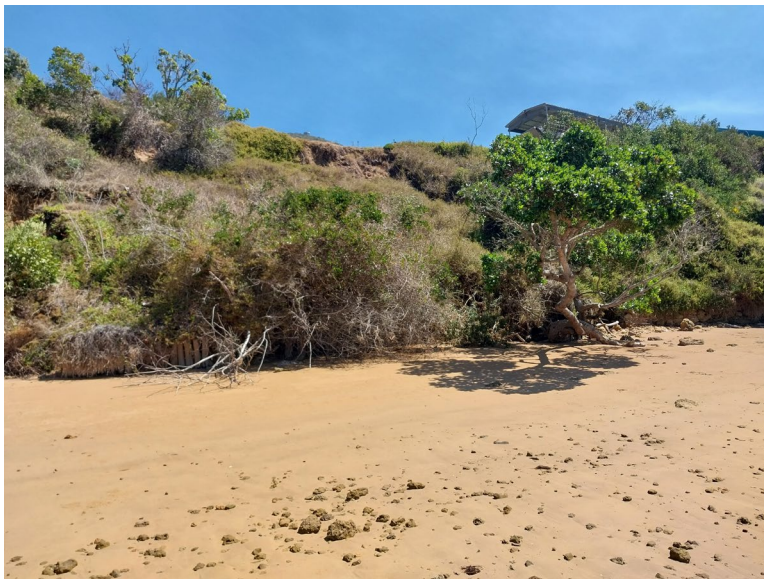
- Vegetation appears in good condition, which is an indicator of stability.
- Evidence of toe scour or undercutting near the waterline.
- Presence/condition of protection (e.g., timber piles)
- Signs of recent wrack lines indicating high-water marks, attributed to recent spring high tides.
- Presence of sandy beach from water level up to toe of dune embankment

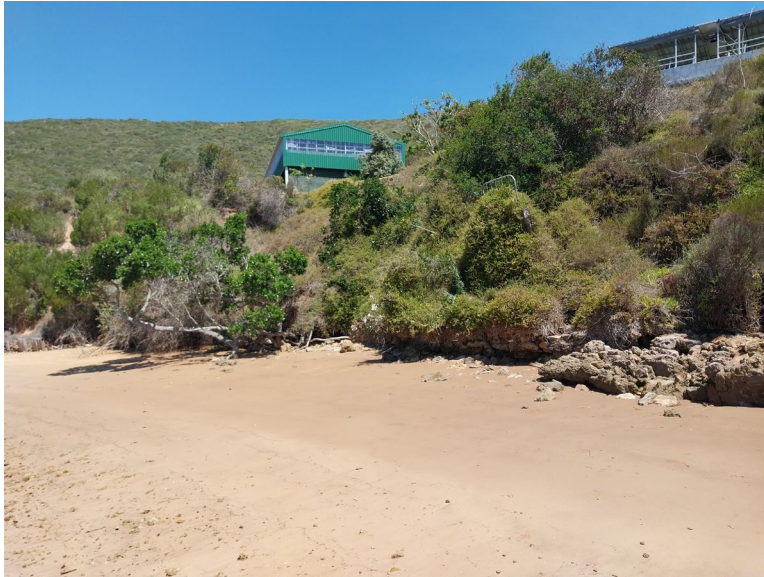
- Vegetation appears in good condition, which is an indicator of stability.
- Evidence of toe scour or undercutting near the high spring tide waterline, with some rock outcrops evident on the right side of the photograph (which provide some form of limited erosion protection.)
- Presence/condition of protection (wooden piles) on far left.
- Signs of recent wrack lines indicating high-water marks, attributed to recent spring high tides.
- Presence of sandy beach from water level up to toe of dune embankment.

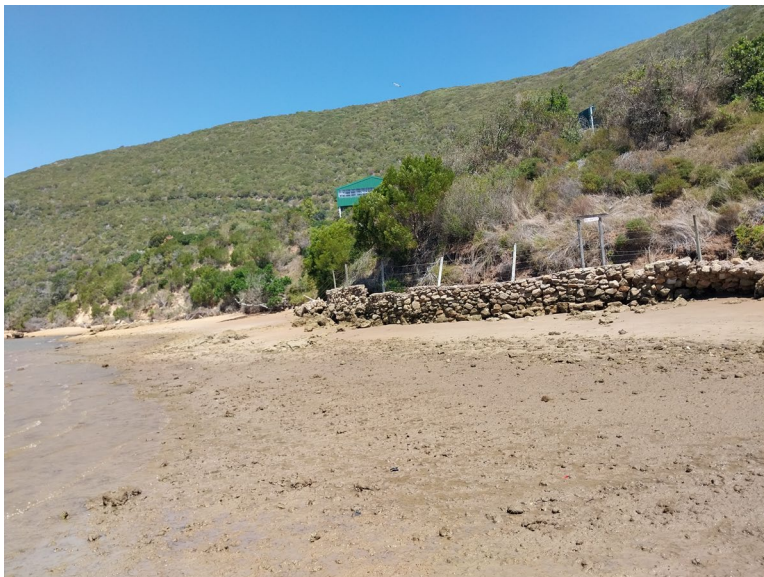
- Vegetation: fynbos with some milkwood trees.
- Evidence of toe scour or undercutting behind the protective man-made rock structure.
- Presence of sandy beach from water level up to toe of dune embankment, with reasonable amounts of lightly cemented sand / weak rock fragments on the lower reaches of the beach.

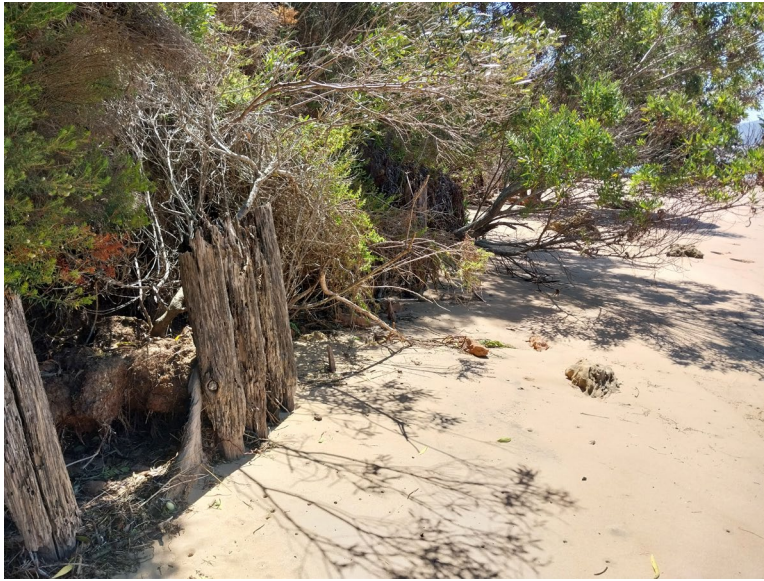
- Evidence of toe scour or undercutting near the high spring water mark covered with vegetation, with erosion area significantly beneath and behind the vegetation line.
- Presence/condition of old/damaged protection without any functionality (expired design life).
- Signs of recent deposition or wrack lines indicating high-water marks, with vegetation growth concealing (and lightly protecting) the eroded dune toe.

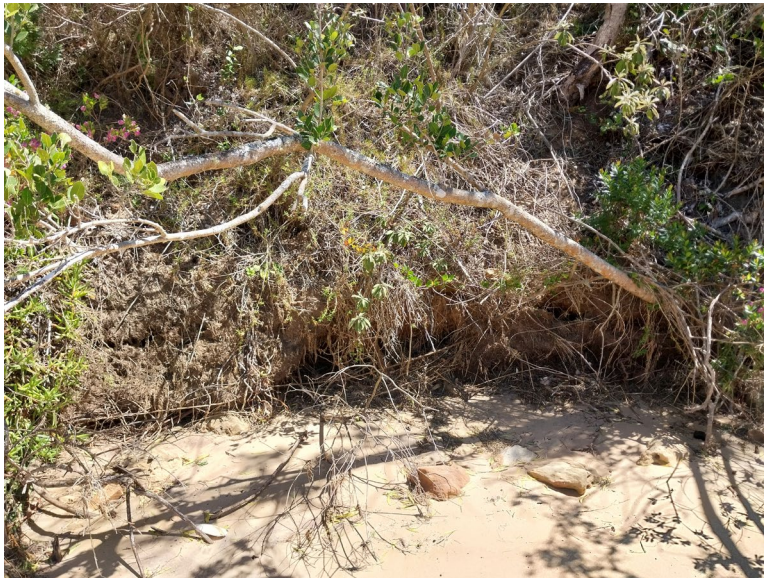
- Evidence of toe scour or undercutting near the high spring water mark covered with vegetation, with erosion area significantly beneath and behind the vegetation line.
- No erosion protection structures – apparently totally degraded / removed.

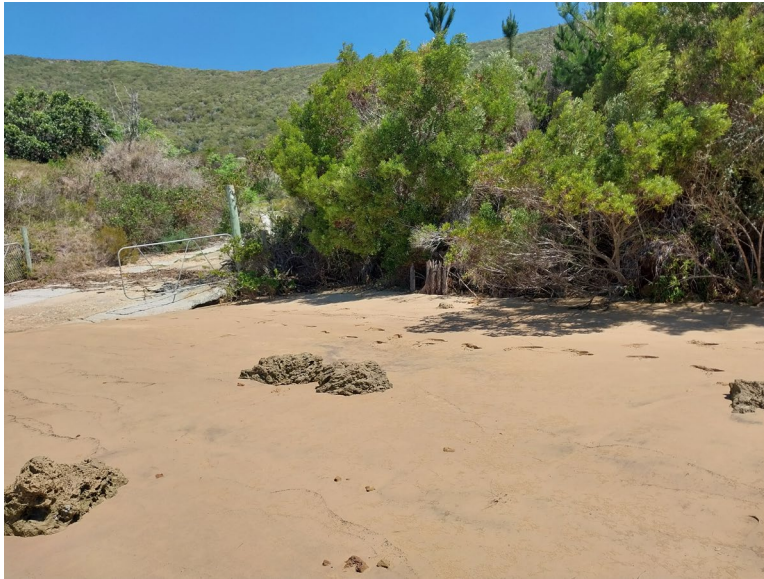
- Vegetation health and continuity is an indicator of stability, in particular along the edge of the dune toe, inside and/or close to spring high water mark.
- Evidence of toe scour or undercutting near the waterline.
- Presence/condition of protection, e.g. the wooden piles, but again with limited functionality (past design life).
- Signs of recent deposition or wrack lines indicating high-water marks, especially visible at the concrete boat ramp, with similar extents along the beach.

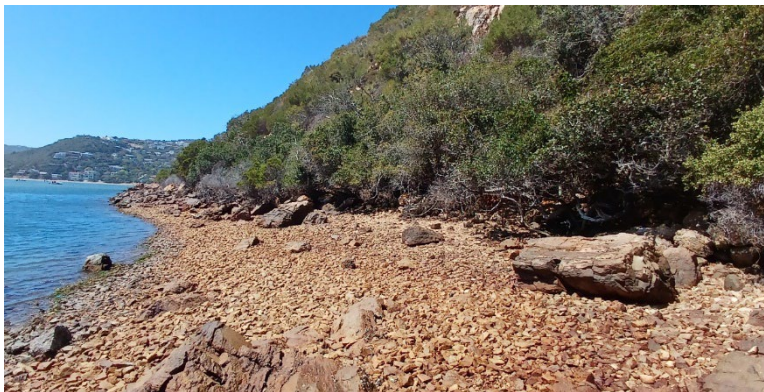
- Rocky cliff face visible in isolated locations, while sandy dunes not visible / apparent.
- Good vegetative cover across the area.
- Rocky pebble beach exists (in lieu of (suggests lack of sediment supply to his location)

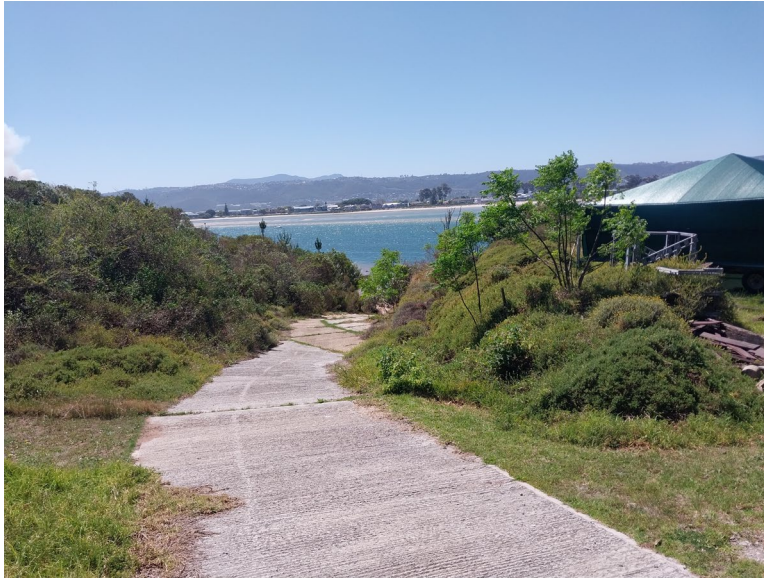
- Free and open stormwater discharge flow, largely uncontrolled down to lagoon.

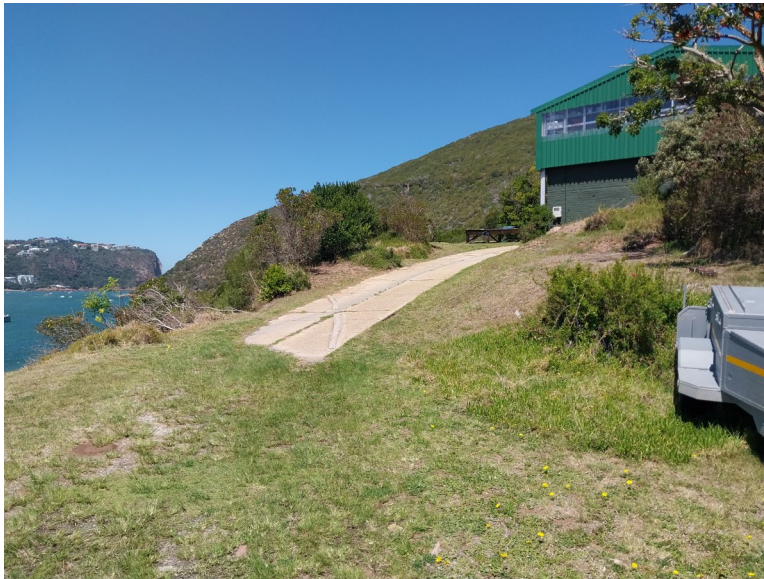
- Stormwater discharge from upper areas of the site, along concrete road on to open grassed area

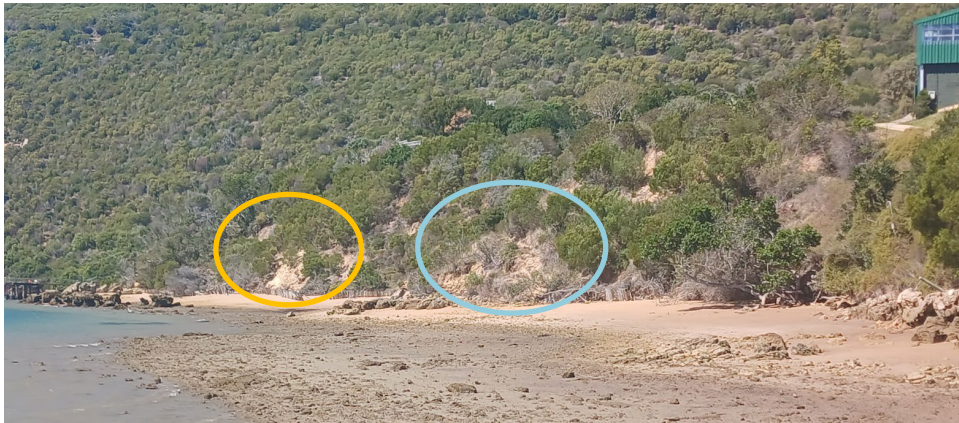
- Patchiness of vegetation vs exposed soil.
- Certain areas exhibit localized slope failure inclusive of soil/vegetation mass, or a steep slope more than 45°. This suggests recent local erosion at the base, or recent slope failure, or soil mass with increased internal strength.

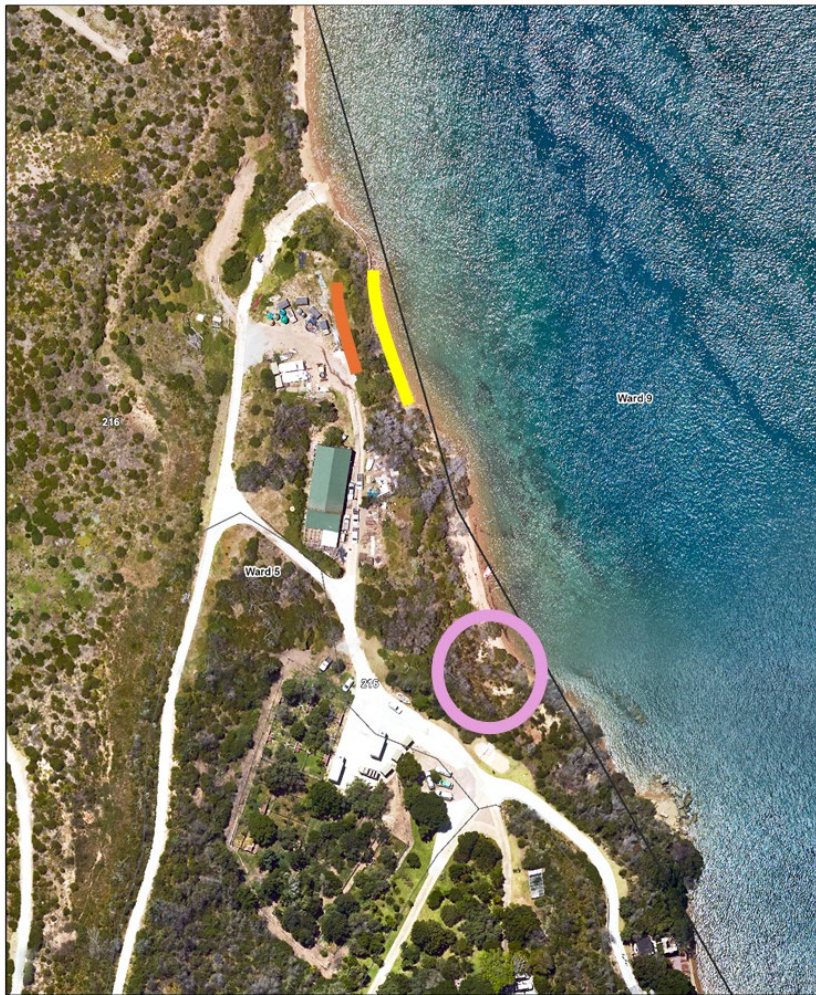
Figure 4: Observations from Aerial Imagery

- A recession of the vegetation line (interface between vegetation and sandy beach) is evident between 2009 and 2019 of up to 5m (shown as yellow line figure).
- Recession of the top vegetation line by some 5 m between 2009 and 2019 (orange line).
- Lack of vegetation exposing dune face (pink circle).

- Recession landwards of the vegetation is noted by some 5m in one location. The cause of this is unknown but could be due to changes in gardening landscaping practices in the recent past, or due to slope failure. In general, the top of the slope does not show other signs of recession.
- The impact of the Knysna fires on stability on this area is considered likely but minor (in terms of the longer-term erosion trend)
- The impacts of climate change is considered a potential issue with respect to stormwater through potentially increased rainfall but can be managed.
