GRANNY'S POOL TO MAIN BEACH SITE PHOTOGRAPHS

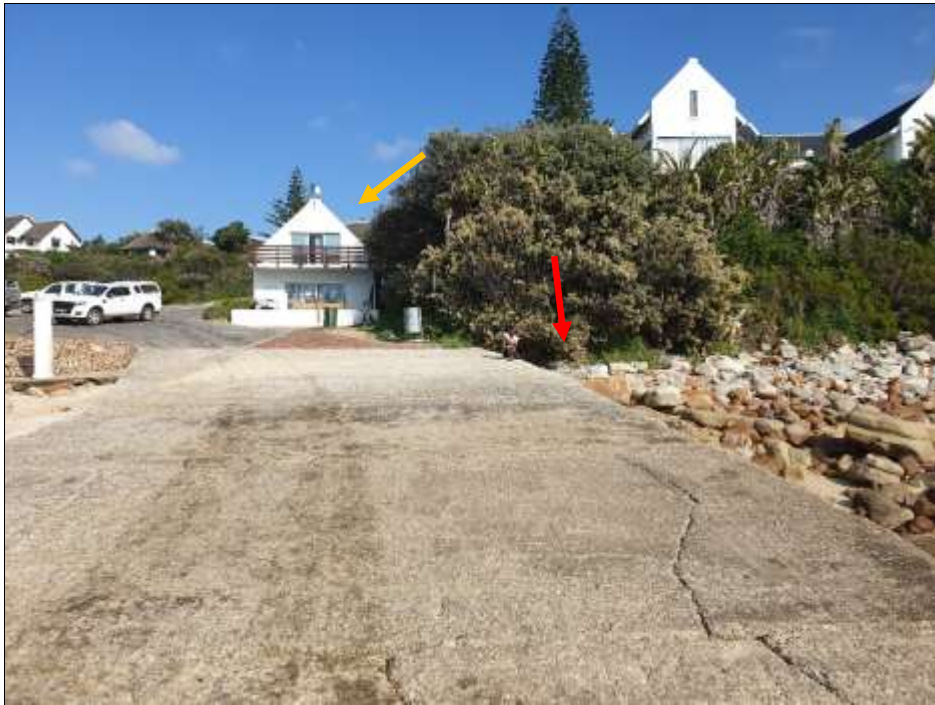
This photograph was taken on the existing slipway facing west toward the Heritage Centre (orange arrow) and car park $34^{\circ}10'11.71''\text{S}$ $24^{\circ}50'1.05''\text{E}$
The boardwalk begins at the red arrow $34^{\circ}10'11.82''\text{S}$ $24^{\circ}50'0.66''\text{E}$

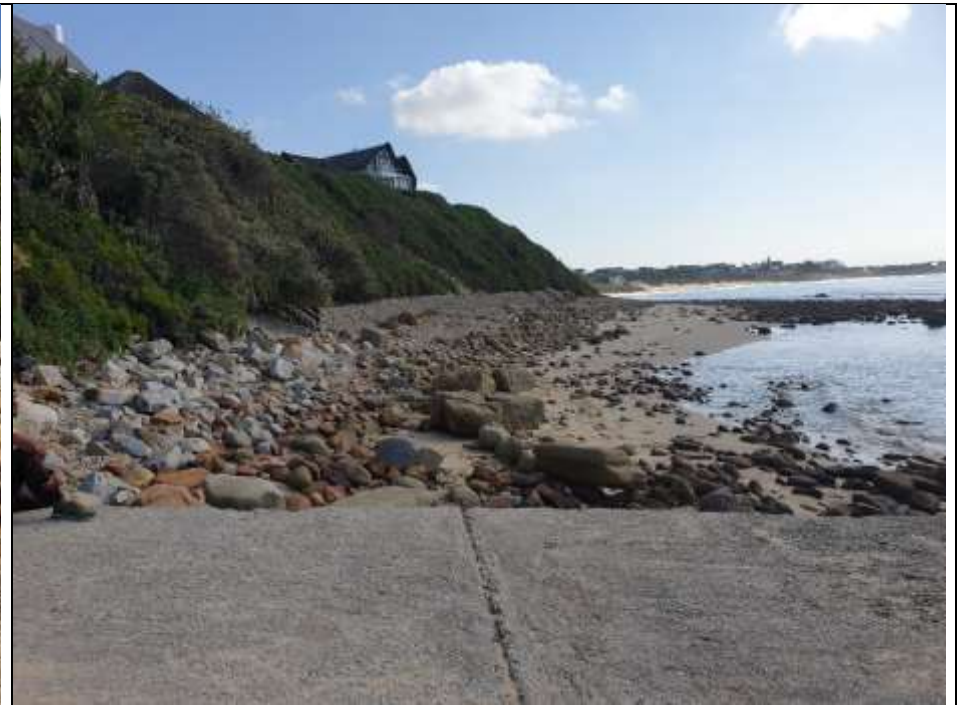
This photograph was taken facing a north-westerly direction $34^{\circ}10'11.98''\text{S}$ $24^{\circ}50'0.74''\text{E}$. This area is known as Granny's Pool. The entire route of the boardwalk along the shoreline is boulder strewn as is evident from all photographs.

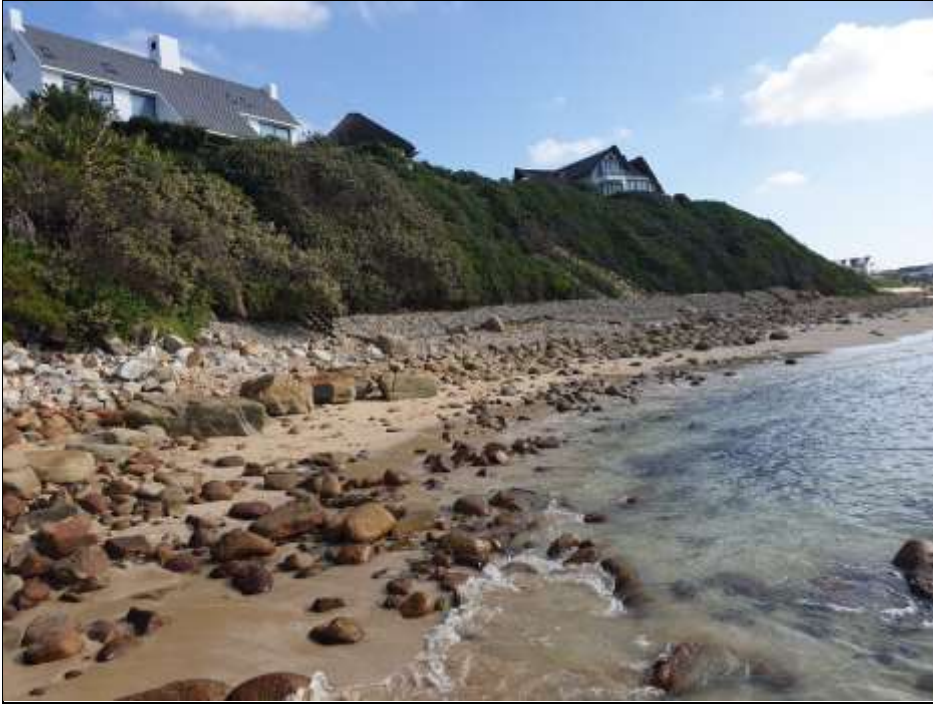
This photograph shows the route of the boardwalk along the shoreline on the Granny's Pool side facing north-west $34^{\circ}10'11.61''\text{S}$ $24^{\circ}50'0.85''\text{E}$

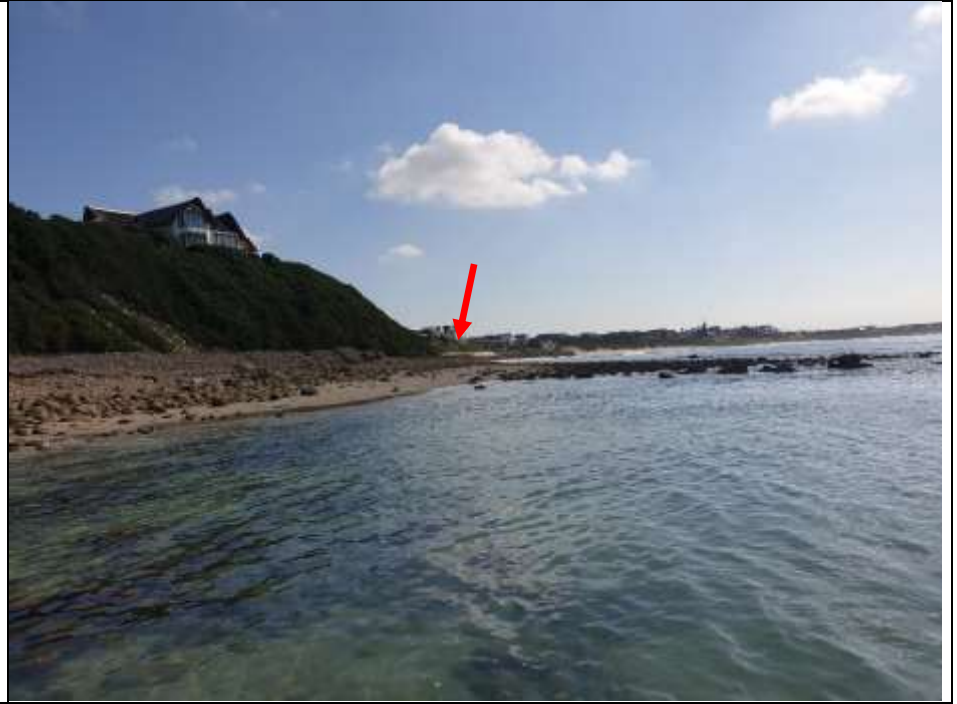
This photograph facing north shows the route of the boardwalk up until approximately the middle point of the route (red arrow) $34^{\circ}10'11.49''\text{S}$ $24^{\circ}50'1.23''\text{E}$

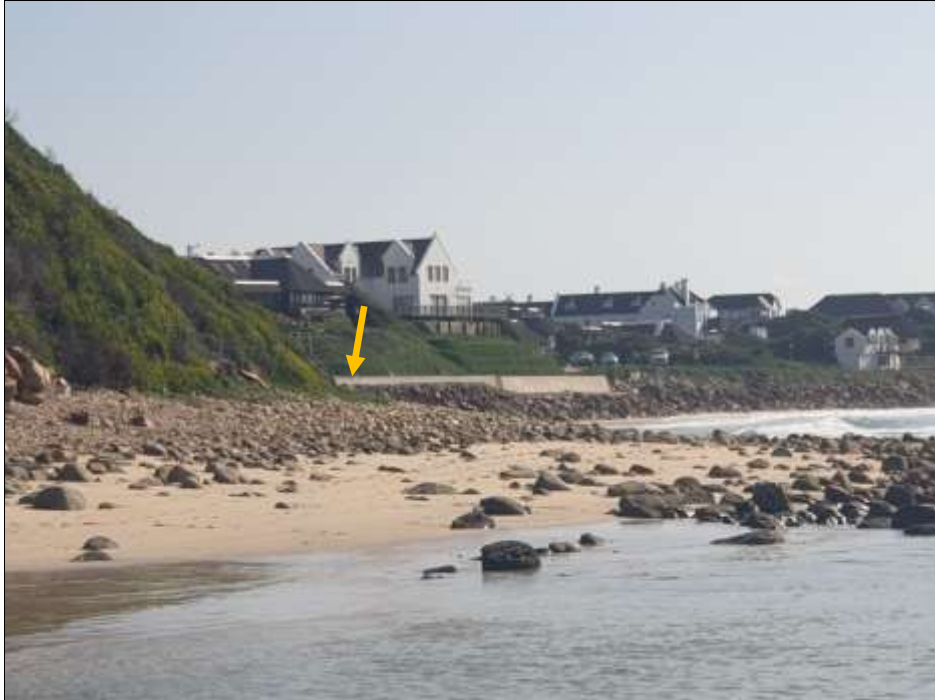
This photograph shows a close-up of the middle section of the proposed boardwalk 34°10'11.49"S 24°50'1.23"E. The concrete retaining wall can be seen in the distance (start of retaining wall – orange arrow).

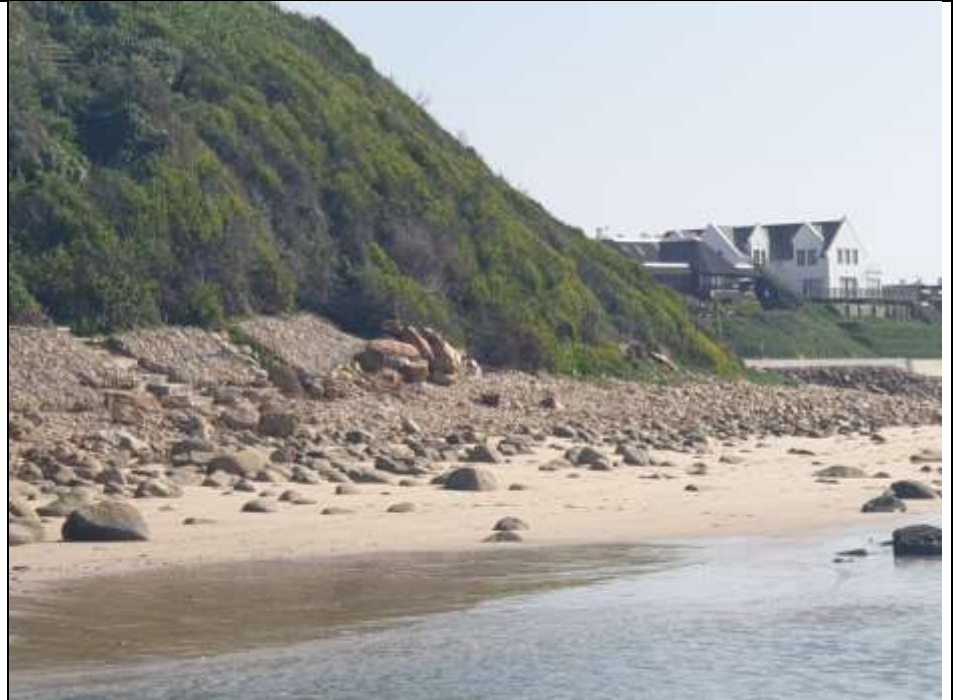
A close-up of the boulder strewn shoreline 34°10'11.49"S 24°50'1.23"E

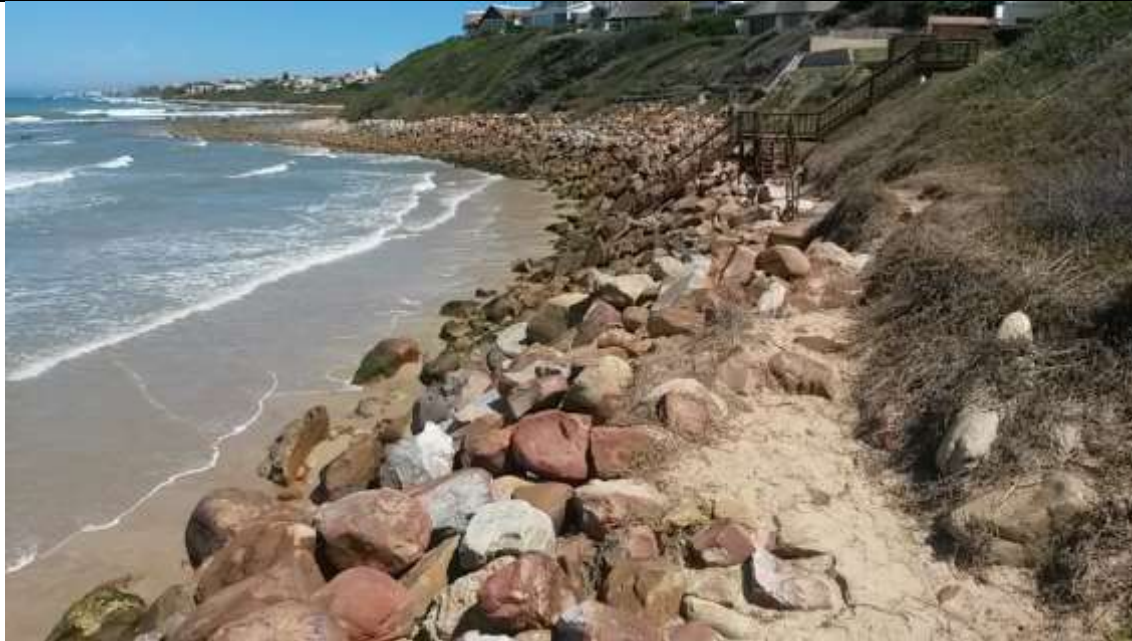
This photograph was taken facing south and includes areas to the south-east and parts of south-west $34^{\circ}10'2.82''\text{S}$ $24^{\circ}49'54.46''\text{E}$. This photograph was taken at the proposed end of the boardwalk i.e. at the existing concrete retaining wall. This photograph shows the shoreline at high-tide. It is clear in this photograph that it is not safe to traverse this entire stretch of the shoreline at high-tide.
