GEOTECHNICAL SOIL TEST REPORT

Client: Dr Marx c/o Eco Route Environmental Consultancy

Project: Erf 1510, Sea Vista, St Francis Bay

Date of test: 21.7.2022

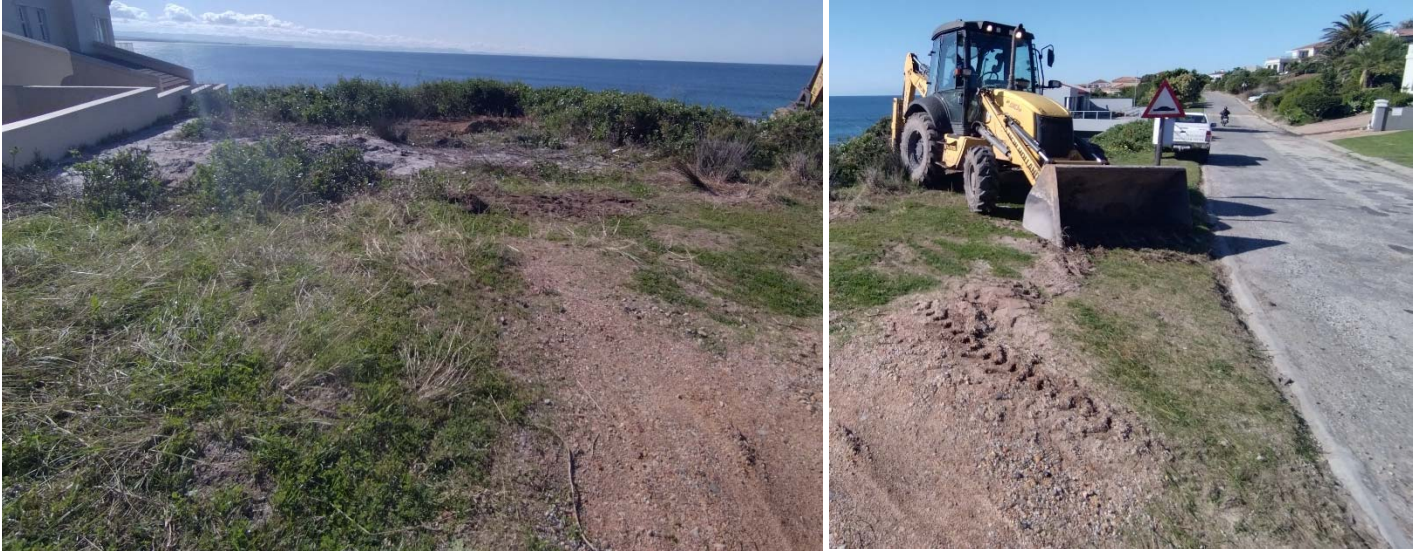
The site is located in the residential suburb of Sea Vista in St Francis Bay. The site was vacant and positioned on a coastal dune, approximately 80m south-west of the beach (see Fig1). Access to the site was gained from the road on the southern side of the stand. The terrain on the site was fairly irregular with fairly gentle access from the street level, but then dropped away steeply on the northern portion of the erf. The site naturally drains towards the north and east. At the time of the investigation, the ground conditions were generally dry and well drained and macro-stable with no signs of any drainage problems or features such as marshes, but there were some marginally stable steep slopes on the northern side.

Figure 1: Photo of site, looking north and east

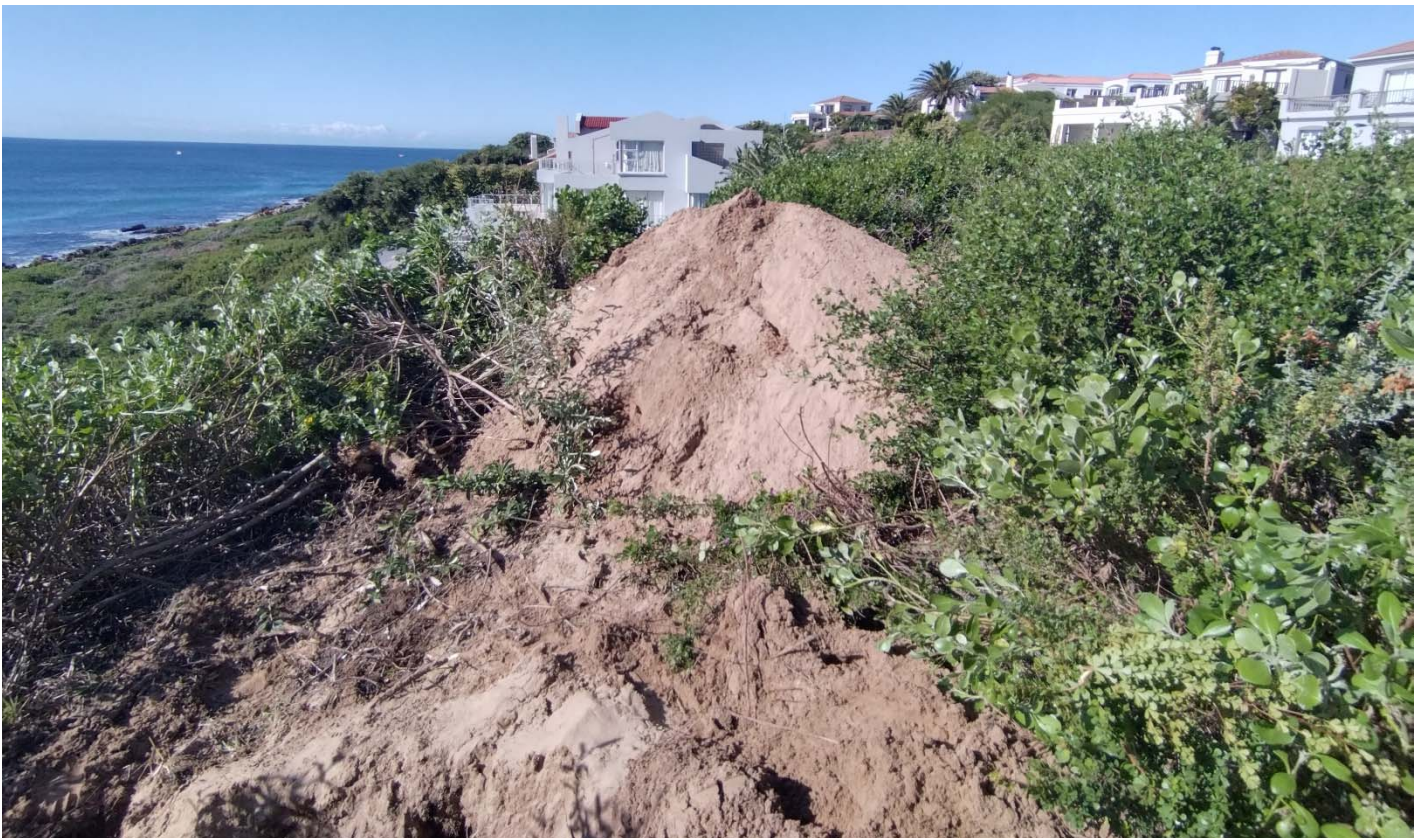
Figure 2: Photo of sandy soil excavated from test pit TP1

yellow (becoming lighter with increasing depth), poorly graded, non-plastic slightly silty fine sand of aeolian origin (see Figure 2). There was an organic-rich topsoil layer of approximately 200mm thick which covered the natural aeolian soil.

DCP tests indicated that the soil consistency was variable but potentially very loose to loose in the upper 2m with penetration rates typically exceeding 40mm/blow. The tests indicated potentially highly compressible soil, requiring adequate compaction to mitigate settlement of structures, especially on or near steep slopes.

Foundations and floors: Single/double/triple storey masonry structures can be founded on reinforced concrete strip, pad or raft foundations. Piled foundations should only be considered for excessively heavy structures as this method is generally an uneconomical in the area due to high establishment costs of specialist contractors. Strip and pad foundations should be founded at a minimum depth of 0.8m below ground level (platform level) on well compacted insitu sands. Bearing pressures should be limited to 125-150kPa where possible, to minimise settlement. As a guideline to achieve adequate compaction to avoid settlement, the foundation trenches should be excavated to the recommended minimum founding depth, well wetted and compacted with several passes of a mechanical trench rammer (Wacker), until the DCP penetration rate is less than 20mm/blow to a depth of 1m below the foundation invert. If adequate compaction cannot be achieved with this method, the contractor should remove additional loose soil from below the founding level (e.g. over-excavate 0.3-0.5m), recompact the base of the excavation and then replace the insitu soil in compacted layers. The structural engineer can consider additional techniques such as replacing insitu soil with 3-5% cement-stabilised sand. Foundations near/above retaining walls and steep natural slopes (within 3m) will require careful consideration, possibly including special measures such as deeper foundations to prevent surcharge loading of walls or slopes. The structural engineer should inspect foundation trenches and ensure adequate testing of before casting concrete. Filling under reinforced concrete floors should be compacted at the optimum moisture content (10-12%) to 100% of maximum dry density.

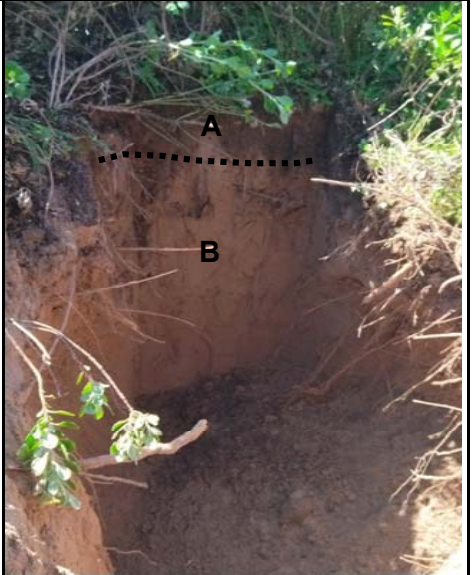
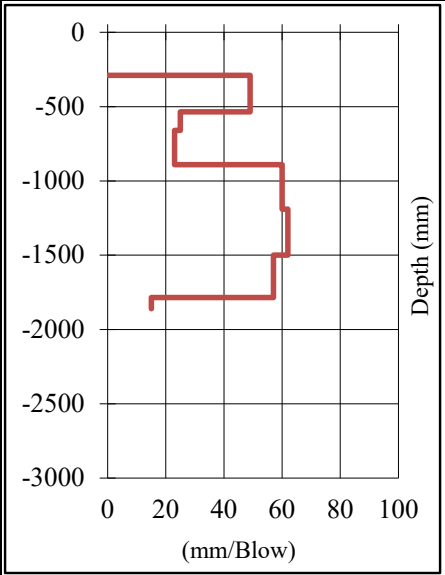
TP 3		Datum:	Co-ords:	Dynamic Cone Penetrometer (DCP)		Photo of Test Pit
		NGL	25 Y0014556 X3783473

(0 to 200)	Moist, dark brown, very loose, intact, SILTY SAND & ROOTLETS , aeolian.

(200 to 2100)	Moist, light brown, loose to medium dense at base, intact, SILTY SAND & ROOTLETS , aeolian.				
Sidewalls collapsed No Water
