# PROPOSED RIVERBANK MAINTENANCE ON REMAINDER 1 of FARM 305 HANGLIP, PLETTENBERG BAY.

Estuarine and Plant Species – Specialist Assessment

**Date:** 26 May 2025

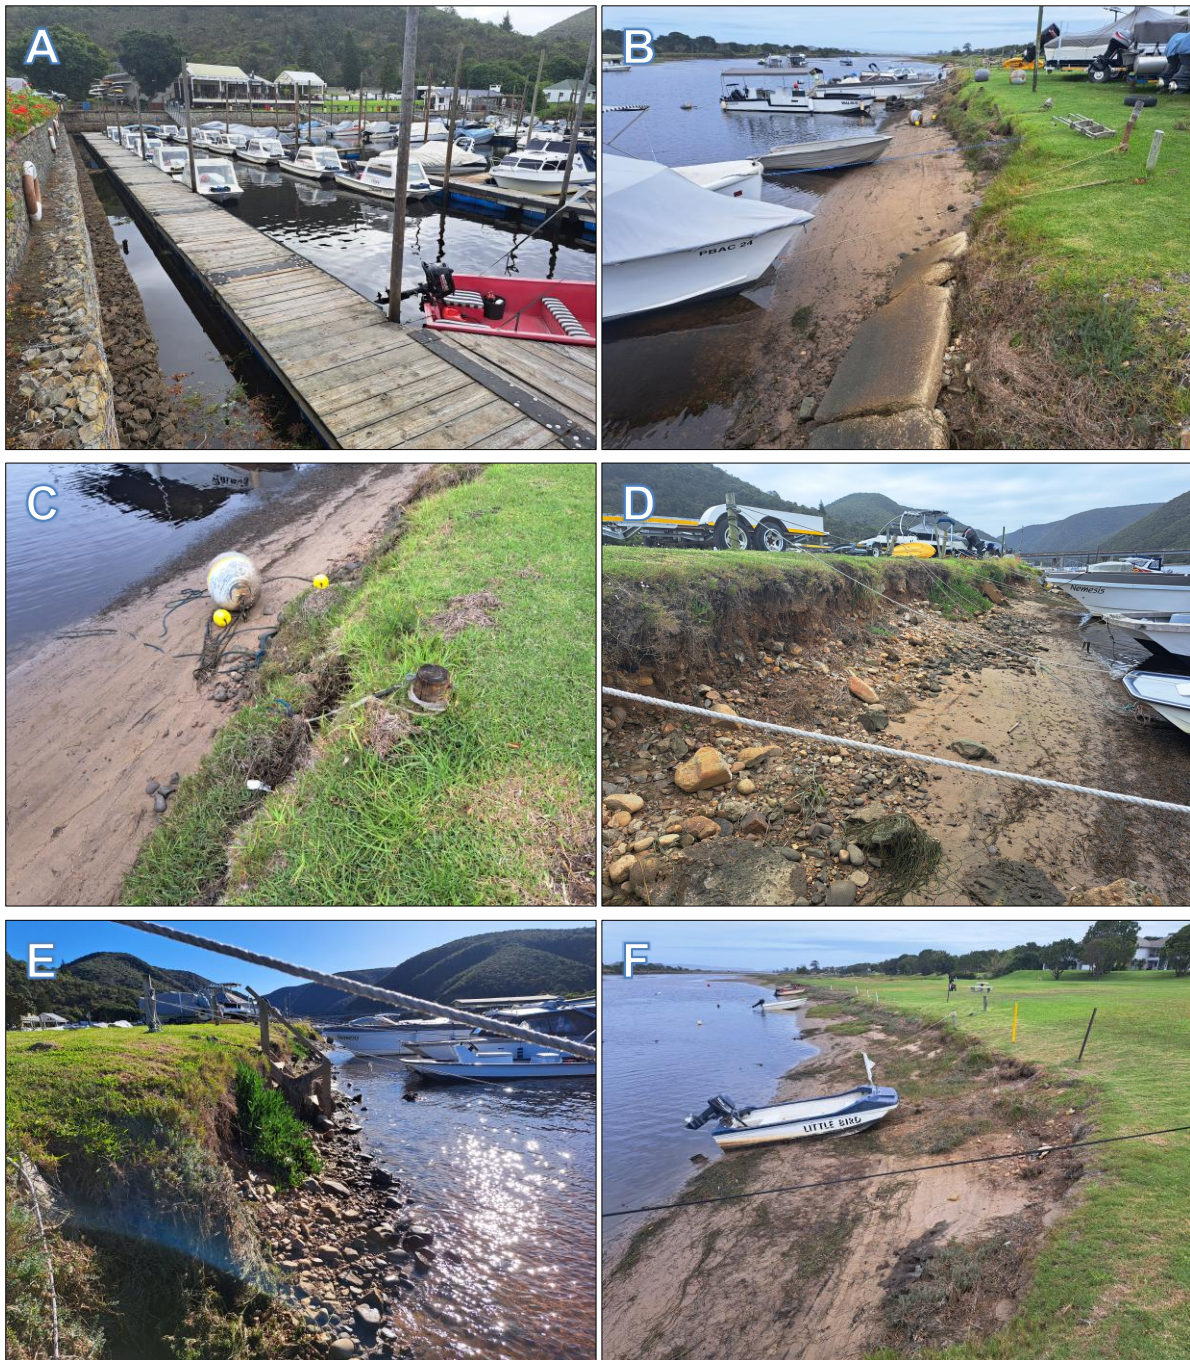
The inter-tidal zone consists of a narrow section mud flat/sand bank and the deeper sub-tidal zone is dominated by *Zostera capensis* on the bed of the estuary. This can clearly be seen in recent aerial images of the site (Figure 12). Numerous boats were moored along the banks (within the inter- and subtidal zone of the estuary) and are tied to wooden poles driven into the bank of the estuary. The stretch of the eroded bank therefore experiences frequent boat traffic

and while *Z. capensis* is abundant, is unlikely to provide suitable conditions for abundant numbers of *H. capensis* (Claassens and Hodgson, 2017) and other estuarine vertebrates (e.g. fish).

Figure 11: Photographs illustrating existing gabions and jetties at the PBAC (A); boats mooring along the eroded bank (B); actively eroding banks (C to E); and the estuary banks further downstream where erosion is not as severe (F).

In summary, the impacts associated with Options 1 to 3 are considered acceptable. Of the three proposed alternatives, Option 2 is most recommended as it is consistent with other bank stabilisation structures that have been implemented at other locations in the estuary.

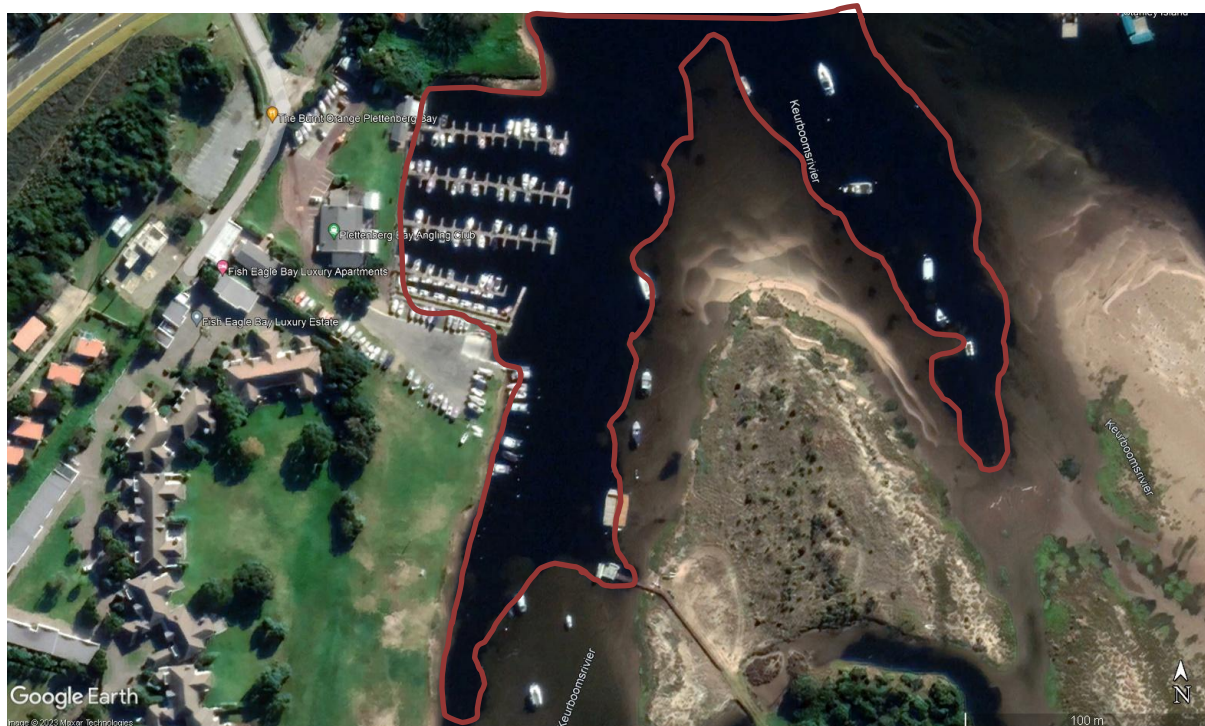
Figure 12: Google Earth image (2022) indicating the extent of *Z. capensis* in the vicinity of the PBAC.

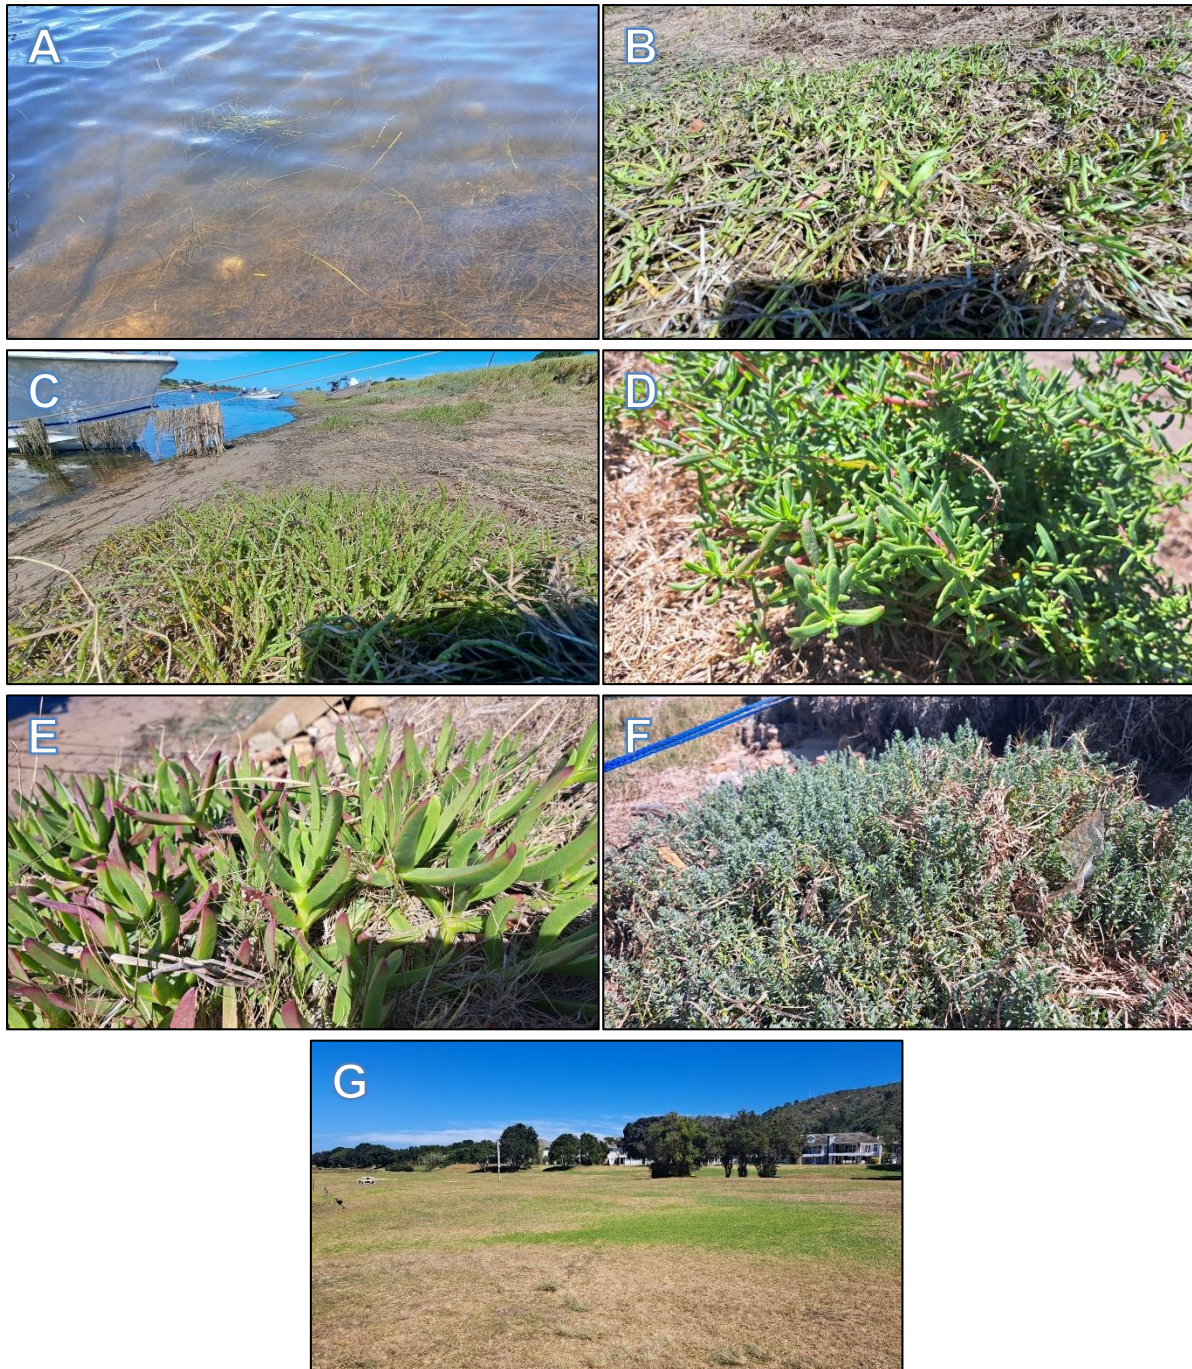
The terrestrial component of the PAOI consists of a large, open grass lawn comprised predominantly of a mixture of low growing grass species (invasive *Clandestinus cenchrus* and indigenous *Cynodon dactylon*). No trees or shrubs were present within or close proximity to the PAOI. The inter-tidal zone habitat is very narrow (exposed sand banks at low tide are less than 3 m in width) and is used to moor boats along the shoreline. Vegetation is limited, consisting of *Z. capensis* within the inundated subtidal zone of the estuary and isolated patches of salt marsh species along the outer edge of the inter-tidal zone (Figure 3). Other terrestrial/ estuarine species observed are illustrated in Figure 13. Apart from *Z. capensis* no other SCC were observed within the PAOI and are also deemed to have a very low probability of occurrence due to the complete transformation in natural terrestrial habitat that has occurred.

Figure 13: Plant species observed at the site, including *Z. capensis* (A) *Plantago carnososa* (B) *Salicornia* sp. (C) *Tetragonia fruiticosa* (D) *Carpobrotus* sp. (E) *Chenolea diffusa* (F) and transformed terrestrial habitat adjacent to the bank of the estuary (G).

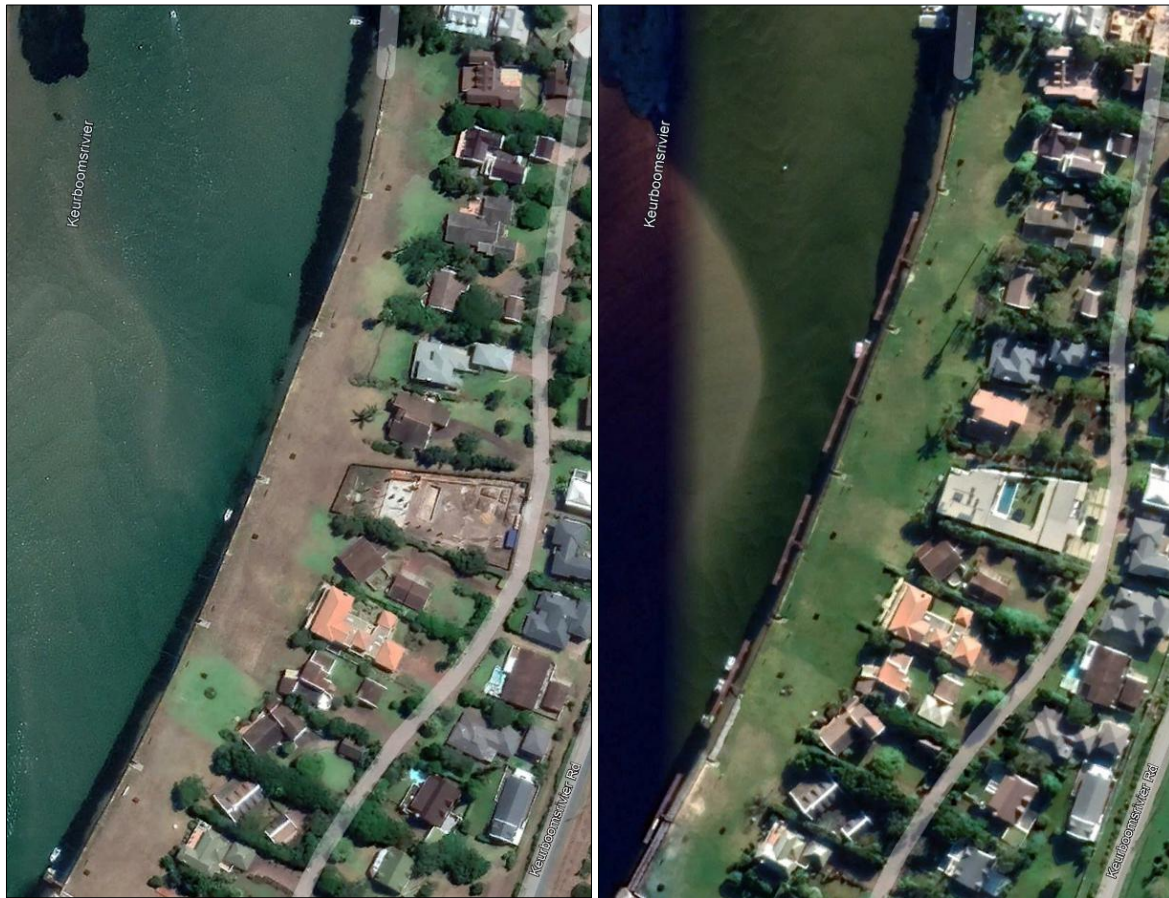
It is worth noting that similar bank stabilisation structures have been implemented at other locations along the estuary bank. This author has had experience with the San Marino Estate and the Silverstreams River Estate, both of which occur along the eastern bank of the estuary. In both these cases, a sloped reno mattress stabilisation structure, similar to Option 2 was implemented - in combination with the construction of floating jetties. In both cases, the reno mattress replaced a pre-existing vertical wooden bank stabilisation structure. The Silverstreams River Estate bank stabilisation commenced in the beginning of 2019 and was

completed in the same year. The bank stabilisation (and jetty construction) has not had a serious impact on *Z. capensis* beds which are still present post construction (Figure 14).

Figure 14: Google Earth images showing *Z. capensis* beds pre (left) and post (right) construction of bank stabilisation and floating jetties along the eastern bank of the Keurbooms Estuary.

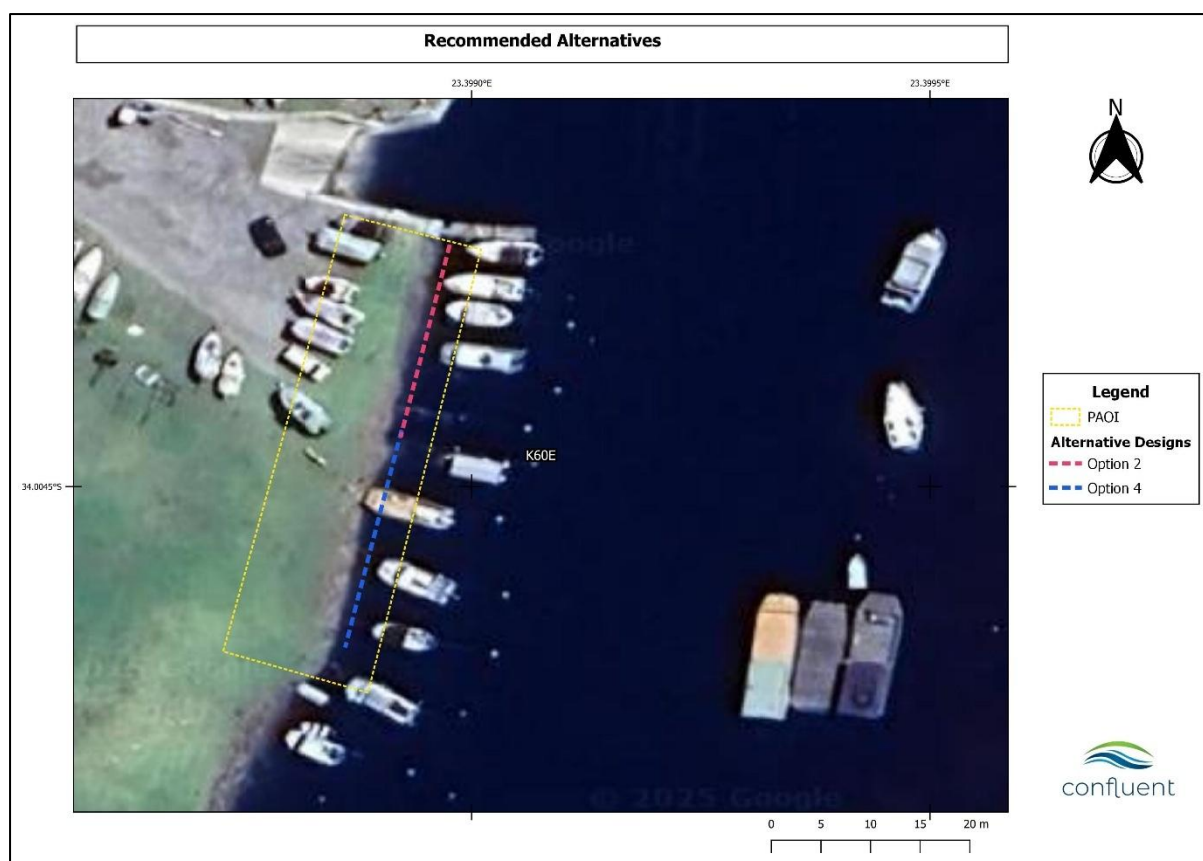
Figure 15: Map illustrating the recommended alternatives options to be implemented to address bank erosion along the estuary shoreline.

Option 4 will result in lower construction phase impacts but will not yield any positive long-term erosion control benefit if mooring of boats and pedestrian traffic along the banks is allowed to continue. Even if boat mooring and pedestrian traffic are to be controlled, the close proximity of the tarred car park to the edge of the re-profiled estuary bank would most likely compromise the integrity of the bank in the long-term. This option would however be preferable downstream of the tarred car park as there will be sufficient space to accommodate and protect the re-profiled bank. It is therefore recommended that Option 2 be implemented adjacent to the tarred area and - provided that mooring of boats and pedestrian traffic is prohibited - that Option 4 is implemented further downstream (Figure 15). This recommendation would whilst minimising the footprint of hard engineered structures along the shoreline and represents the best compromise of the options assessed.
