# HERITAGE IMPACT ASSESSMENT

# PROPOSED REZONING AND RESIDENTIAL DEVELOPMENT ON ERF 155 KEURBOOMSTRAND, PLETTENBERG BAY

14 June 2022

HWC CASE REFERENCE: 21060110AM0615E

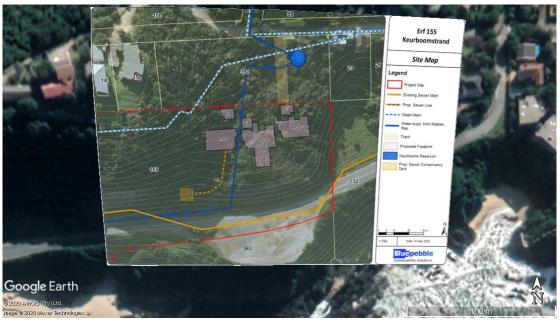
Figure 3: Map of preferred layout, Development Option C (Alternative 1 as per VIA), of Keurboomstrand residential development (Nilssen, 2021)

Initially three development options were proposed by the developer and informed by site sensitivities. Development Option C was selected as the preferred alternative. Since the NID, two more design alternatives have been drafted to respond to the specialist studies that have been completed (PIA, AIA, VIA).

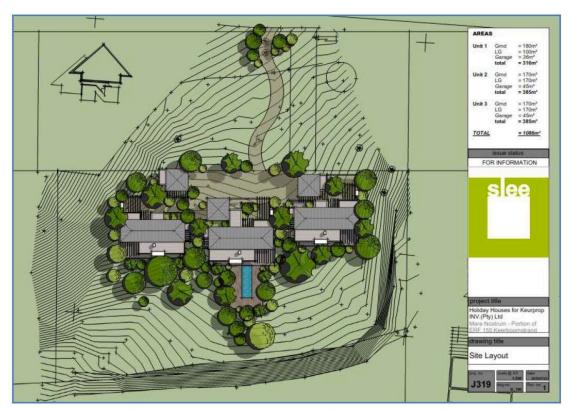
Figure 5: Site layout preferred option (Option C/ Alternative 1)(Slee architects, 2020)

The buildings are double storey with flat roofs throughout, with a total height of 7,1m measured from top of finished floor level. All the buildings are proposed on the same height, which will require cut and fill to create what is essentially one platform for all three structures. This total height is exceeded in six places by the chimney stacks, which measure 8,1m in height.

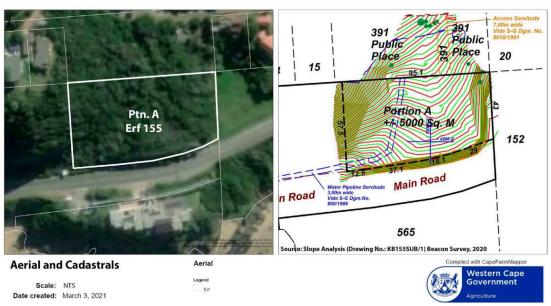
Figure 7: Aerial image of site alongside site survey (Smit, 2021)

The subject site is undeveloped, containing no existing buildings, services or infrastructure (with one exception being some decommissioned water pipelines and associated infrastructure). It is offset from the nearest road (Main Street) by the 27m width of the adjoining public place (Erf 391), which shares its northern boundary. Its southern boundary is delineated by the 25m wide road servitude set out for Main Road 394, which is the main access and entrance road for the whole of the Keurboomstrand town. The eastern and western boundaries are shared with Erf 152 and Erf 155, respectively.

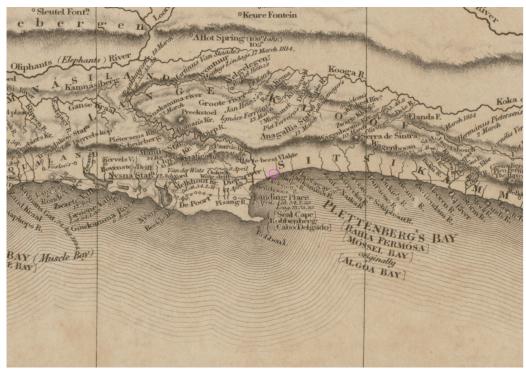
Figure 8: Excerpt from Burchell's 1822 map of the Cape Colony showing approximate location of Keurboomstrand development site in pink.

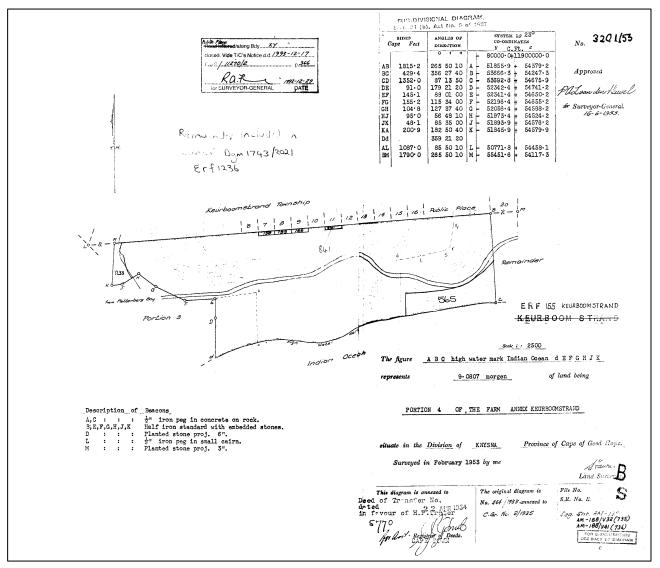
Figure 10: 1953 SG Diagram of Ptn 4 of Farm Annex Keurboomstrand, now Erf 155, showing the historic road running past the site to Plettenberg Bay (Cape Farm Mapper, June 2022).

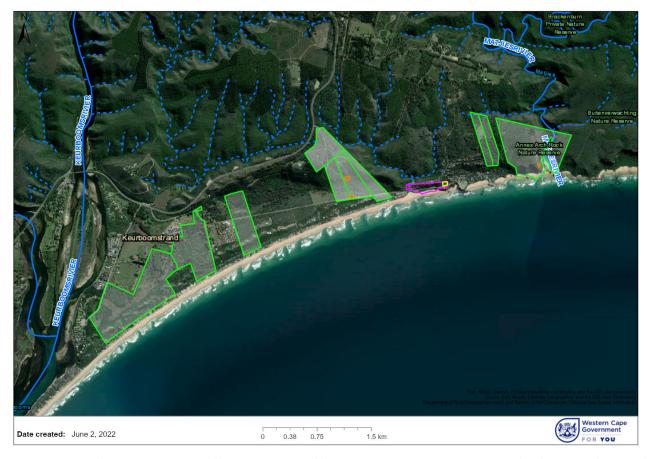
Figure 11: Map showing portions of the area surveyed for previous AIA reports (SAHRIS database) as discussed (green), Keurbooms 155 (pink) and proposed development site (yellow). The orange polygons represent identified archaeological sites as per the reviewed reports. The green polygon furthest east includes the site of Matjes River Rock Shelter.

Webley's 2001 Phase 1 AIA of Ptns 1/15, 92 and R16 of Farm Matjiesfontein, No 304 Keurboomstrand found two possible areas of archaeological settlement sites, neither substantial in size or remains. Site 1 represented a very diffuse scatter of shell in the disturbed soil around the recently constructed brick utilities building. Site 2 had some large undiagnostic quartzite stone tools scattered around the forest at the base of a footpath, which are imported from elsewhere and probably not in context. The recommendations were for care to be taken by developer to avoid destroying archaeological sites which may be buried beneath the soil surface with the following features to be aware of: 1 dense accumulations of marine shell, concentrations of shell associated with pieces of bone, pottery and stone artefacts, concentrations of fossilized bone and human remains.

Webley's 2004 Phase 1 AIA of of Ptns 1 and 2 of Arch Rock 296, Plettenberg Bay observed no archaeological sites during the foot survey of the area above the cliff face, however the extremely dense vegetation is mentioned as a limitation in the survey process. The report recommended that development may proceed but that the following archeological material/ sites may still be uncovere during levelling of the soil: 1) concentrations of stone tools, 2) shell middens, 3) human remains, including burials and 4) remains of earlier stone structures.

ACRM's 1999 AIA for the Sanderlings development located one archaeological site comprising of low density scatter of fragmented shellfish remains, weathered OES and stone flakes on a high, partially vegetated sand dune on the eastern boundary of the study area. The site was given a low conservation rating. A few quartzite chunks were located on the south facing barrier dunes and a number of stone tools alongside the gravel roads, none of which were considered significant. This site was also 'severely vegetated' resulting in low archaeological visibility. The report recommended that the site was suitable for development, however some archaeological monitoring may be required if development should take place in the vegetated frontal dunes and that human burial remains may be uncovered during development.

Deacon's 2001 Phase 1 AIA at Farm Arch Rock 296, Keurboomstrand identified a 'conservation-worthy' MSA site at the top of the cliff above the Matjes River Rock Shelter with associated quartzite and silcrete flakes dated to around 100 000yrs old. It's value is on a landscape scale as a record of where MSA occupations took place. No other archaeological materials were noted. It was recommended that the development avoid the MSA site with a 50m buffer around the site.

ACRM's 2001 HIA for Ptn 10 of the Farm Matjiesfontein No 304, Keurboomstrand identified "no significant archaeological or heritage remains". A few small, discreet patches of shellfish remains, OES and two stone flakes were located in open patches on the steep north facing slopes of the large barrier dunes which probably represent small food parcels consumed by prehistoric people during visits to the beach. No cultural material was found associated with the shell and no archaeological remains were located in the frontal dunes. Kaplan mentions the very limited archaeological visibility in the area between the barrier dunes and the escarpment. The report recommended that 1) an archaeologist assess the site after vegetation clearing and 2) sampling if any identified significant sites. The possible uncovering of human remains was also mentioned.

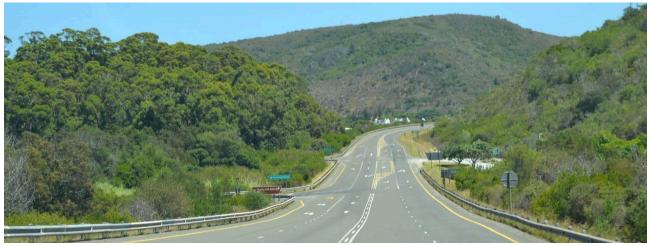
Figure 12: Site photograph of the N2 freeway just before the Keurboomstrand access road turnoff (left), demonstrating the typical inland topography and vegetation cover (Smit, 2021)

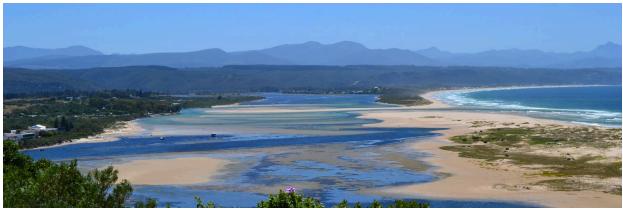
Figure 13: Site photograph illustrating topographical and landform features: mountain backdrop, deeply incised forested river valleys on the inland plateau; estuaries, lagoons and either dune systems or rocky headlands at the coast (Smit, 2021)

- Long sandy beaches of the crenulate bay and small coves;
- The Keurbooms river valley and estuary;
- The vegetated coastal dune systems and the dune slack area directly inland;
- Urban development areas (medium to high density settlement);
- The inland coastal plateau containing minor and major river valleys (forested \_commercial and indigenous);
- Rural settlements within the inland coastal plateau;
- Vegetated foothills at the coast, which give way to hard rock cliffed coasts with rock shore platforms (interrupted by small sandy river mouths).

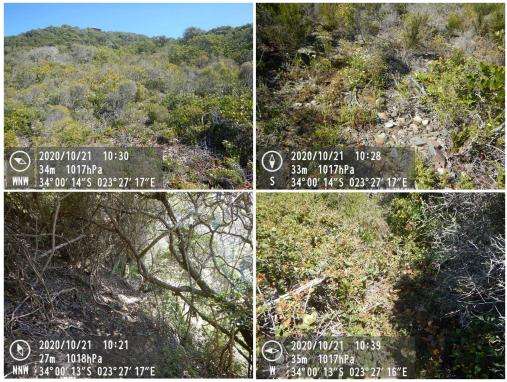
Figure 14: Examples of the affected environment showing topography, vegetation cover and exposed surfaces

Apart from existing development activities, disturbances and modern rubbish on Erf 391, there is no evidence of historic or prehistoric occupation of Erf 391 or Erf 155. Existing developments include a water reservoir, pipelines, levelling and trenching for pipelines, small excavations or disturbances and a small electrical "sub-station". The litter on site is mostly on Erf 391 and includes plastic, glass, piping, a vehicle tyre, and so on. No refuse of historic or prehistoric interest or significance was seen on site.

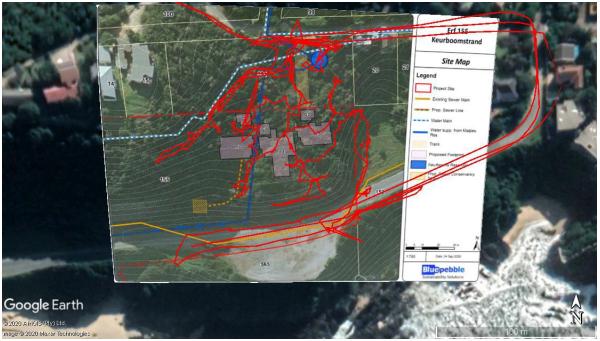
Figure 15: GPS fixed tracks (red lines) of the site inspection overlaid on the conceptual site development plan for the eastern extent of Erf 155 and Erf 391, Keurboomstrand. Courtesy of Bluepebble (Mr Jonathan Kingwill) and Google Earth 2020.

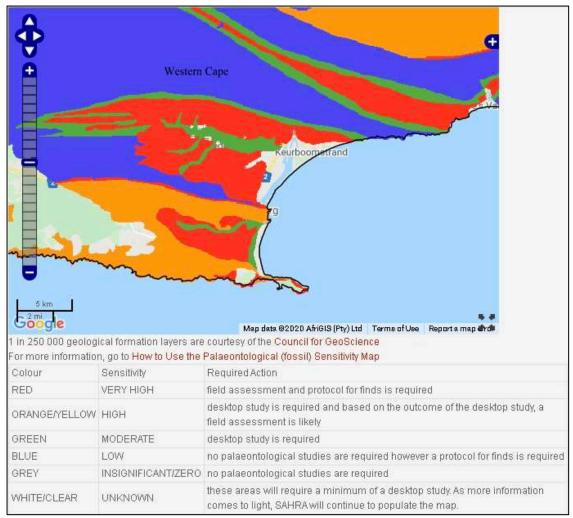
Figure 16: Extract from the SAHRIS Palaeosensitivity Map on the SAHRIS Website showing the Medium Sensitivity assigned to bedrocks in the Keurboomstrand residential development project area on the south coast near Plettenberg Bay (yellow circle). The Gydo Formation (Bokkeveld Group) bedrocks here are normally assigned a High palaeosensitivity. The site visit indicates that their palaeosensitivity is LOW, however. (Almond, 2021)

There are therefore no objections on palaeontological heritage grounds to authorisation of the housing development, and no specialist palaeontological monitoring or mitigation measures are proposed here, pending the potential discovery of new fossil finds during the construction phase.

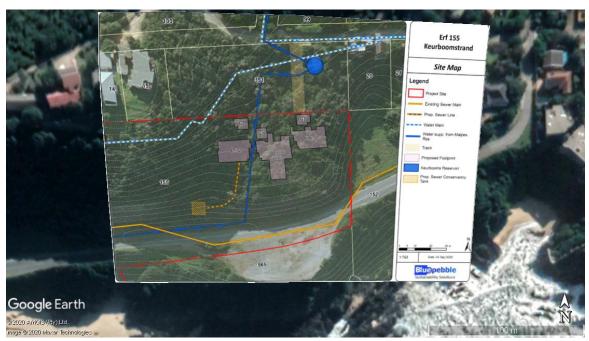
Figure 17: Conceptual site development plan overlaid on the eastern extent of Erf 155 and Erf 391, Keurboomstrand. Courtesy of Bluepebble (Mr Jonathan Kingwill) and Google Earth 2020 (Nilssen, 2020).

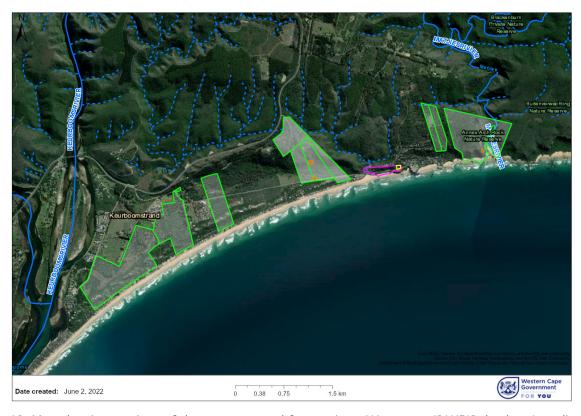
Figure 18: Map showing portions of the area surveyed for previous AIA reports (SAHRIS database) as discussed (green), Keurbooms 155 (pink) and proposed development site (yellow). The orange polygons represent identified archaeological sites as per the reviewed reports. The green polygon furthest east includes the site of Matjes River Rock Shelter.

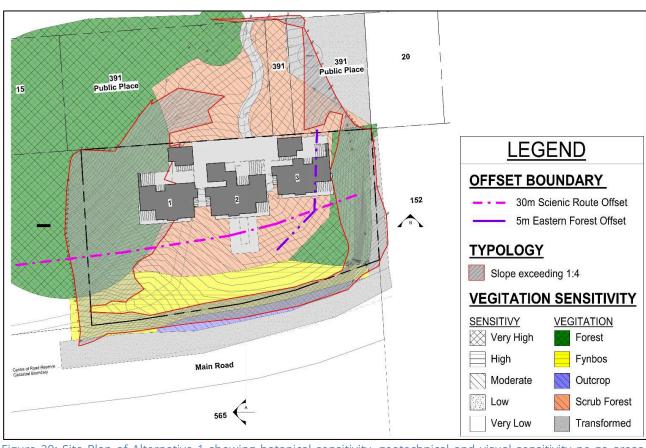
Figure 20: Site Plan of Alternative 1 showing botanical sensitivity, geotechnical and visual sensitivity no-go areas and setbacks/offsets over site contours. (van der Merwe, 2021)

To augment the botanical and geotechnical sensitivity mapping, the following visual sensitivity parameters have been established and should be adhered to in the final proposal for all alternatives:

- a) A <u>35m Scenic route setback</u> (offset) that delineates a no-go area for development on the site from the part of the receiving environment with the highest exposure and sensitivity;
- b) Additional <u>5m offset</u> from the eastern ecological and slope sensitivity exclusion area, to ensure that the dense forest vegetation screening views of the proposed development from the east remains unaffected by development.
- c) Adherence to the key parameters of the Architectural Guidelines (Pg 118, Smit VIA, 2022)

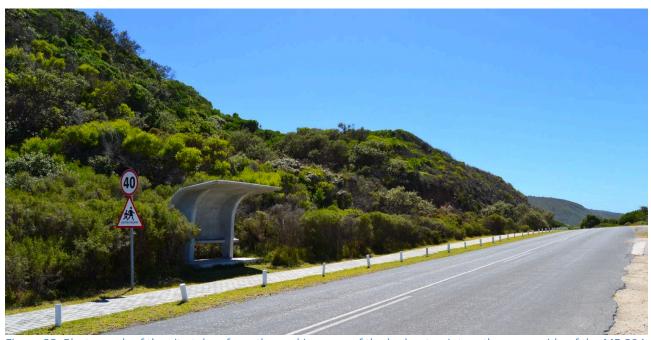
Figure 23: Photograph of the site taken from the parking area of the lookout point on the ocean side of the MR 394 scenic route. Note the steep cutting and density of vegetation covering the site (Smit, 2021)

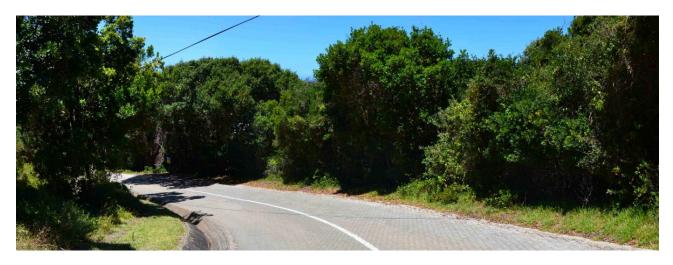
Figure 24: Site photograph taken from the junction of Game and Main Streets, approximately 50m from the subject property boundary. The vegetation in the foreground is growing on Erf391 upslope to the north (Smit, 2021)

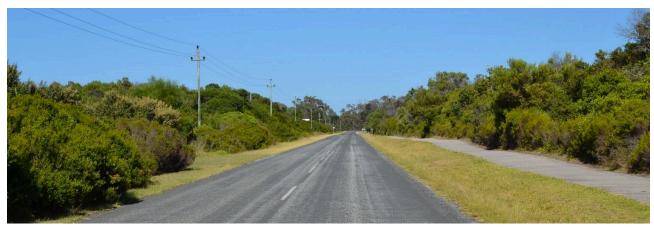
Figure 25: Site photograph (looking west) along the MR349, showing the roadway and the paved pedestrian route alongside. Note also the height of the vegetation alongside, typical of this stretch of road (Smit, 2021).

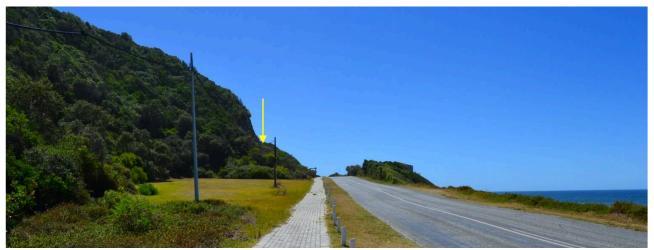
Figure 27: Site photograph taken from the pedestrian walkway alongside the MR394 scenic route at 150m from the project site, looking east (Smit, 2021)

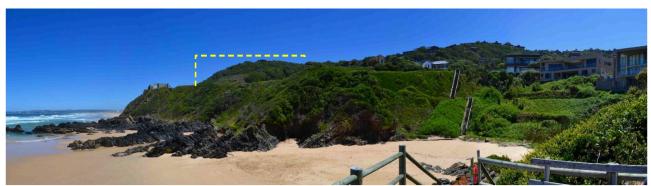
Figure 28: Site photograph taken from the publicly accessible private staircase across the small cove beach from the site, at 180m, looking west (Smit, 2021)

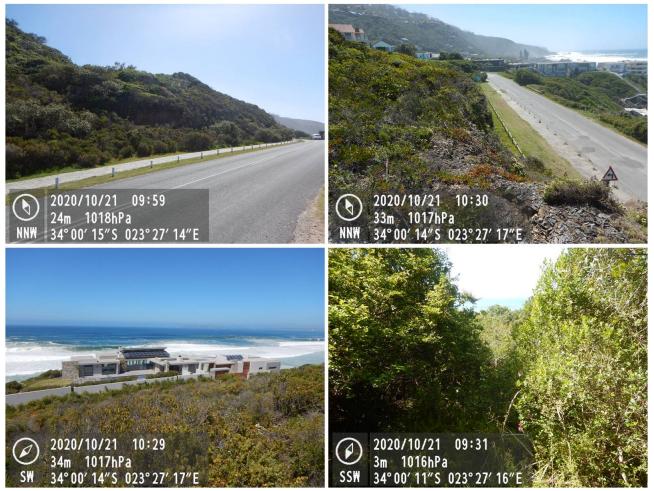
Figure 30: Examples of the affected environment showing topography, vegetation cover and existing developments in the immediate surroundings. Except top left, all views are from Erf 155. (AIA, Nilssen, 2020)

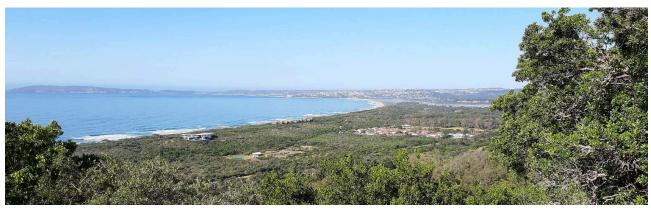
Figure 32: Site photograph taken from the old N2 (a scenic route), showing a view of the study area as the road winds its way down the outside of the hill slope overlooking the floodplain and estuary. These dramatic views are not enjoyed by the "new" N2 route which passes through a cutting further inland (van der Merwe, 2021)
