Aquatic assessment for proposed multi-use development on RE/1627, Sedgefield

Prepared by Dr. Jackie Dabrowski of Confluent Environmental (Pty) Ltd

July 2021

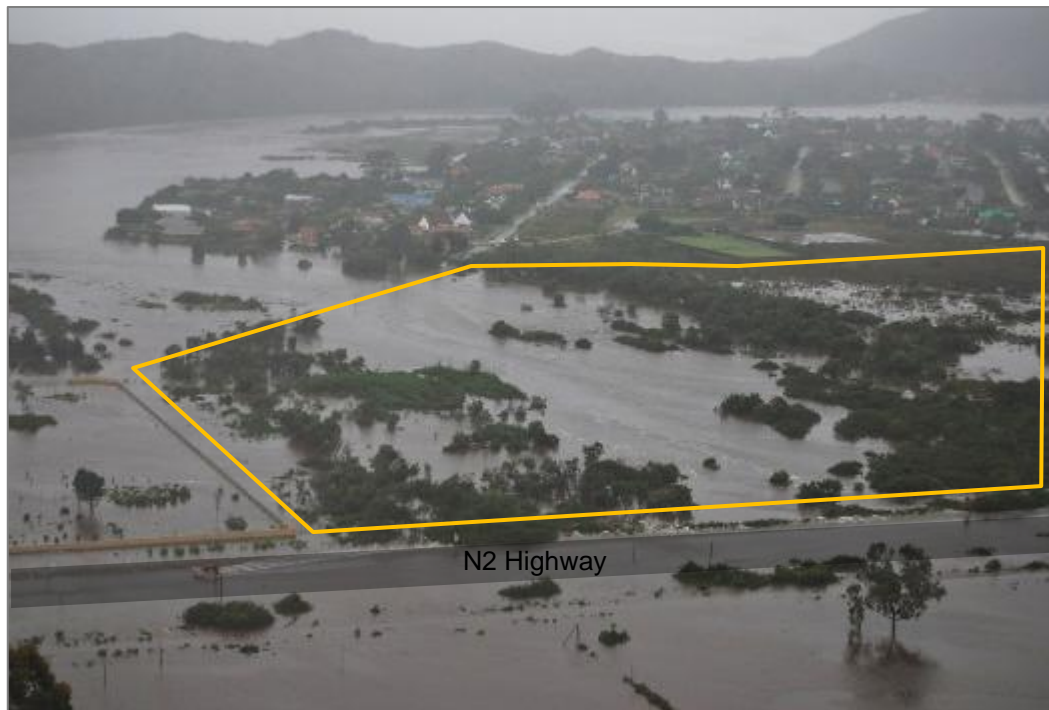
Figure 2. Photo of part of Sedgfield during flooding in 2007. View looking south shows the N2 Highway and the general area of RE/1627 (yellow area).

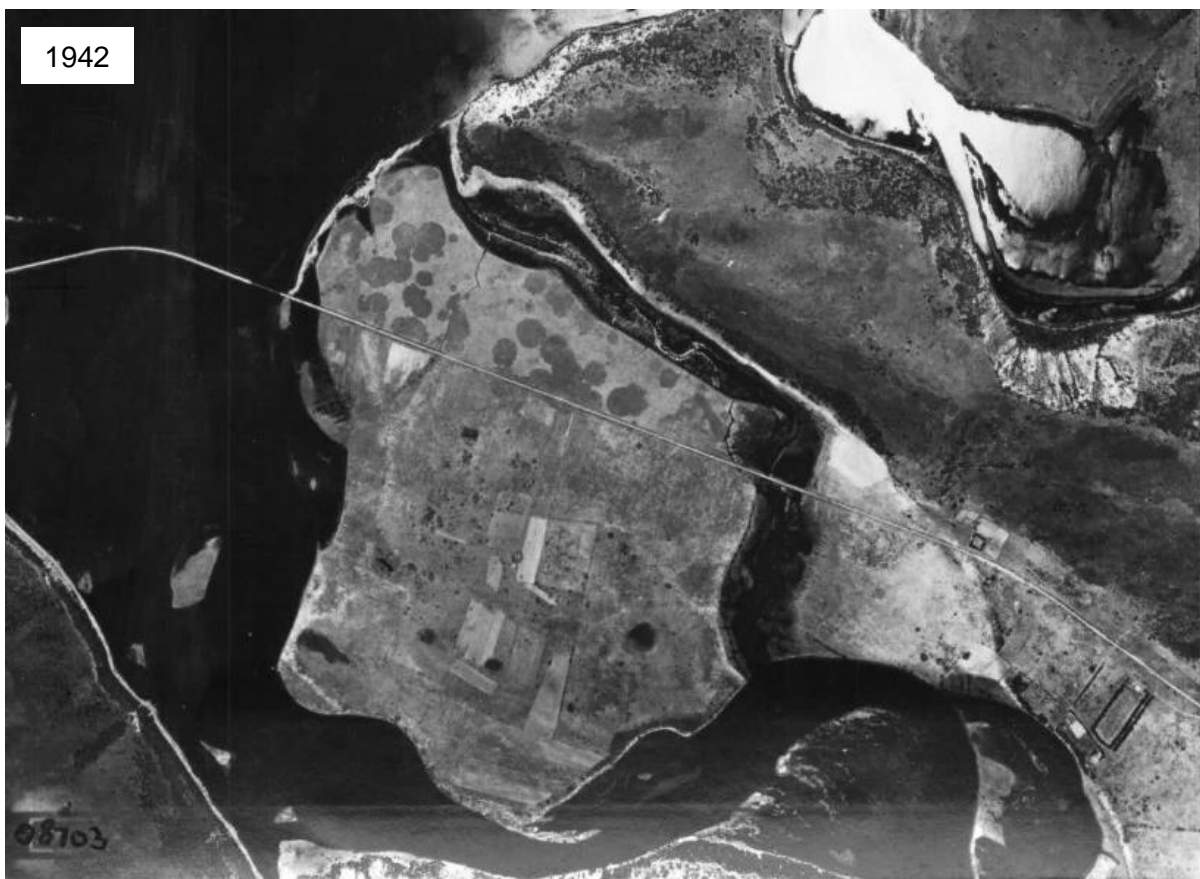
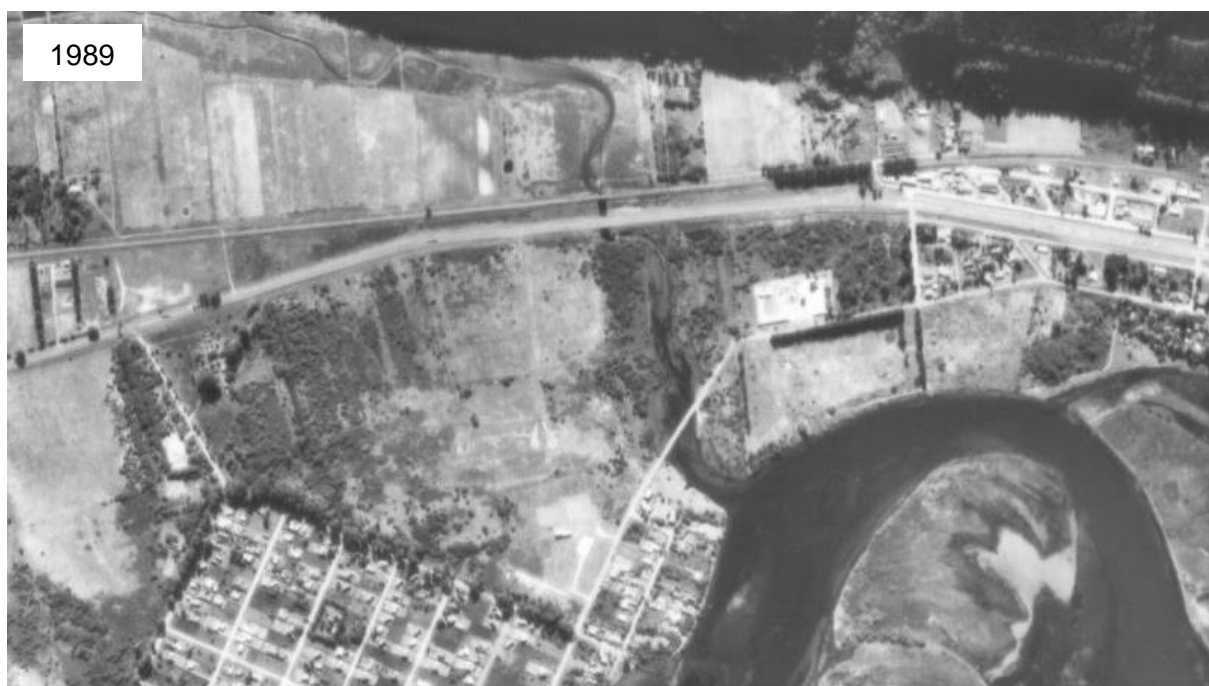
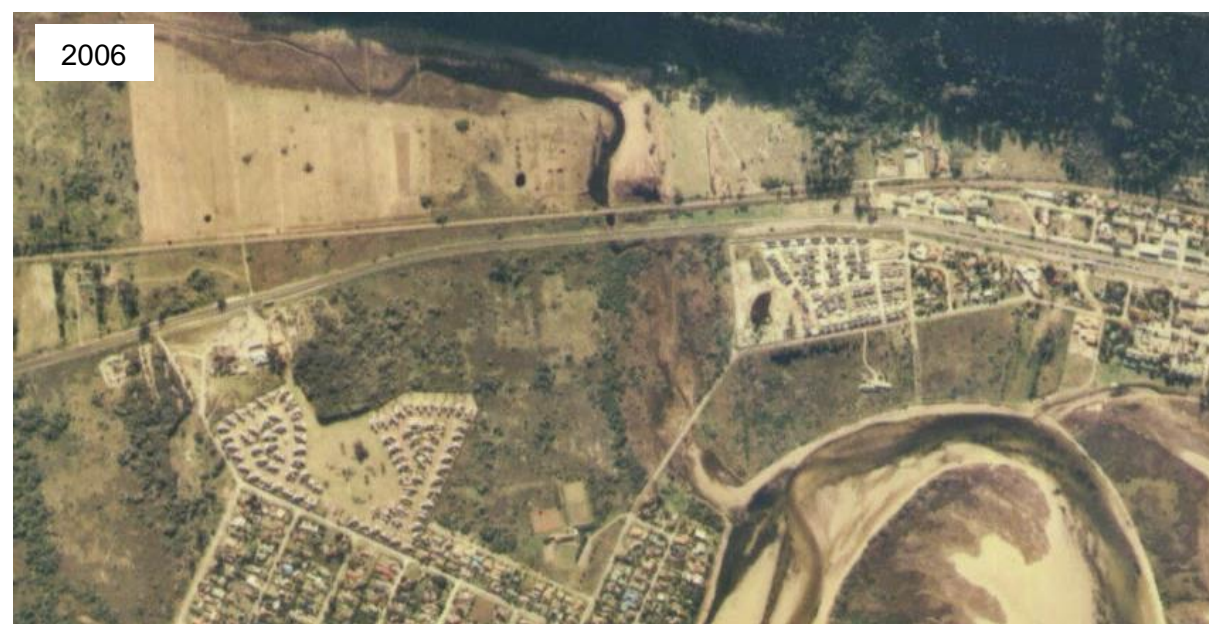
Figure 7. Historical aerial photos of the site in 1973, 1989 and 2006.

In 1942 little of present-day Sedgfield was developed (Figure 7). The road can be used as reference in this image as the N2 highway is still in this position. The Perdespruit was a far more distinct arm of the estuary in 1942, and minor agricultural fields were the only observable modification. In the following decades natural vegetation at the site was cleared for agricultural activities on either side of the Perdespruit. This is evident in a historical photo from 1973. The fields appear to have been abandoned over a decade later, as the 1989 image shows encroachment by bushy vegetation throughout the fields and into the Perdespruit. The road crossing the Perdespruit to the south of the property (Dr Malan) appears on the 1989 image for the first time. Bush encroachment is further advanced by 2006 and likely consisted of a large proportion of alien vegetation (Figure 7).

This observation is confirmed by the 1942 image in Figure 7.

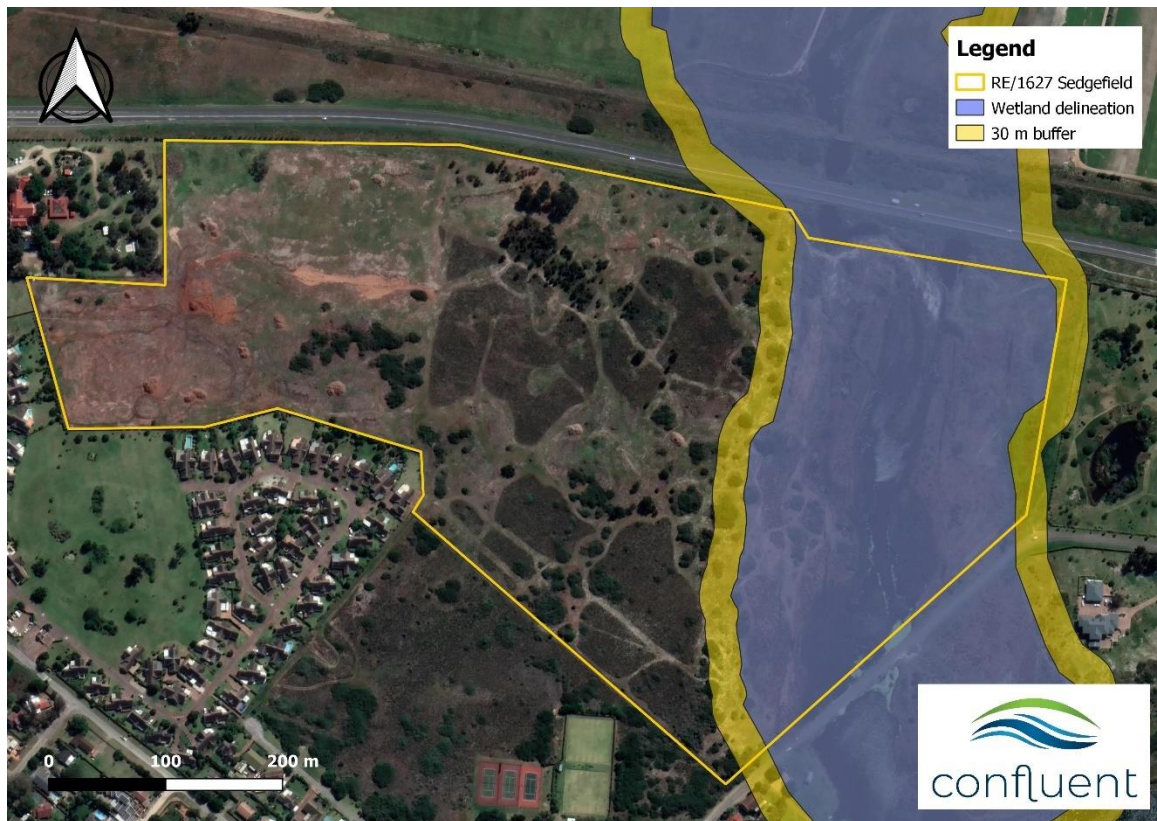
Figure 9. Delineated wetland area and associated 30 m buffer for RE/1627 Sedgefield.

The recommended buffer is **30 m** from the delineated edge of the wetland / estuarine area which is indicated in Figure 9. This buffer is applicable in both the construction and operational phase of development.

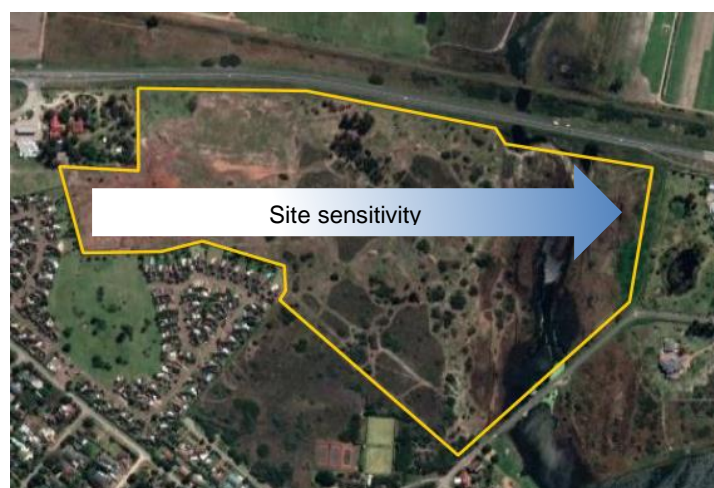
Figure 10. General direction of site sensitivity at RE/1627.

The proposed mixed-use development has not been finalised and is to be informed by site-specific ecological sensitivities. Generally, ecological sensitivity at the site follows a west-east gradient with less sensitive, more modified areas to the west, and more sensitive, less modified areas to the east (Figure 10). At a broad-scale level it is therefore recommended that development planning consider more intensive, higher impact developments to the west of the property and reserve lower impact, softer developments towards the east of the development area.

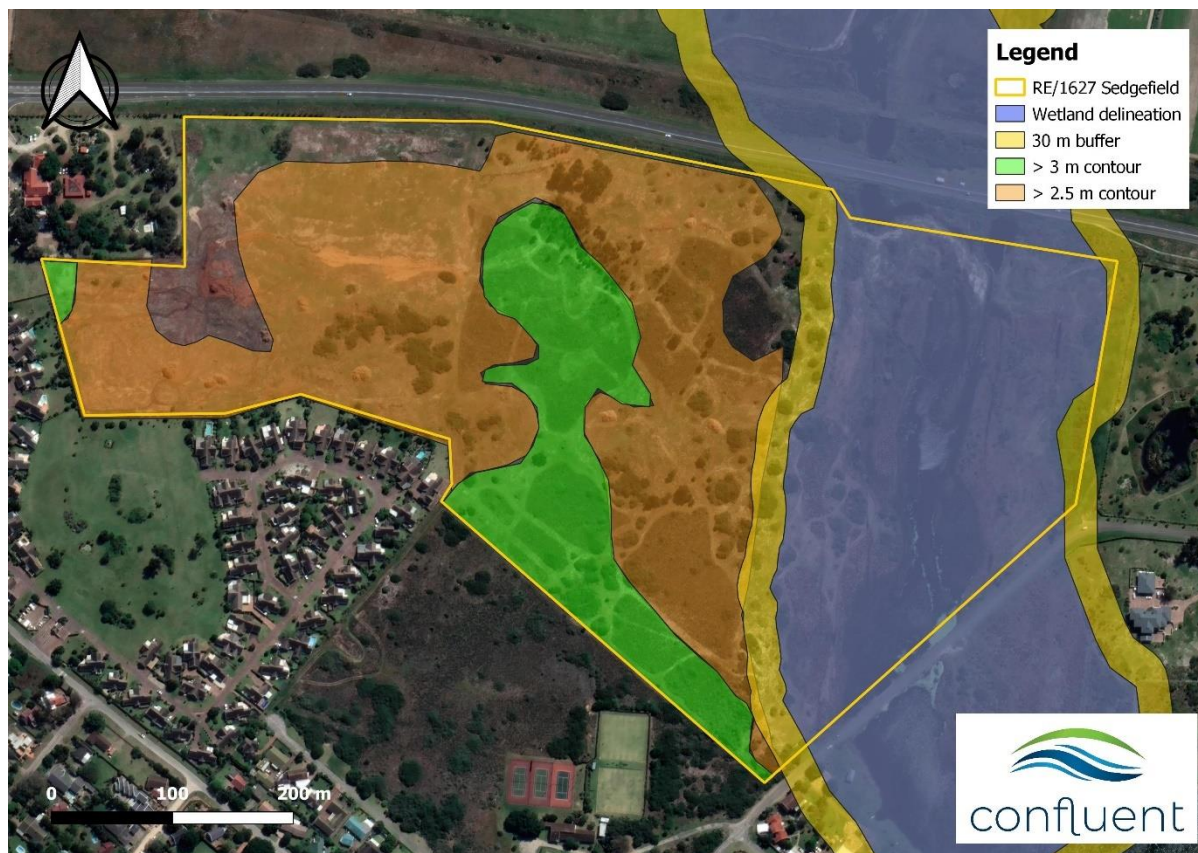
Figure 11. Synthesis of sensitive aquatic habitats and relevant surveyed contours.

This must be considered in conjunction with other factors such as the elevation of the site above sea level (Figure 11) and terrestrial sensitivities (vegetation and animals; Figure 5). While the wetland area on the property has been delineated and buffered to protect the water resource, the remaining area of the property is still entirely located within the EFZ. It is also sensitive to flooding as previously discussed.

It is recommended that infrastructure below the 2.5 m contour (open areas on Figure 11) be reserved to roads, walkways, and structures that can withstand being fully inundated and do not impede floodwaters (are porous).

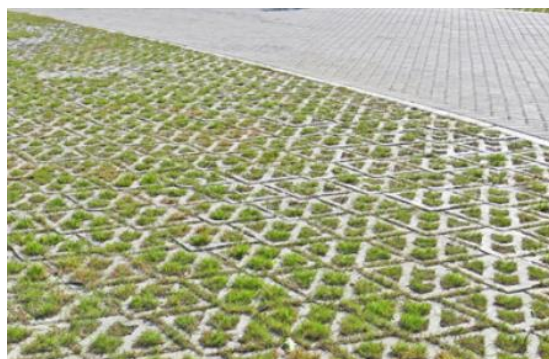
Figure 12. Example of grass pavers combined with conventional paving in a parking lot.

runoff. The use of pervious materials such as bark, gravel or grass pavers is recommended on as many parking areas, roads, and pathways (Figure 12).

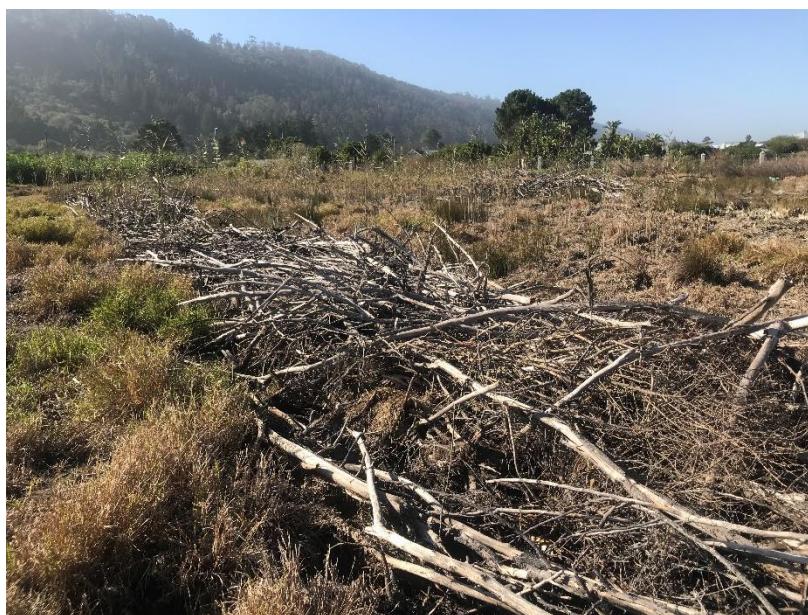
Figure 13. Channel within the wetland that has been filled with woody material which must be removed.

- Remove all woody material that has been dumped in one of the smaller channels along the western edge of the wetland (Figure 13). This practice is damaging to the watercourse as it restricts flow, causes sedimentation (clogging), smothers vegetation, and modifies natural processes. This practice should not occur anywhere within the wetland, and although commonly practiced in agriculture, should cease altogether as it constitutes a type of infilling which is unlawful.
