REPORT

On the Geotechnical Investigation undertaken for Erf 1058, Whites Avenue, Hoekwil, Wilderness in the Western Cape Province

REPORT DATE:	-	24 July 2023
PROJECT DESCRIPTION:	-	Erf 1058, Whites Avenue, Hoekwil, Wilderness, George Local Municipality
GPS Co-ordinates:	-	33°59'20.27"S 22°35'55.96"E
PREPARED FOR:	-	TESTPRO Laboratory (Pty) Ltd
PREPARED BY:	-	Casper Badenhorst

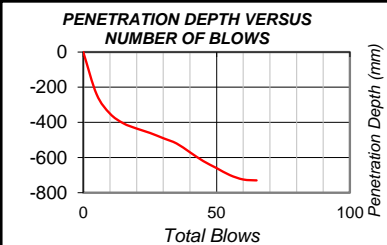
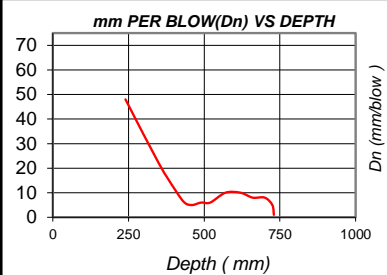
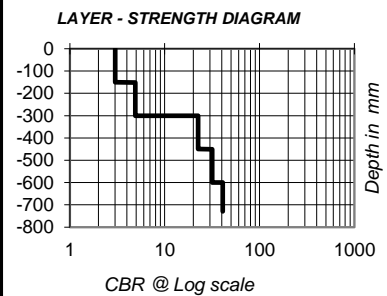
Comments: **Refusal at 730mm**

No.	Depth(mm) From-To	Dn (mm/blow)	Roads		Foundations
			CBR	UCS (kPa)	Bearing Capacity (kPa)
1	1-150	48	3	39	69
2	151-300	33	5	61	102
3	301-450	10	23	233	341
4	451-600	8	32	314	448
Max	601-730	6	41	393	548

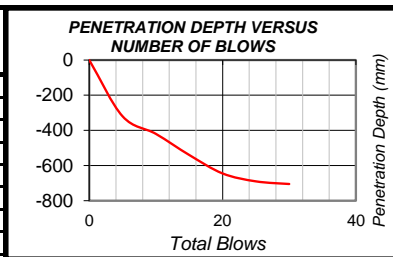
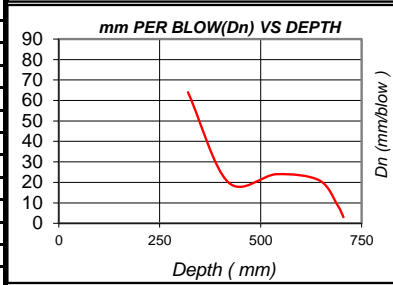
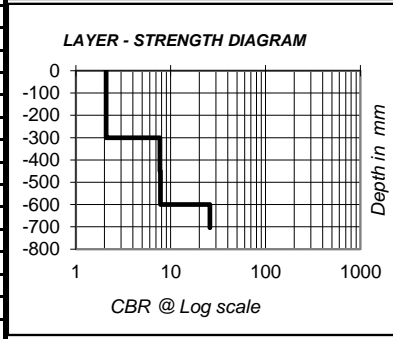
Comments: **Refusal at 705mm**

No.	Depth(mm) From-To	Dn (mm/blow)	In Situ Layer Strength		
			Roads CBR	UCS (kPa)	Foundations Bearing Capacity (kPa)
1	1-150	64	2	29	51
2	151-300	64	2	29	51
3	301-450	23	8	90	145
4	451-600	23	8	91	146
Max	601-705	9	26	263	381

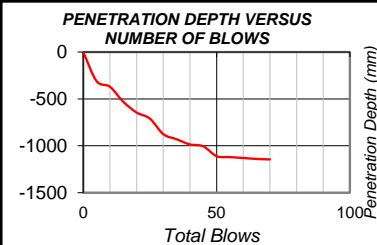
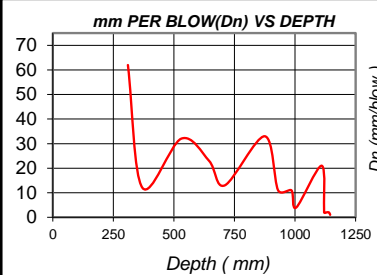
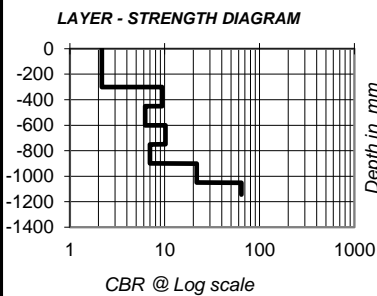
Comments: **Refusal at 1145mm**

No.	Depth(mm) From-To	Dn (mm/blow)	Roads		Foundations
			CBR	UCS (kPa)	Bearing Capacity (kPa)
1	1-150	62	2	30	53
2	151-300	62	2	30	53
3	301-450	20	9	108	170
4	451-600	27	6	75	122
5	601-750	18	10	116	181
6	751-900	25	7	83	134
Max	1051-1145	4	64	585	785

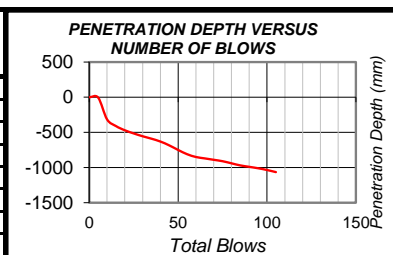
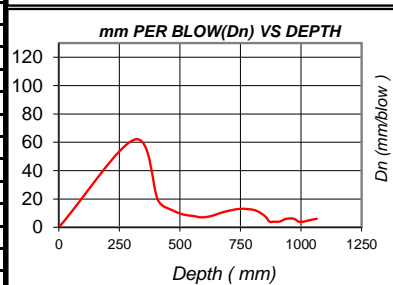
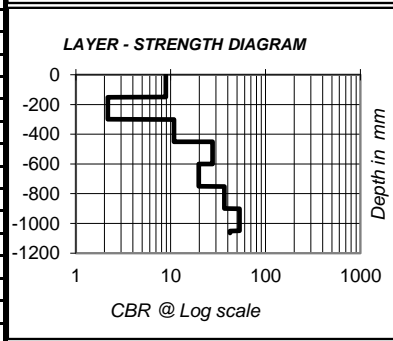
Comments: **Refusal at 1065mm**

No.	Depth(mm) From-To	Dn (mm/blow)	Roads		Foundations
			CBR	UCS (kPa)	Bearing Capacity (kPa)
1	1-150	20	9	103	163
2	151-300	62	2	30	53
3	301-450	17	11	122	190
4	451-600	8	28	278	401
5	601-750	11	20	207	307
6	751-900	7	37	359	504
Max	1051-1065	6	42	403	561

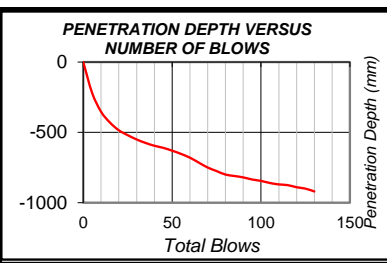
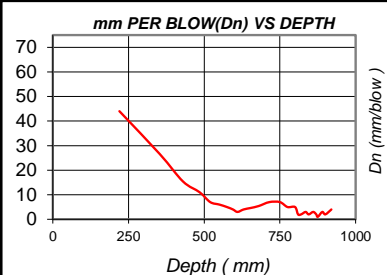
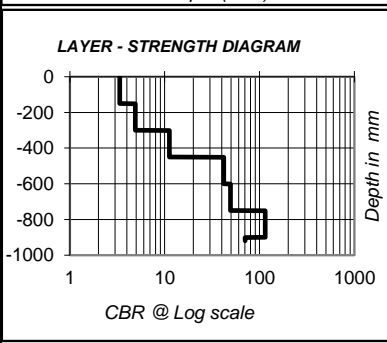
Comments: **Refusal at 920mm**

No.	Depth(mm) From-To	Dn (mm/blow)	Roads		Foundations
			CBR	UCS (kPa)	Bearing Capacity (kPa)
1	1-150	44	3	44	75
2	151-300	33	5	61	101
3	301-450	17	11	126	196
4	451-600	6	42	401	557
5	601-750	5	49	464	636
6	751-900	3	115	972	1244
Max	901-920	4	70	635	845

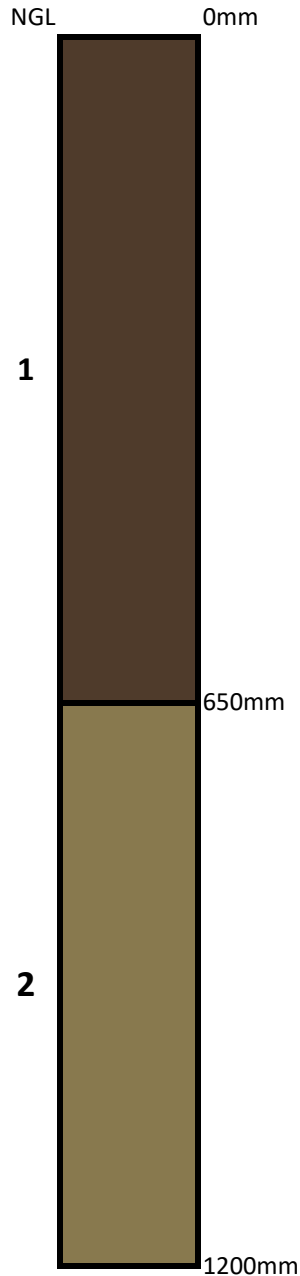
TEST PIT 1 : PROFILE

1 Moist, dark brown, loose, soft, fine intact transported sandy topsoil with organic material. No sample.

2 Moist, yellowish orange olive, dense to very dense, stiff, medium coarse intact residual weathered granite gravel. Sample no 2789.

No seepage water was observed.
Refusal in test pit at NGL -1200mm.
Excavation method : Mini tracked excavator
Date of excavation : 4 July 2023

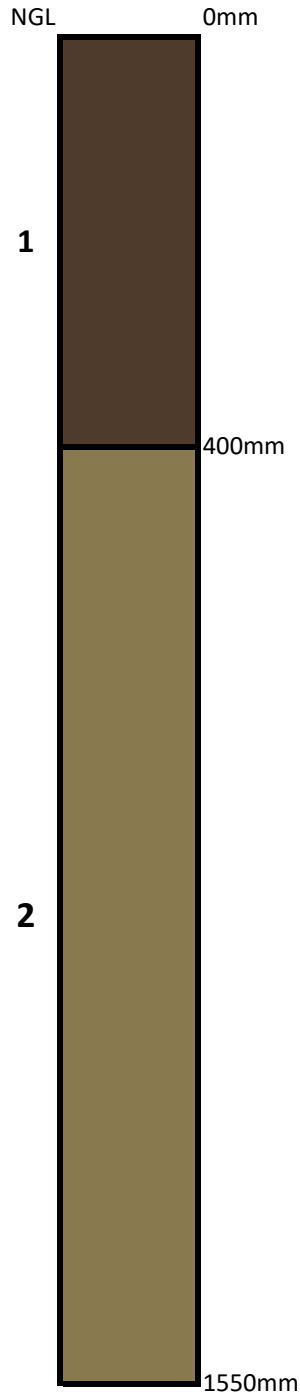
TEST PIT 3 : PROFILE

Moist, dark brown, medium dense, soft, fine intact transported sandy topsoil with organic material. No sample.

Moist, orange to yellow grey olive, dense, stiff, medium coarse intact residual clayey weathered granite gravel. Sample no 2788.

Seepage water was observed at NGL -640mm.
No refusal in test pit.
Excavation method : Mini tracked excavator
Date of excavation : 4 July 2023

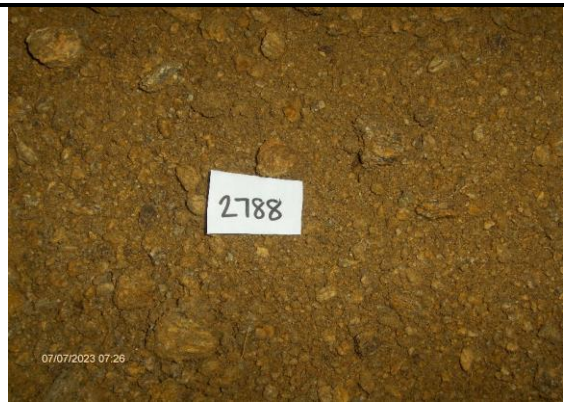
5 Voorbaai Crescent, Bayview, Hartenbos Tel. : (044) 695 0831		P.O. Box 35, Hartenbos, 6520 e-mail : jaco@testpro.co.za																																																																																																																																																																									
Client:	Wealth Spring (Pty) Ltd Erf 1058 Hoekwil	Date Reported:	19/07/2023																																																																																																																																																																								
		Job nr:	TP19163																																																																																																																																																																								
		Specification:	COLTO																																																																																																																																																																								
		Order no:	-																																																																																																																																																																								
Attention:	Alexander Polson, 0824819434	Project: Geotechnical Investigation: Erf 1058 Whites Avenue, Hoekwil, Wilderness																																																																																																																																																																									
SOIL ANALYSIS TEST REPORT																																																																																																																																																																											
SAMPLE INFORMATION		MATERIAL PROPERTIES																																																																																																																																																																									
Material Description	Orange to yellow grey olive clay weathered granite gravel																																																																																																																																																																										
Source	Test Pit 3	Position/ Layer	Layer 2																																																																																																																																																																								
Date Received	05/07/2023	Date Tested	18/07/2023																																																																																																																																																																								
Sampling Method	TMH5:MA2	Sample Number	2788																																																																																																																																																																								
MOD, BD & AD Analysis																																																																																																																																																																											
MDD	2074	OMC	7.0																																																																																																																																																																								
BD	-	WA	-																																																																																																																																																																								
AD	-																																																																																																																																																																										
Method	Scalped	% Scalped	0.0																																																																																																																																																																								
Uncertainty																																																																																																																																																																											
MDD		OMC

<table><tr> <th>Test</th> <th>Results</th> <th>Specifications</th> <th>Opinion</th> </tr><tr> <td>Grading Modulus</td> <td>1.4</td> <td>0.75<2.7</td> <td style="text-align: center;">✓</td> </tr></table>

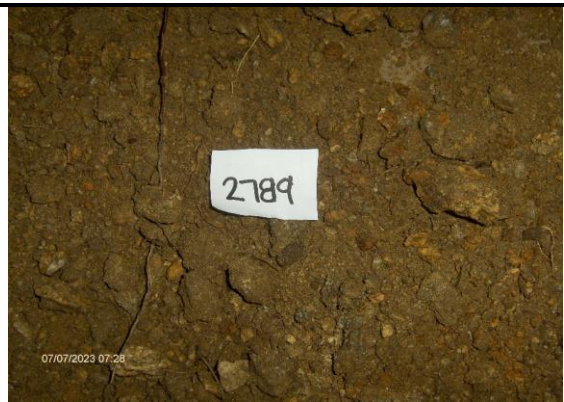
5 Voorbaai Crescent, Bayview, Hartenbos Tel. : (044) 695 0831		P.O. Box 35, Hartenbos, 6520 e-mail : jaco@testpro.co.za	
Client:	Wealth Spring (Pty) Ltd Erf 1058 Hoekwil	Date Reported:	19/07/2023
		Job nr:	TP19163
Attention:	Alexander Polson, 0824819434	Specification:	COLTO
		Order no:	-
		Project:	Geotechnical Investigation: Erf 1058 Whites Avenue, Hoekwil, Wilderness
SOIL ANALYSIS TEST REPORT			
SAMPLE INFORMATION		MATERIAL PROPERTIES	
Material Description	Yellowish orange olive weathered granite gravel		
Source	Test Pit 1	Position/ Layer	Layer 2
Date Received	05/07/2023	Date Tested	18/07/2023
Sampling Method	TMH5:MA2	Sample Number	2789
MOD, BD & AD Analysis			
MDD	2078	kg/m ³	OMC 8.4
BD	-		WA -
AD	-		%
Method	Scalped	% Scalped	0.0
Uncertainty			
MDD		kg/m ³	OMC

Test	Results	Specifications	Opinion
Grading Modulus	1.5	0.75<2.7	✓
Coarse Sand Ratio	33	N/A	
Strength (kN)			
10% FACT (Dry)		Mudrock Only

10% FACT (Wet)			
Wet/Dry Rel. (%)			
CBR			
Moulding MC%	8.3		
CBR @ 98%	32		
CBR @ 97%	27		
CBR @ 95%	19		
CBR @ 93%	13	Min 10	✓
CBR @ 90%	7		
Swell			
Swell @ 100%	0.4	Max 1.5%	✓
Durability (%)			
ACV (Dry)			
ACV (Wet)			
Flakiness Index			
20mm<28mm			
14mm<20mm			
Atterberg Limits			
-0.425mm			
Liquid Limit	24		
Plastic Limit	17		
Linear Shrinkage	2.0		
LSx%Pass0.425	102		
Plasticity index	7	Max 14.6	✓
-0.075mm			
Liquid Limit	-		
Plastic Limit	-		
Linear Shrinkage	-		
Plasticity index	-		
Classification:	G8		
Fractured Faces		In Spec Out of Spec	
Size	Fractured Faces %	Size	Fractured Faces %

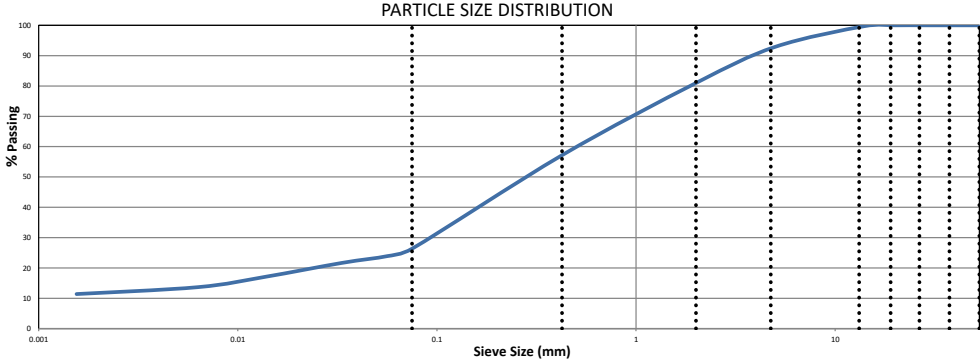
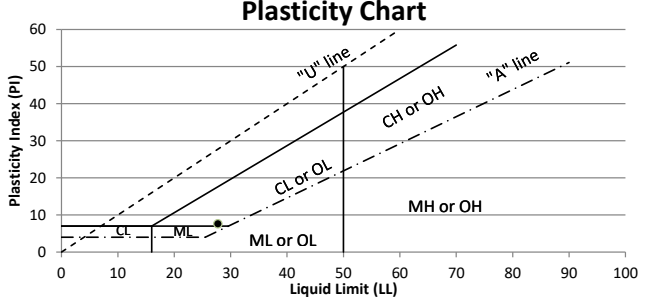
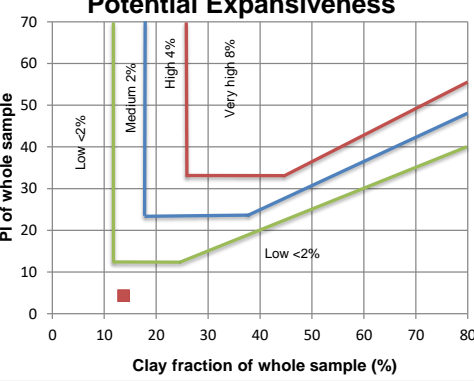
37.5	100						
28	100						
20	100						
14	100						
5	93						
2	81						
0.425	57						
0.075	26.3						
0.0565	23.9						
0.0332	21.6						
0.0138	17.1

Atterberg Limits		Activity	0.65	Inactive			
Liquid Limit	LL	28			USCS ² Classification		
Plastic Limit	PL	20			Sandy ML		
Linear Shrinkage	LS	3.5			NHBC Site Class		
Plasticity Index	PI ₄₂₅	8			USCS ²		
Grain Size Distribution ¹		USCS ²	Lean Clay	CL			
			Silt	ML			
			Organic Clay	OL			
			Fat Clay	CH			
			Elastic Silt	MH			
Swell		Activity	< 0.75	Inactive

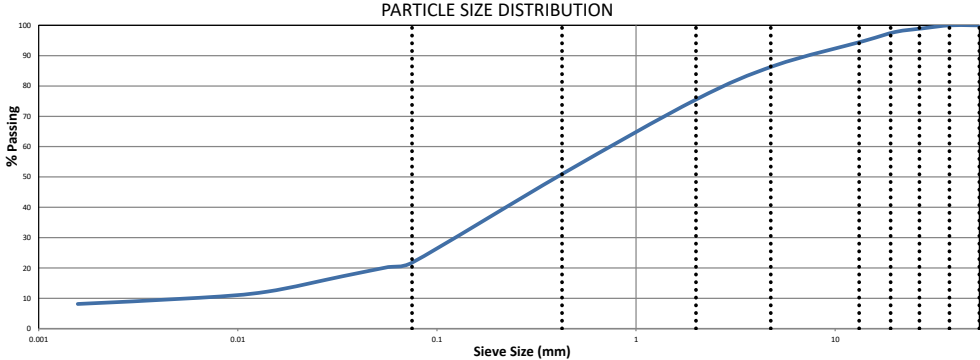
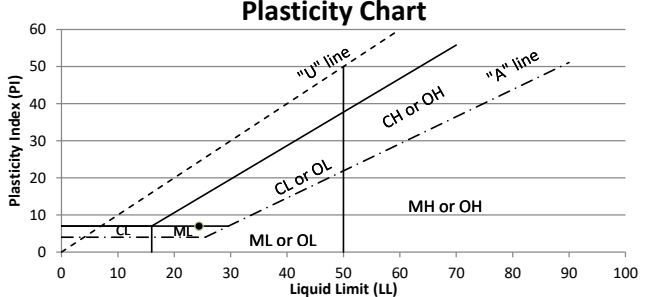
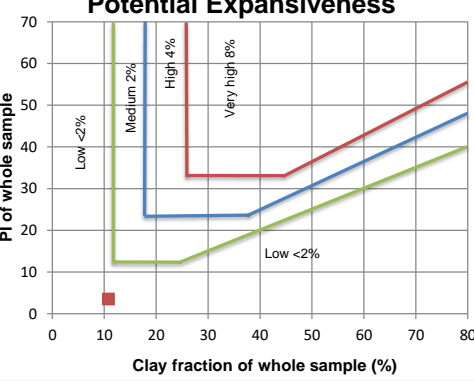
Material Description	Weathered Granite Gravel	Depth	NGL -650mm to -1200mm	Date Received	05/07/2023
Source	Test Pit 1	Position / Layer	Layer 2	Moisture Content	-
				Date Tested	18/07/2023

Sieve Size	% Pass
75	100
63	100
50	100
37.5	100
28	99
20	98
14	95
5	87
2	76
0.425	51
0.075	21.7
0.0570	20.3
0.0336	17.2
0.0140	12.2
0.0064	10.1
0.0016	8.1

Atterberg Limits			
Liquid Limit	LL	24	%
Plastic Limit	PL	17	%
Linear Shrinkage	LS	2.0	%
Plasticity Index	PI ₄₂₅	7	%

Grain Size Distribution ¹				
Gravel	Coarse	75 - 20mm	2.2	%
	Fine	20 - 5.00mm	11.0	%
Sand	Coarse	5.00 - 2.00mm	11.2	%
	Medium	2.00 - 0.425mm	24.6	%
	Fine	0.425 - 0.075mm	29.2	%
Silt		0.075 - 0.002mm	13.4	%
Clay		<0.002mm	8.3	%

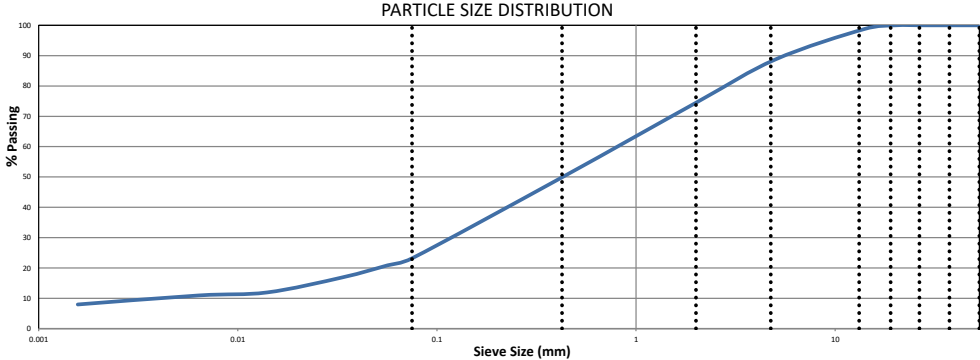
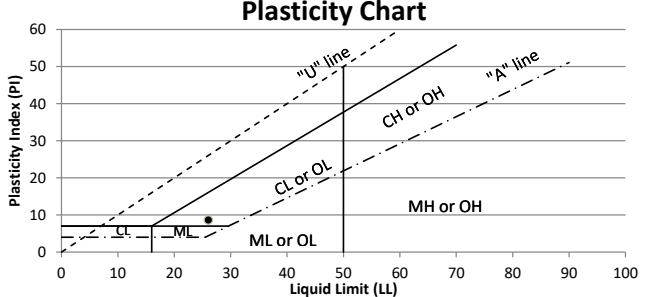
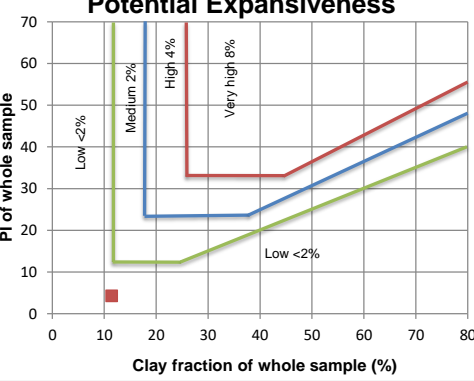
Material Description	Weathered Granite Gravel	Depth	NGL -680mm to -1400mm	Date Received	05/07/2023
Source	Test Pit 2	Position / Layer	Layer 2	Moisture Content	-
				Date Tested	18/07/2023

Sieve Size	% Pass
75	100
63	100
50	100
37.5	100
28	100
20	100
14	99
5	89
2	74
0.425	50
0.075	23.2
0.0565	20.9
0.0336	16.9
0.0140	11.9
0.0064	10.9
0.0016	7.9

Atterberg Limits			
Liquid Limit	LL	26	%
Plastic Limit	PL	17	%
Linear Shrinkage	LS	3.5	%
Plasticity Index	PI ₄₂₅	9	%

Grain Size Distribution ¹				
Gravel	Coarse	75 - 20mm	0.0	%
	Fine	20 - 5.00mm	11.3	%
Sand	Coarse	5.00 - 2.00mm	14.3	%
	Medium	2.00 - 0.425mm	24.6	%
	Fine	0.425 - 0.075mm	26.7	%
Silt		0.075 - 0.002mm	15.0	%
Clay		<0.002mm	8.2	%
