GEOTECHNICAL SOIL TEST REPORT

Client: Mr Coetzee

Project: Erf 2003, Wilderness

Date of test: 23.7.2021

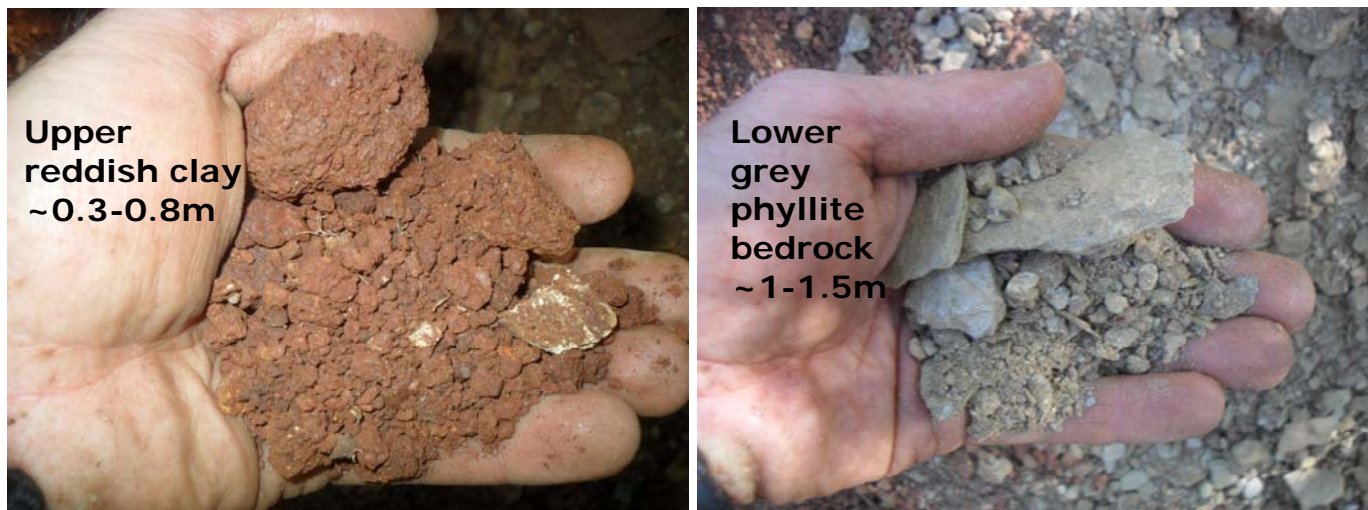
Figure 3: Soil types encountered in test pits

0-0.3m: Dark brown, firm, gravelly sandy clay/clayey sand – ***colluvium (topsoil)***

0.3-0.8m: Dark reddish brown, stiff, shattered, sandy silty clay - ***colluvium***

0.8-1.0m: Light grey to dark brown, dense to very dense, silty clayey gravel - ***residual completely weathered phyllite***

>1.0m: Light grey, very highly fractured, highly weathered, very soft to soft rock – ***phyllite bedrock***

The test pits were terminated due to difficult excavations or refusal on phyllite bedrock (see Fig 2). The depth to the bedrock is variable, and becomes shallower towards the west, but generally occurs at a depth of 0.8-1.5m. Large boulders or fragments of bedrock may also be encountered at this depth. No groundwater was encountered in test pits, but seepage can be expected in wet weather periods.

Foundations & floors: The recommended foundation type for single or double storey masonry or timber structures is reinforced strip and/or pad foundations placed on dense/stiff soil horizons or preferably bedrock at a minimum nominal depth of 0.8m below NGL. The recommended maximum bearing pressure for foundations is 125kPa. Structures founded at the correct levels on suitable bedrock or stiff/dense soil horizons are unlikely to induce or become susceptible to slope instability. Competent supervision in this regard is important. All foundations should be inspected by the engineer before placing reinforcement.

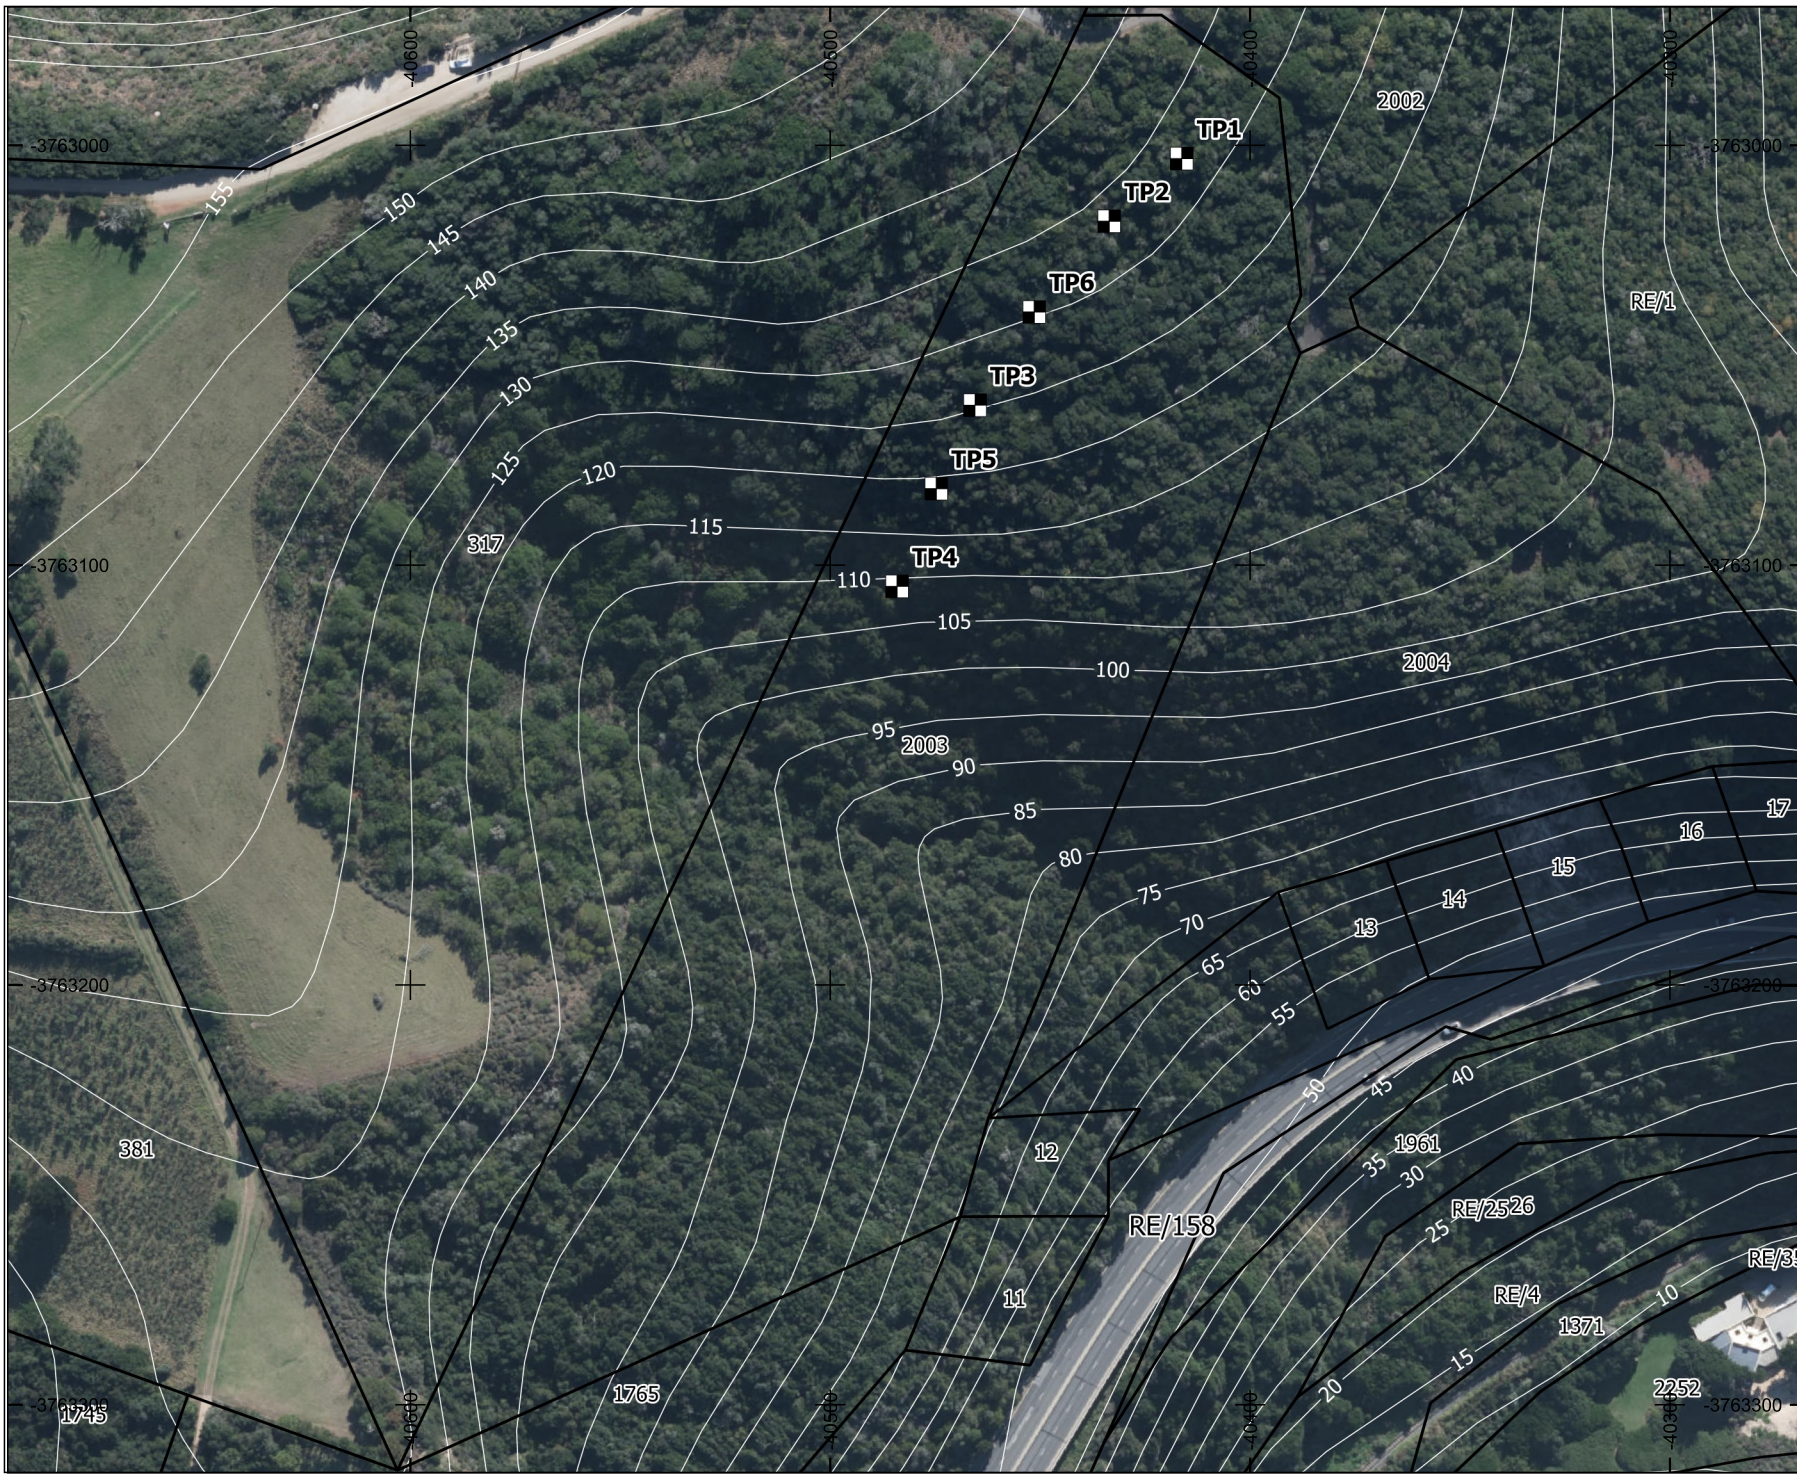
Drawing Name: Geotechnical Plan
 Drawing No:
 Date: August 2021
 Revision: 0
 Drawn by: DB Snyders
 Checked by: I Paton

Test pit/ DCP test position
-

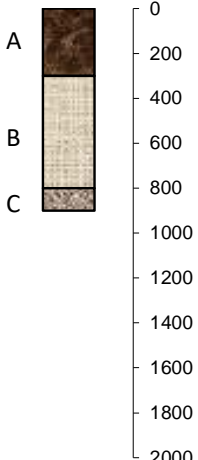
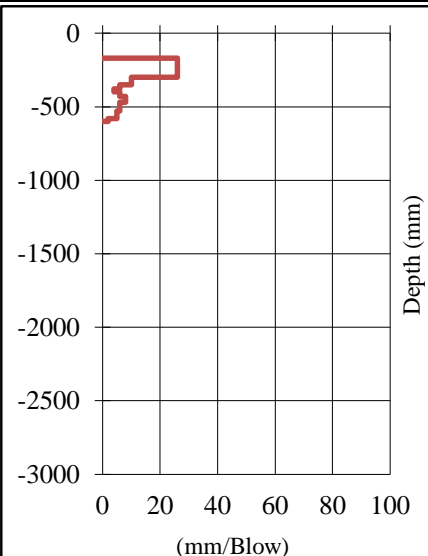
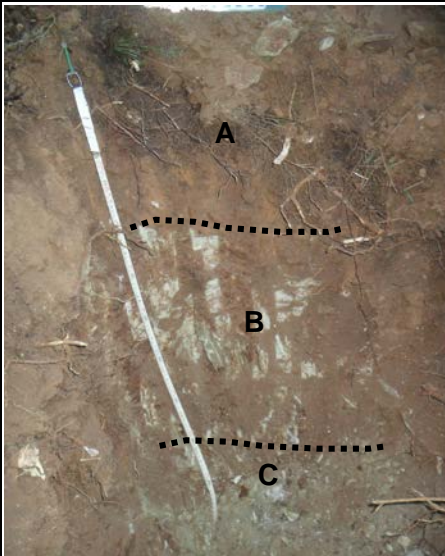
TP 3	NGL	23 Y0040466 X3763062		
		Key to symbols: ● Sample taken	Groundwater		
	(0 to 300)	Slightly moist, dark brown to dark reddish brown, firm, shattered/pinholed, SANDY SILTY CLAY , colluvial/topsoil (with abundant roots & organic material)			
	(300 to 800)	Slightly moist, light grey to light olive & dark red bands, very dense, fissured/intact, SILTY CLAYEY GRAVEL , residual/completely weathered phyllite.			
	(800 to 900)	Light grey to light olive, highly weathered, foliated, very highly fractured, very soft rock to soft rock, PHYLLITE (dipping steeply at 70° southwards)			
		Refusal on soft rock phyllite No water seepage

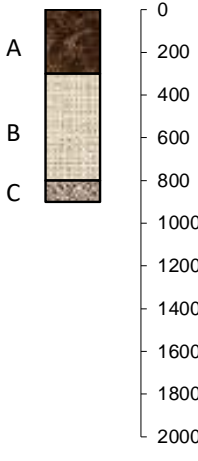
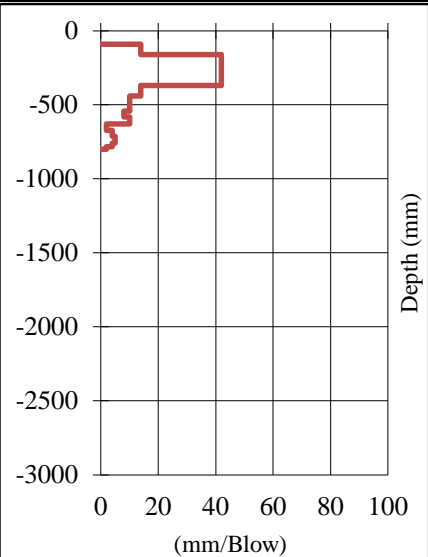
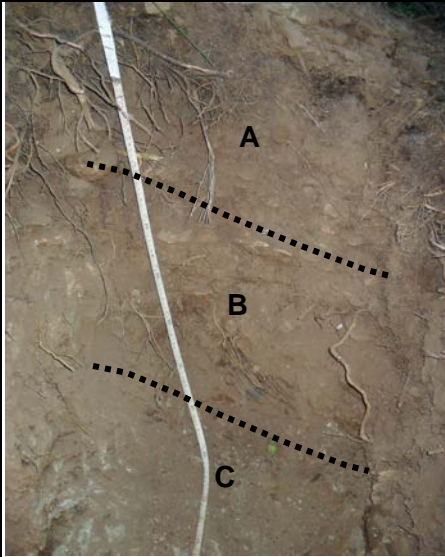
TP 4	NGL	23 Y0040484 X3763105		
		Key to symbols: ● Sample taken	Groundwater		
	(0 to 300)	Slightly moist, dark brown, soft to firm, shattered/pinholed, GRAVELLY SILTY CLAY , colluvial/topsoil (with abundant roots & organic material)

(300 to 800)	Slightly moist, dark brown & light olive, dense to very dense, fissured, CLAYEY & SILTY GRAVEL , residual/completely weathered phyllite.			
	(800 to 900)	Light grey to light olive, highly weathered, foliated, very highly fractured, very soft rock to soft rock, PHYLLITE .			
		Refusal on very soft rock to soft rock phyllite No water seepage Relative steep natural slope (25-30°)
