PROPOSED RIVERBANK MAINTENANCE ON REMAINDER 1 of FARM 305 HANGLIP, PLETTENBERG BAY.

Terrestrial Biodiversity – Compliance Statement

Prepared For: Eco Route
Author: Bianke Fouce (MSc)
Confluent Environmental Pty (Ltd)
7 St. Johns Street,
Dormehlsdrift,
George, 6529
SACNASP: 141757 (Cand.Sci.Nat. In Botanical and
Ecological Science)
Date: 15 April 2024
Version: Draft Final

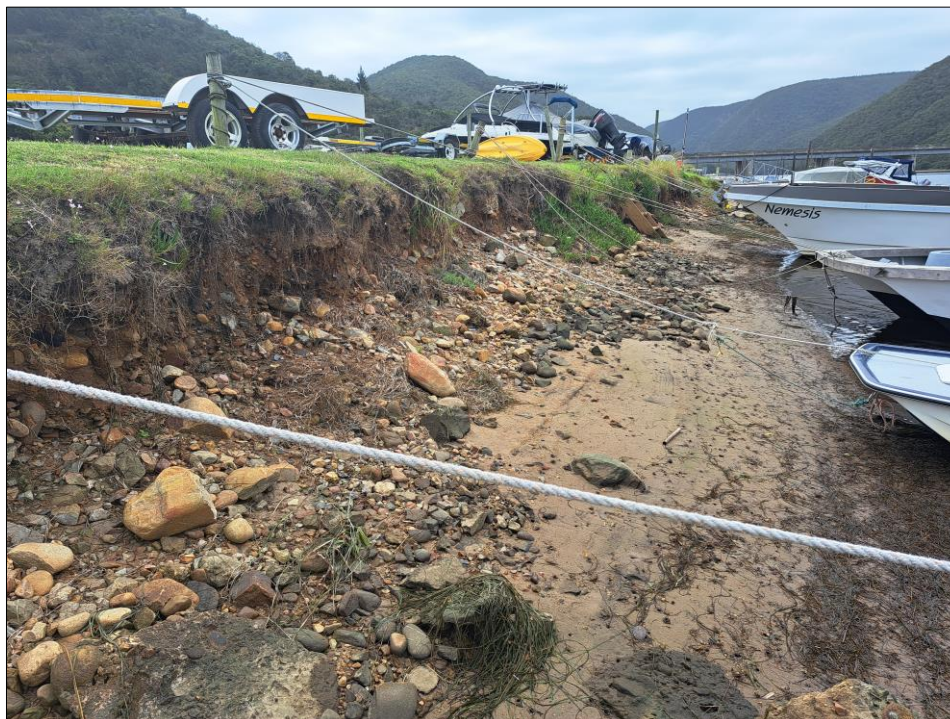
Confluent Environmental (Pty) Ltd was requested by the Plettenberg Bay Angling Club (PBAC) to conduct an animal species assessment for the proposed stabilisation of the banks of a section of the Keurbooms Estuary on the Remainder 1 of Farm 305 Hanglip, Plettenberg Bay. The bank is currently eroding and is placing existing infrastructure at risk (*Figure 1*).

Figure 1: Photograph showing erosion of the bank.

- The site visit confirmed the presence of a heavily eroded bank along the edge of the estuary (Figure 1).
- Inland of the bank vegetation has been entirely transformed to a large open grass lawn that is comprised predominantly of a mixture of low growing grass species (invasive kikuyu grass, *Cenchrus clandestinus*, and indigenous bermuda grass, *Cynodon dactylon*). No trees or shrubs were present, and no fynbos vegetation was present (Figure 10). Boats on trailers are currently parked along the edge of the embankment. A small section of the PAOI is covered under tar.

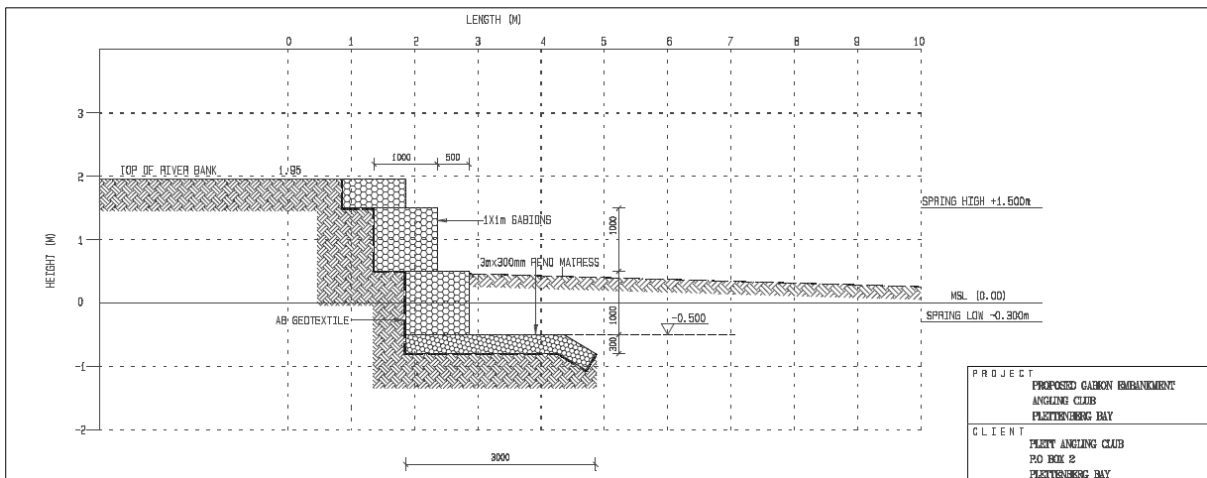
Three alternative options have been proposed and will be assessed in this report. All three options require the construction of a 3 m reno mattress that will be placed approximately 1 m below the existing bed profile of the estuary and will extend approximately 3 m into the estuary. This will prevent undermining of the embankment.

- Option 1: Construction of stepped gabions over a geotextile layer (*Figure 2*).
- Option 2: Reprofilling the bank (1.3 m horizontal to 1 m vertical) using sandbags (800 mm x 500 mm x 170 mm) and covering these with a 0.3 m x 3.0 m reno mattress (*Figure 3*).
- Option 3: Reprofilling the bank (1.3 m horizontal to 1 m vertical) using larger, heavy duty geotextile sandbags (2 m x 1.9 m x 0.65m) which will remain uncovered (*Figure 4*).

Figure 2: Section for Option 1.

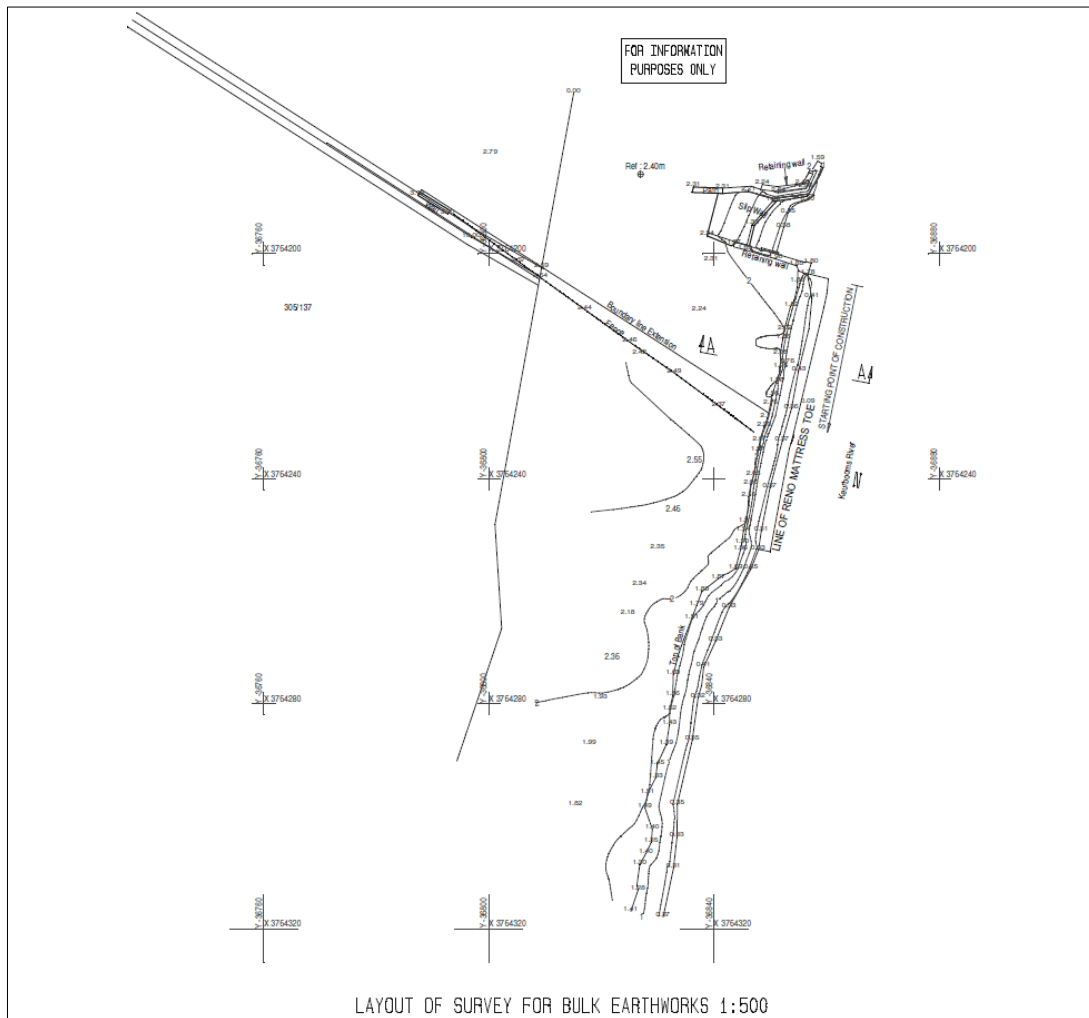
For all options, the stabilisation will be restricted to the steeply eroded section of the embankment and will stop at the point where the gradient of the embankment flattens out and is not actively eroding (Figure 6 and Figure 5).

Figure 5: Proposed bank stabilisation layout.

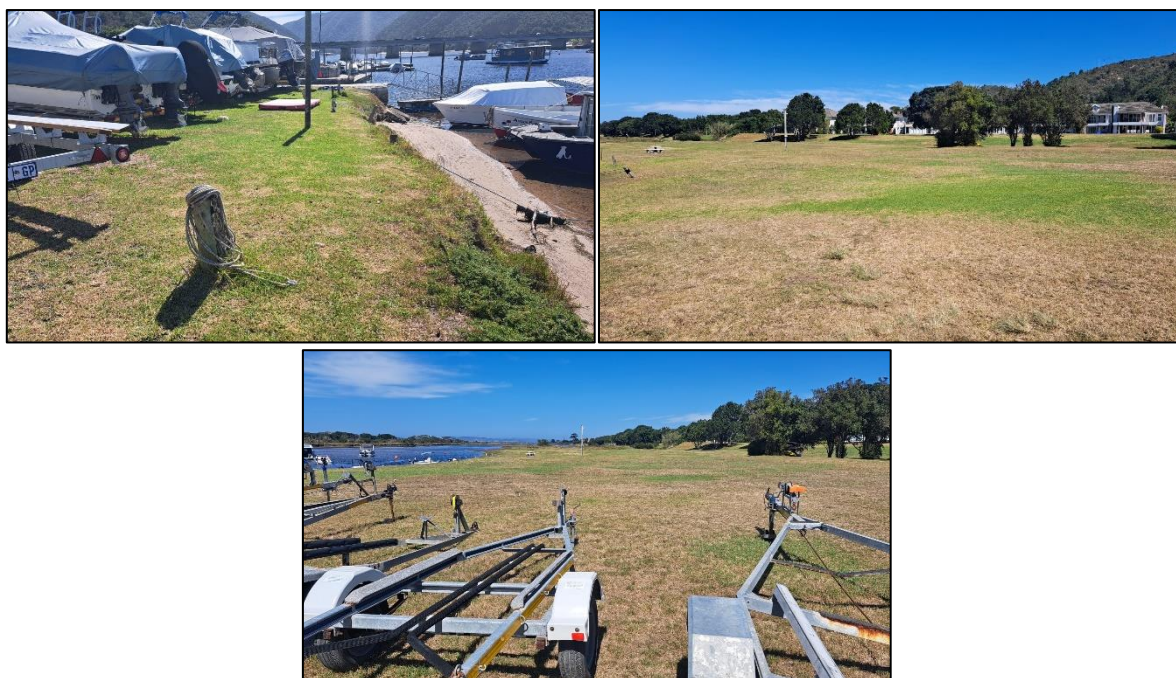
Figure 10: Photographs illustrating the existing the expansive lawn (comprised predominantly of *C. clandestinus* and *C. dactylon*) that falls within the PAOI.

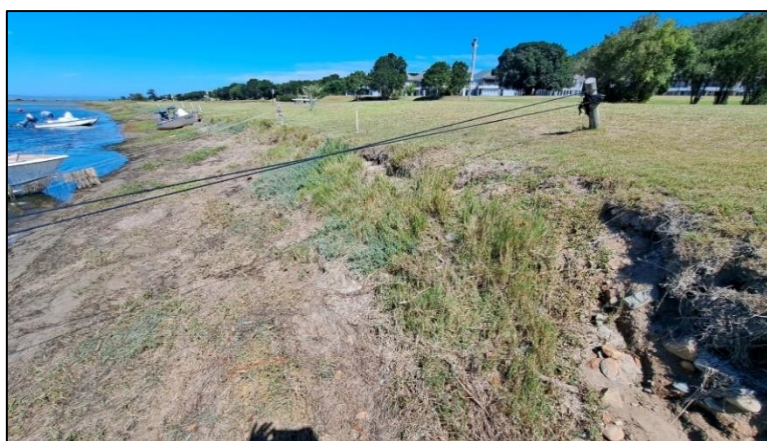
- The inter-tidal zone habitat is very narrow (exposed sand banks at low tide are less than 3 m in width) and is used to moor boats along the shoreline. Vegetation is limited, consisting of *Zostera capensis* within the inundated subtidal zone of the estuary and isolated patches of salt marsh species along the outer edge of the inter-tidal zone (Figure 11).

Figure 11: Photograph illustrating isolated patches of salt marsh vegetation along the inter-tidal zone.
