Aquatic Biodiversity Compliance Statement

**Regional Cemetery on Ptn 33/437 Farm Hill View, Plettenberg Bay,
Western Cape.**

Prepared for EcoRoute (Pty) Ltd

Confluent Environmental (Pty) Ltd

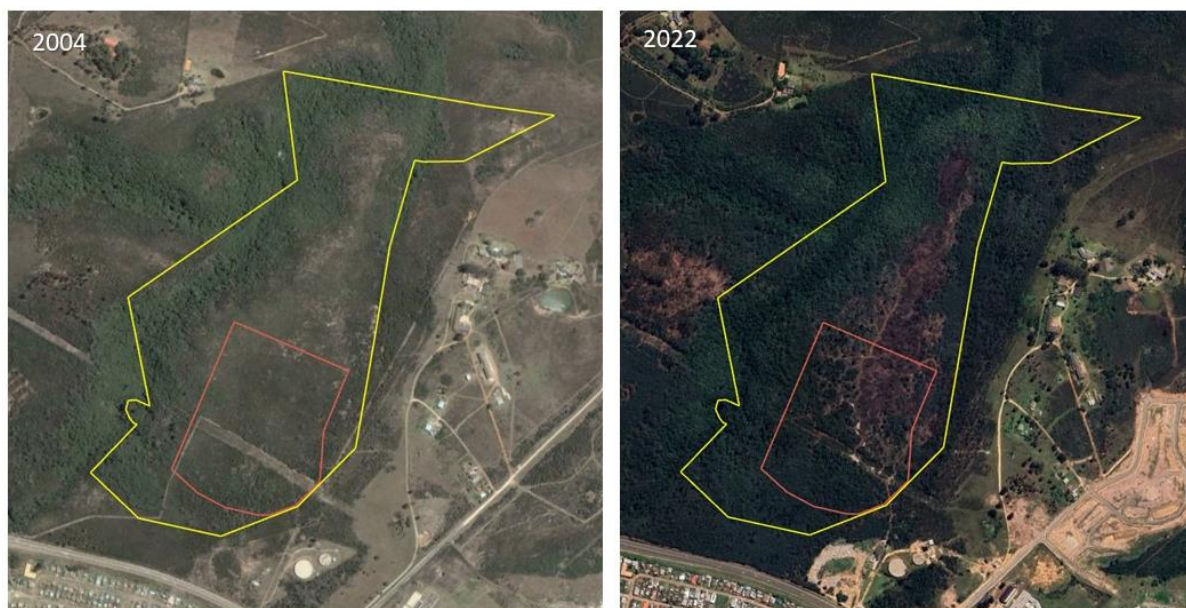
Historical aerial images from the CD:NGI were obtained and show that the property has not been modified to a great extent apart from the Eskom powerline servitude which is indicated across the proposed cemetery site in a SE-NW direction (). More recent satellite images indicate degree of disturbance with pathways and / or roads through the cemetery area, which were observed during the site visit to be routes to illegal dumping sites. The 2022 image compared to the 2004 image also seems to indicate bushier vegetation in the cemetery site which is likely alien trees which were observed during the site visit. Historical images do not indicate any likely wet areas indicative of wetlands within the footprint of the cemetery. Elsewhere in the area, wetland flats on similar terrain are quite distinctive.

Figure 6. Historical photos showing the property (yellow) and proposed cemetery (red) in 2004 and 2022

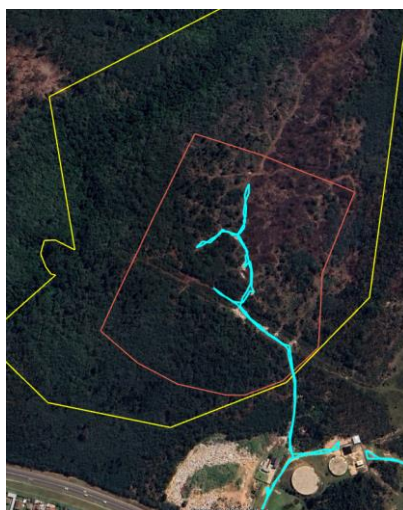
The site was visited on 21 May 2023 which is early winter conditions on the day overcast with periodic rainfall. The preceding few weeks had been unseasonably wet with high rainfall received across the Garden Route. A large section of the site was walked, although security was a concern as mentioned in the limitations of the assessment (Figure 7).

Figure 7. Google satellite image showing the proposed cemetery site with GPS track walked during the site visit (blue).

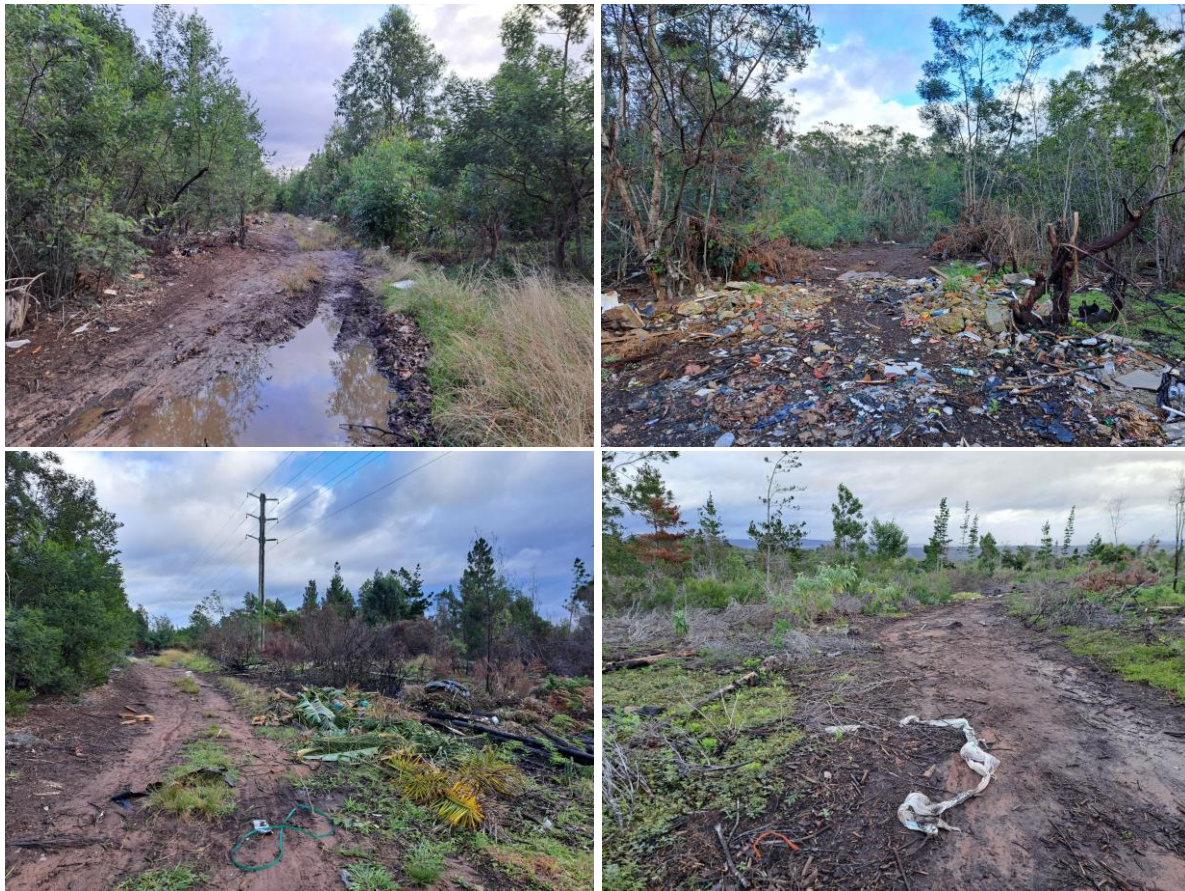
Areas covered by the site assessment indicate that indigenous fynbos vegetation has been transformed to varying degrees by alien vegetation (Black wattle, pine and bugweed), informal roads and pathways, and illegal dumping of a range of materials including garden waste and construction rubble (Figure 8). Topography of the area covered in the assessment was mostly flat.

No flow paths within the footprint of the cemetery would be predicted by the site contours, and none were observed during the site visit. No wetland areas indicated by standing water or wetland vegetation were observed during the site visit. Standing water would be expected in wetland areas given the high rainfall recently experience in the area.

Figure 8. Photos of various aspects of the site indicating invasion of natural vegetation with alien plants, informal roads and paths, and areas of illegal dumping.
