# Heritage Statement

## Proposed Regional Cemetery on Portion 33 of Hill View Farm 437, Plettenberg Bay, Bitou Municipality and Administrative District of Knysna, Western Cape Province

14 June 2023

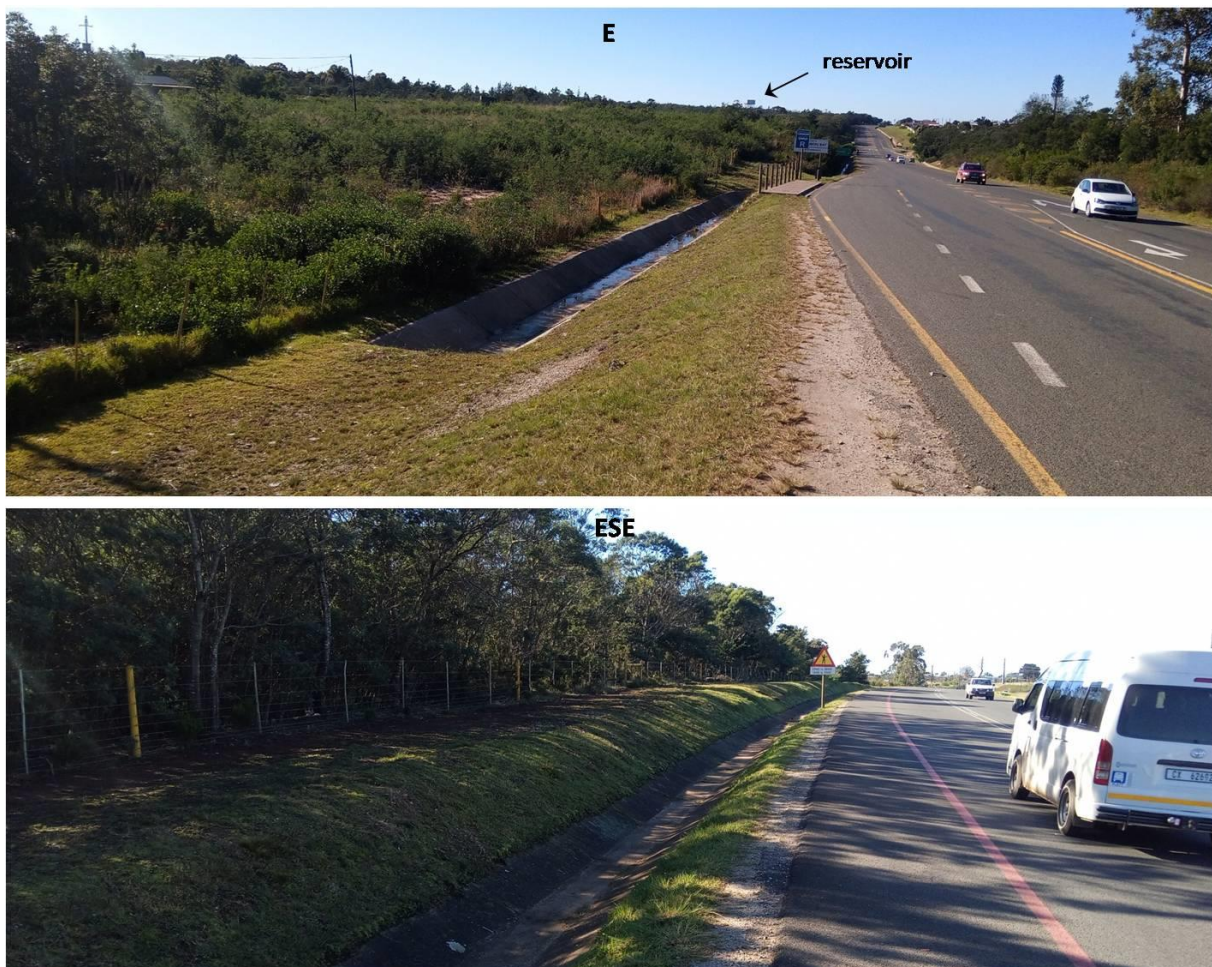
Figure 5. Views towards the study area from the N2. 33/437 is to the left of the reservoir (top) and set back some 90 m from the tree line adjacent to and north of the N2 (bottom).

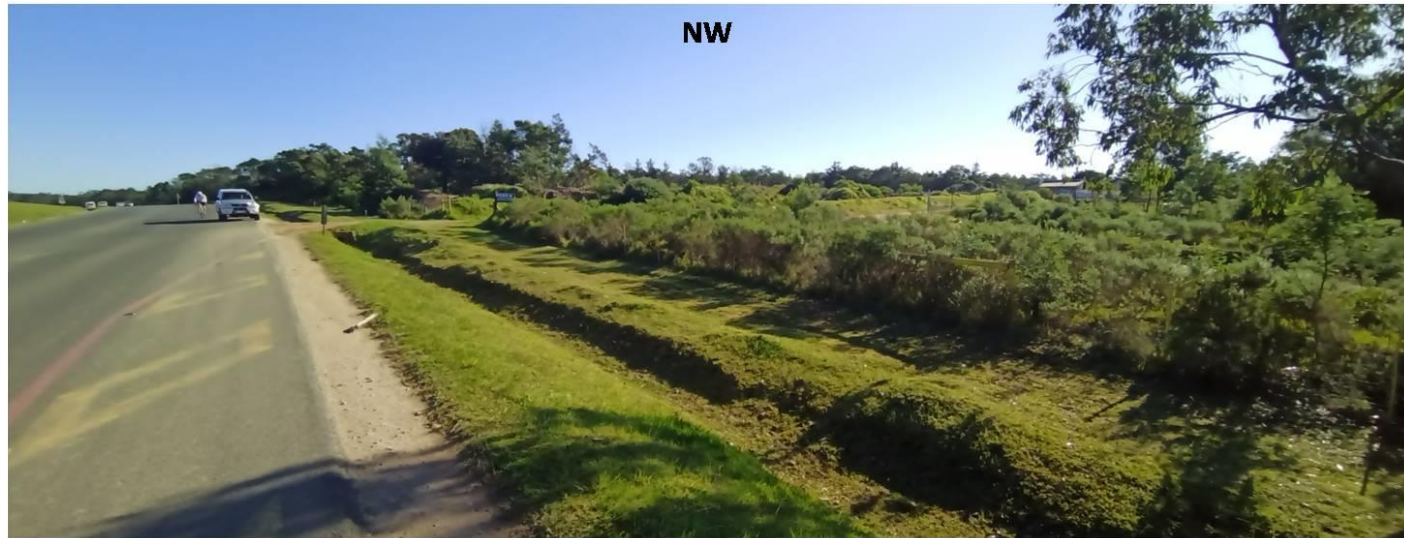
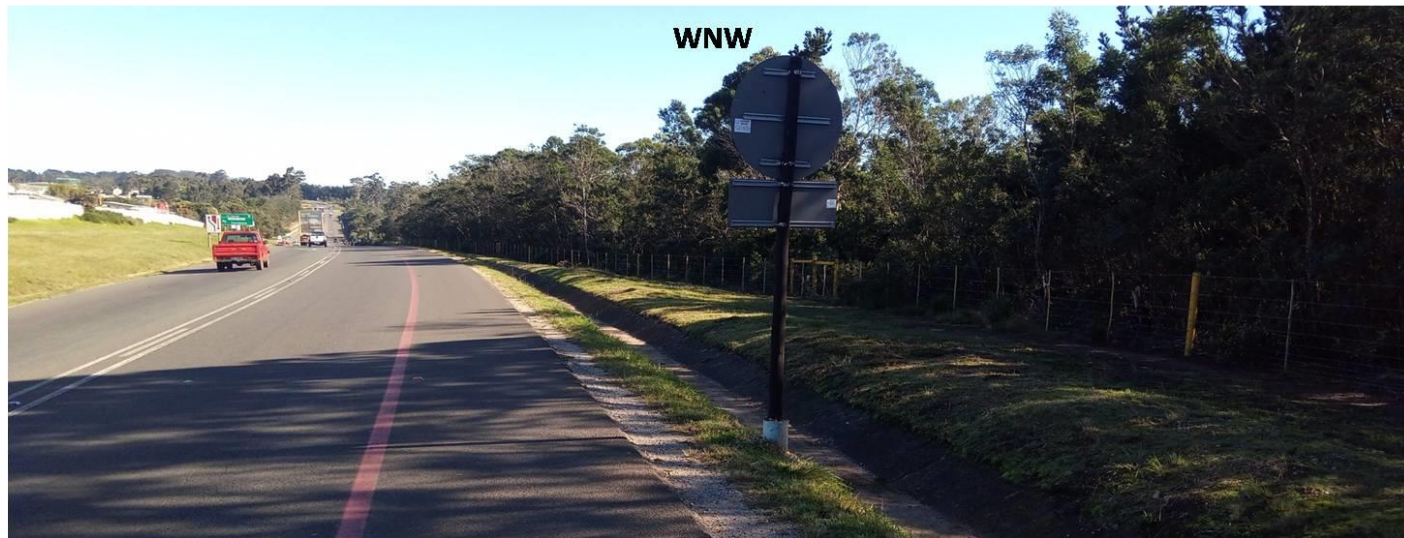
Figure 6. Views towards the study area from the N2. Access road to reservoir, Plet Animal Welfare Service (PAWS) and 33/437 is to the right at vehicle (top) and site is set back some 90 m from the tree line adjacent to and north of the N2 with Kwanokuthula to the left or south of N2 (bottom).

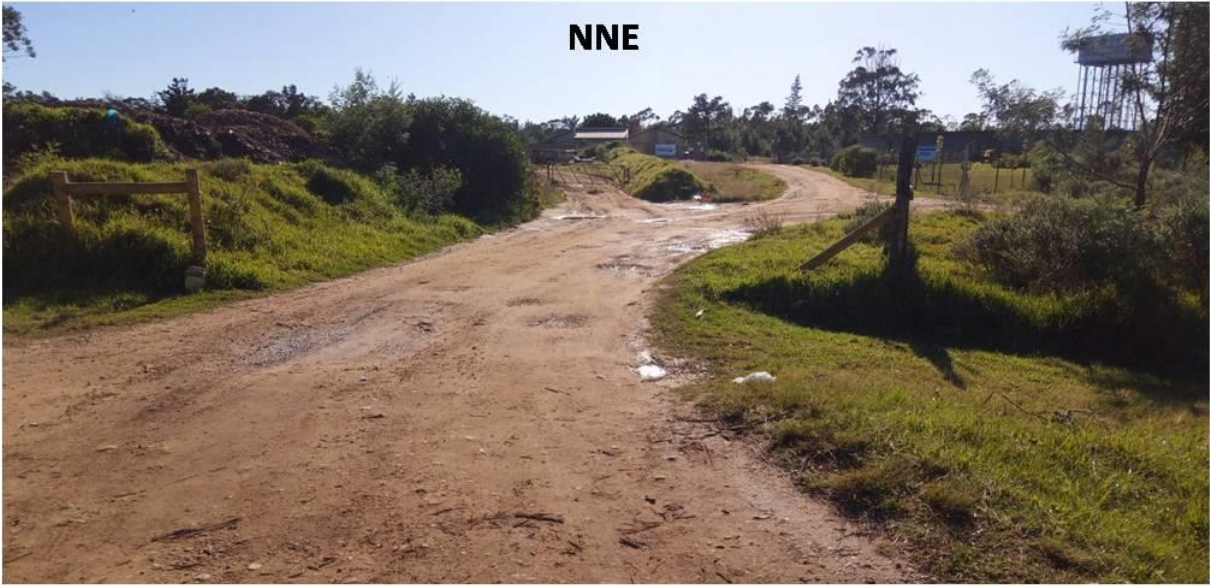
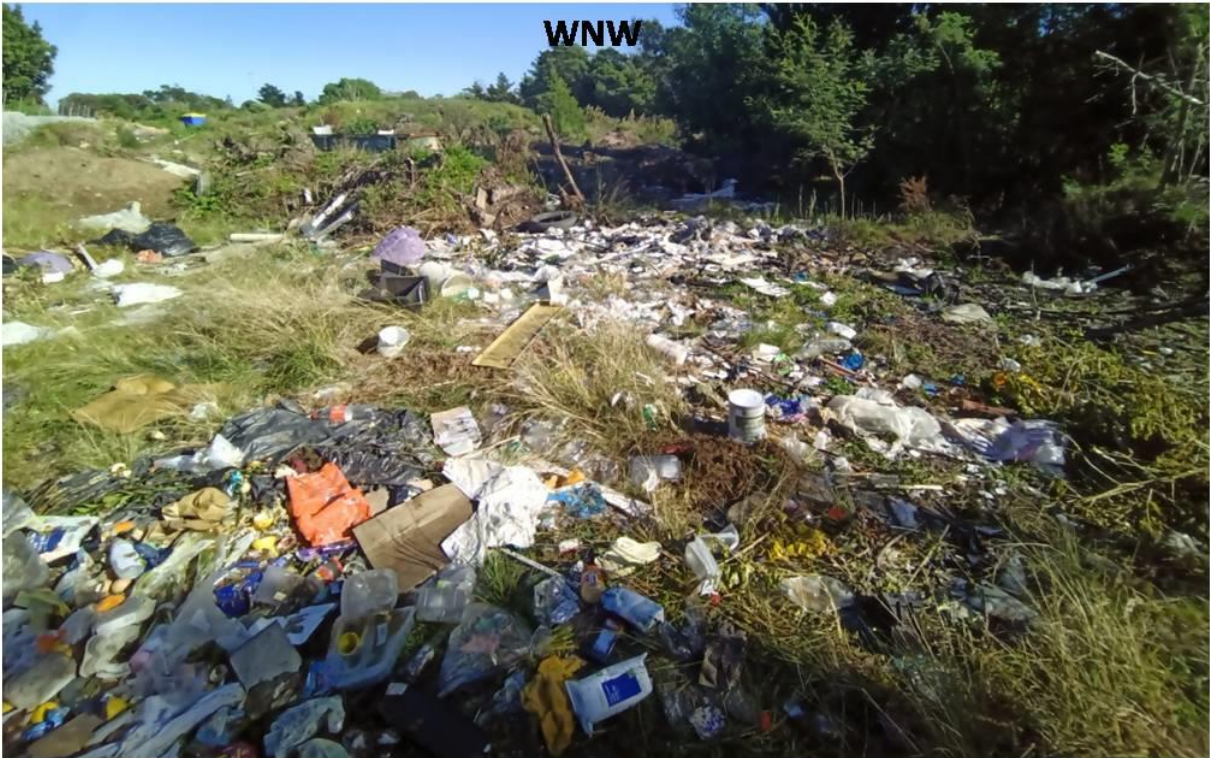
Figure 7. Access road to reservoir, PAWS and 33/437 (top) and rubbish dumped adjacent to access road in vicinity of PAWS (bottom).

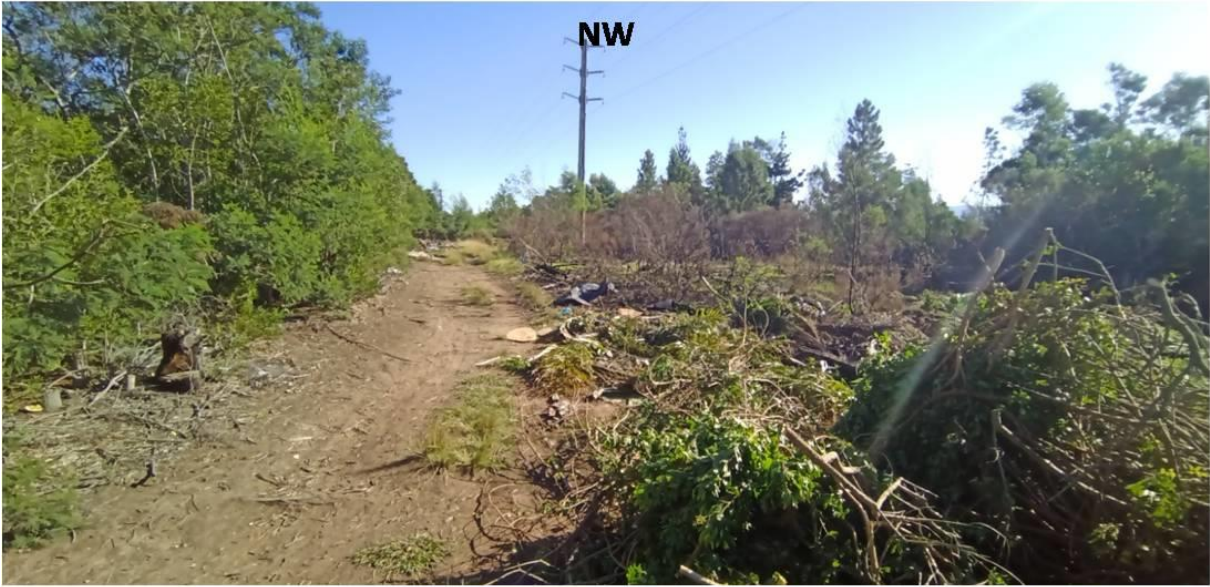
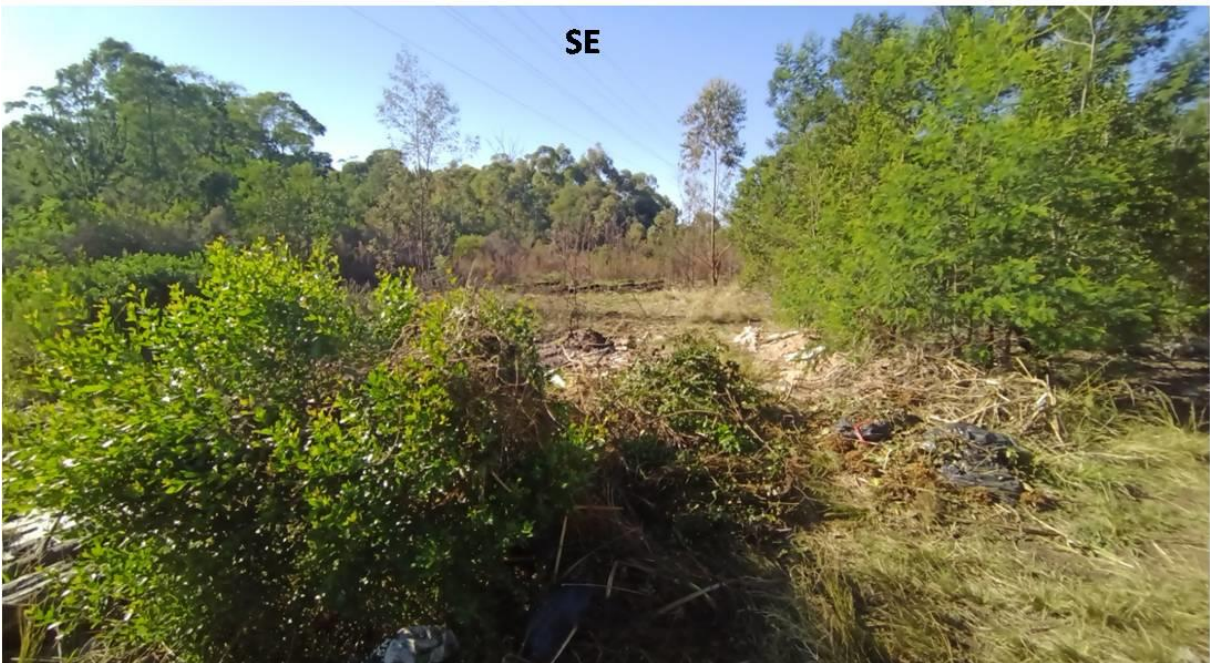
Figure 8. Views along the Eskom servitude in the southern part of 33/437 with overhead transmission lines, pylon and vehicle track.

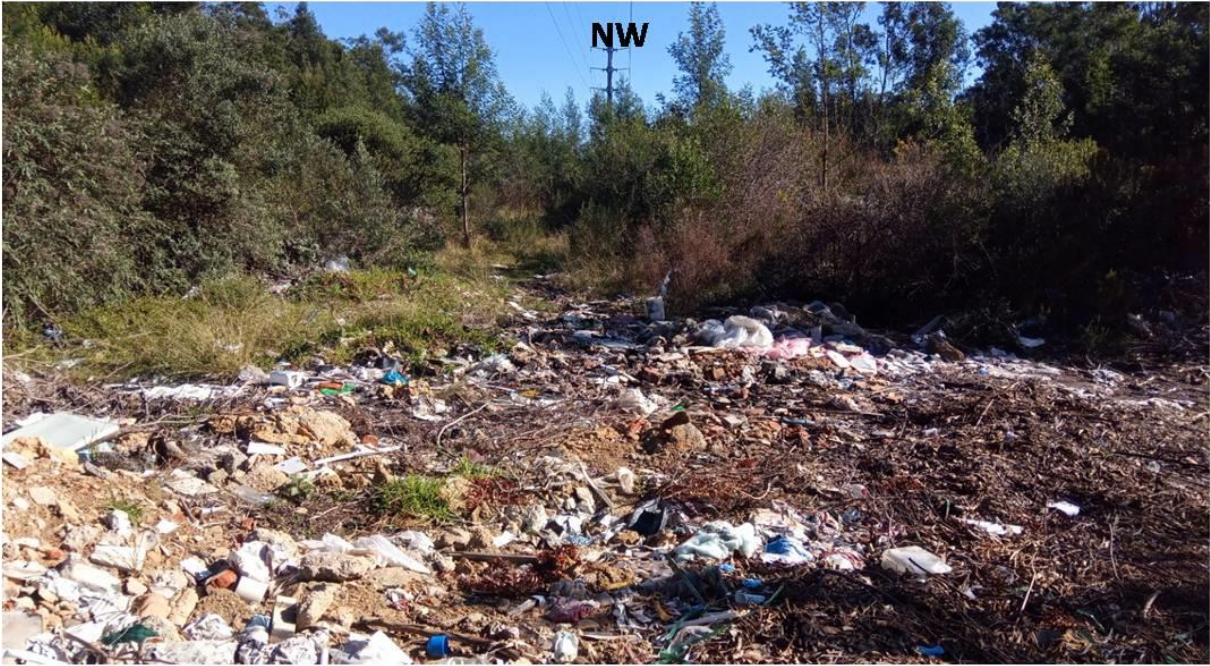
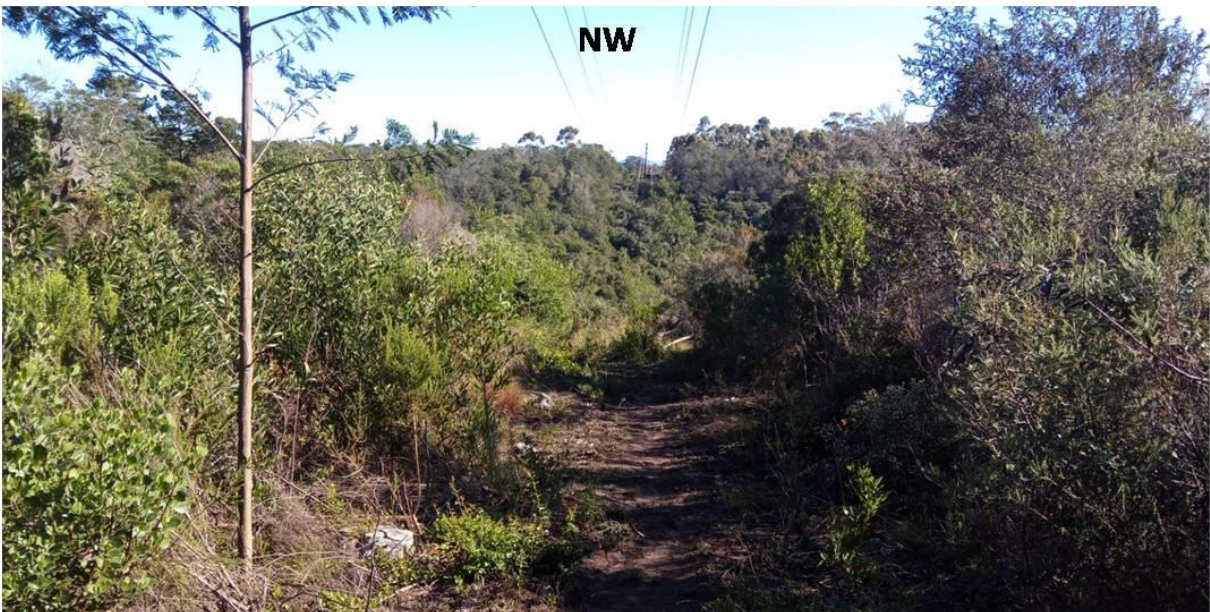
Figure 9. Views along the Eskom servitude in the southern part of 33/437 with pylon and overhead transmission lines. Note steep slope to Dieprivier (bottom).

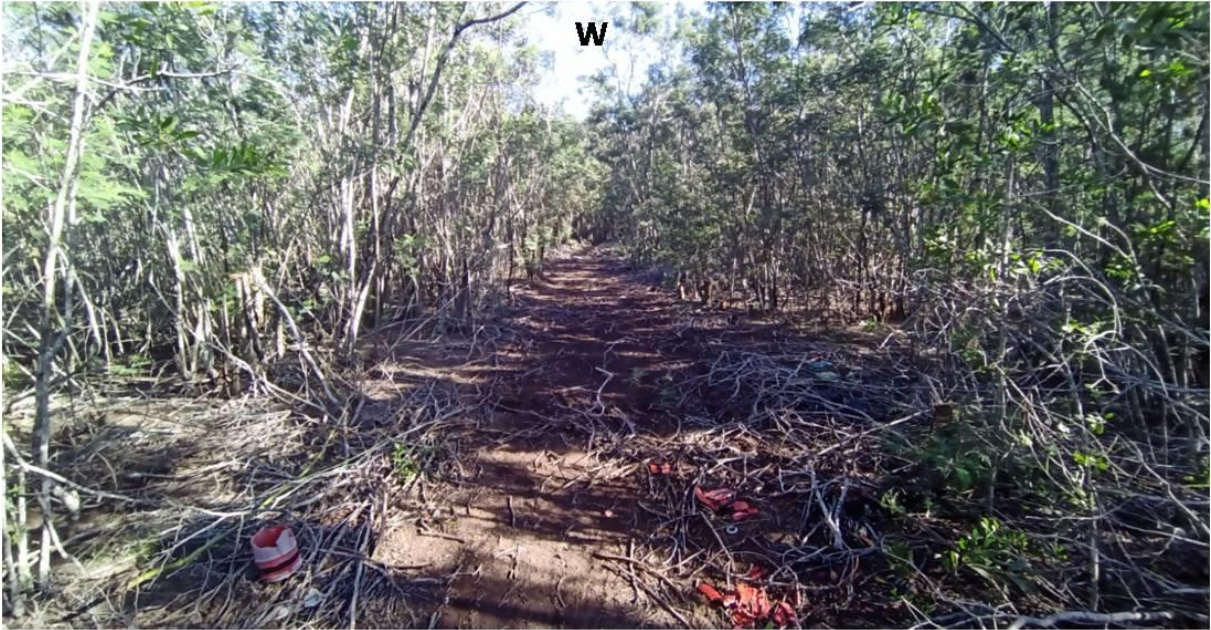
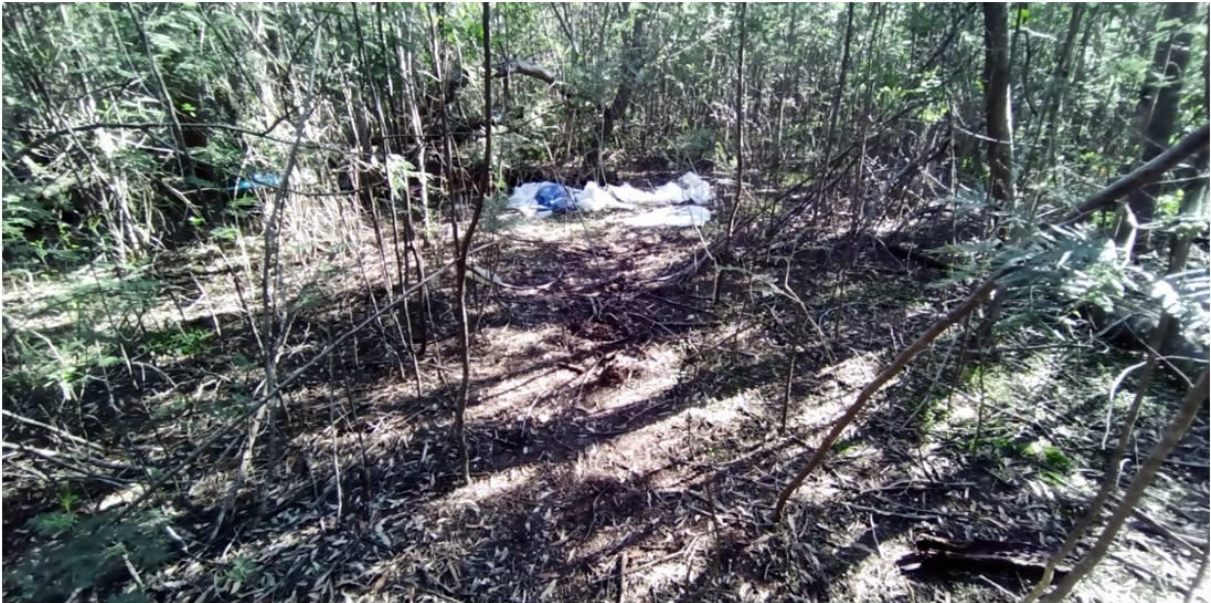
Figure 10. Examples of the southern part of the development footprint with woodcutters' clearings and forest and leaf litter.

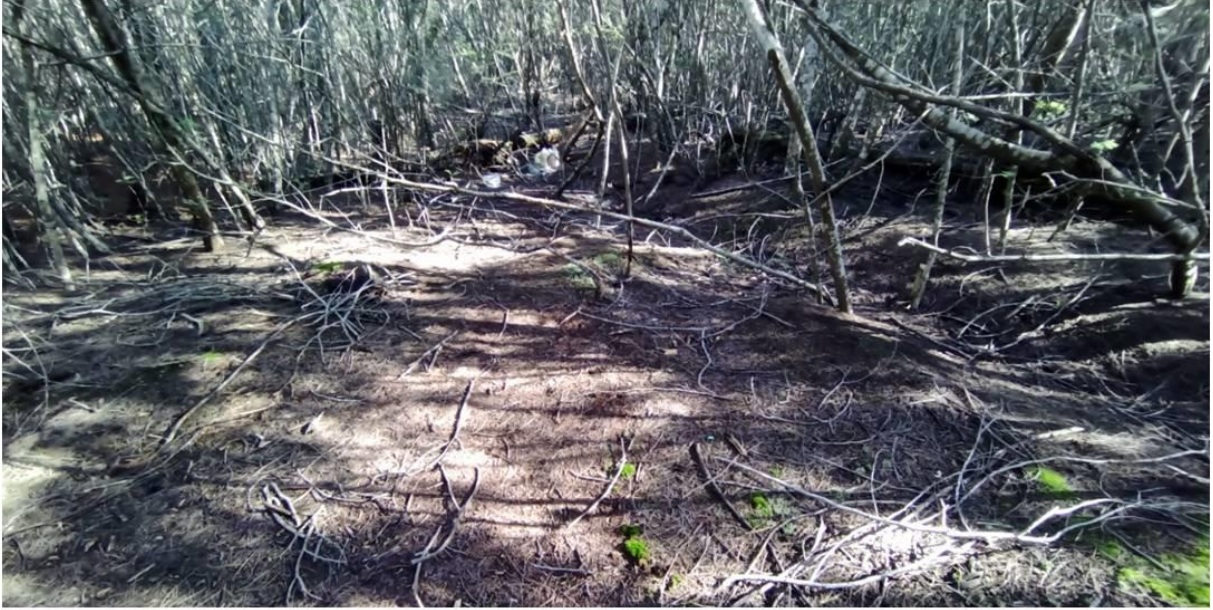
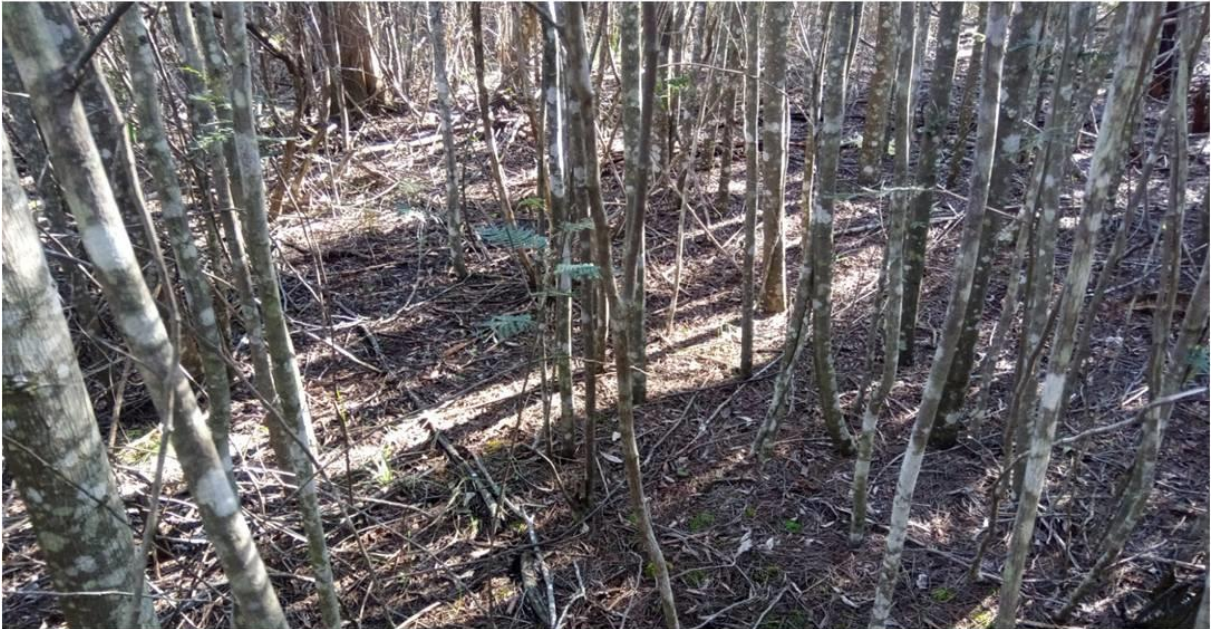
Figure 11. Examples of the southern part of the development footprint with woodcutters' clearings, exposed surfaces and forest and leaf litter.

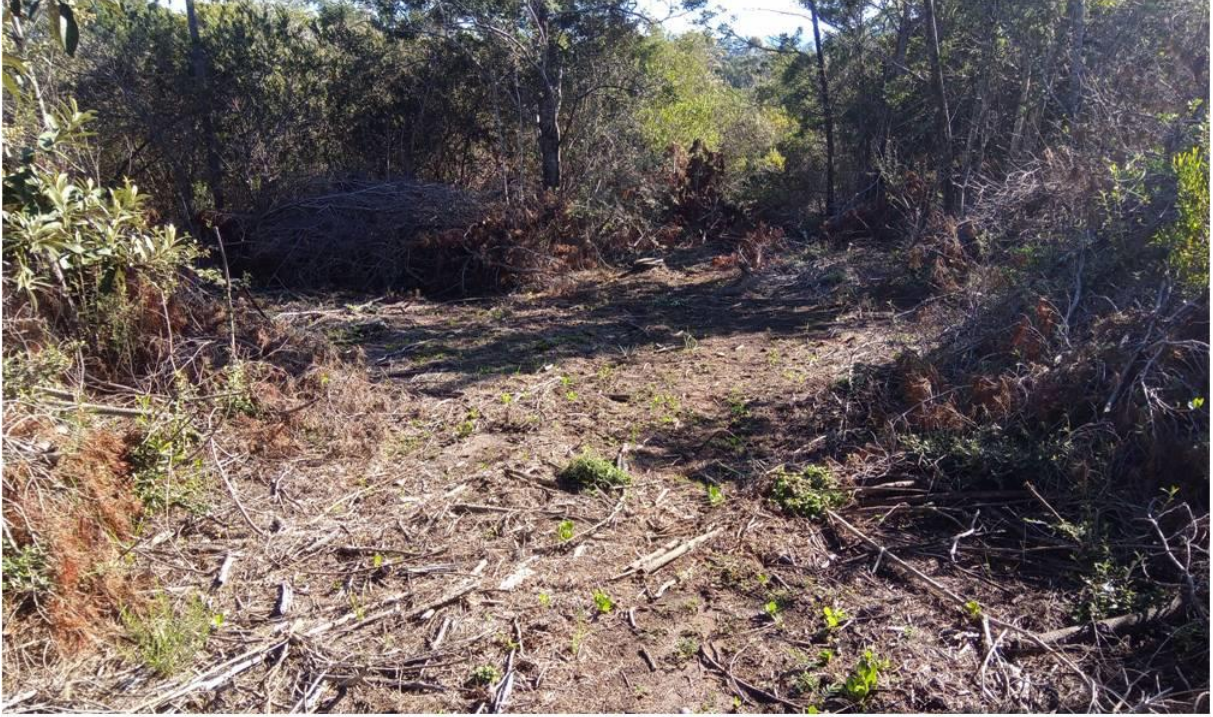
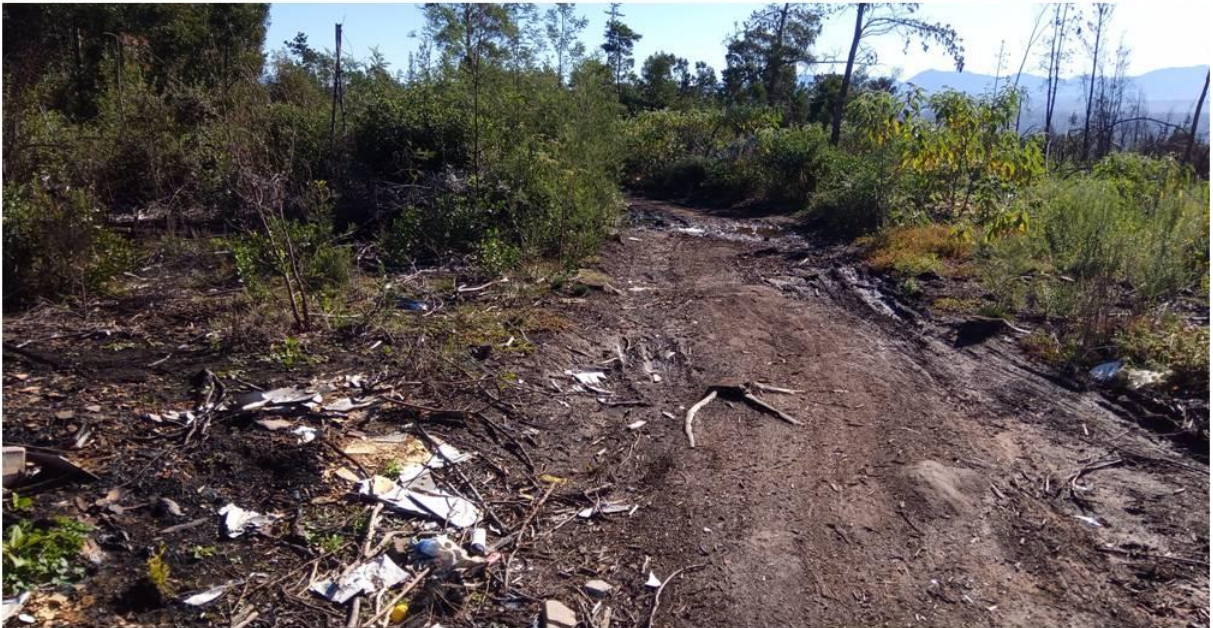
Figure 12. Examples of the northern part of the development footprint with woodcutters' clearings, exposed surfaces and vehicle tracks.

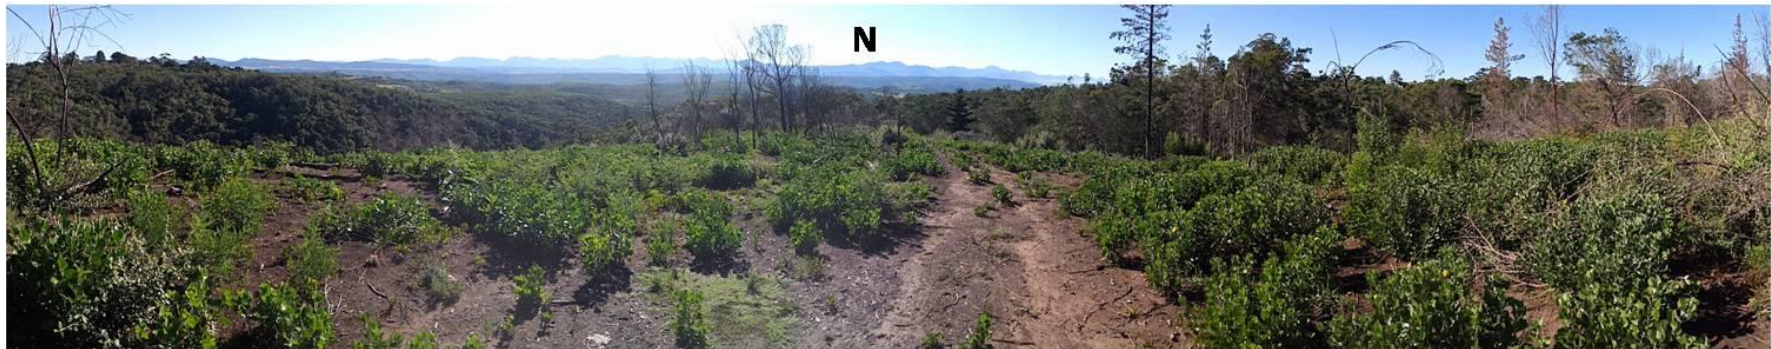
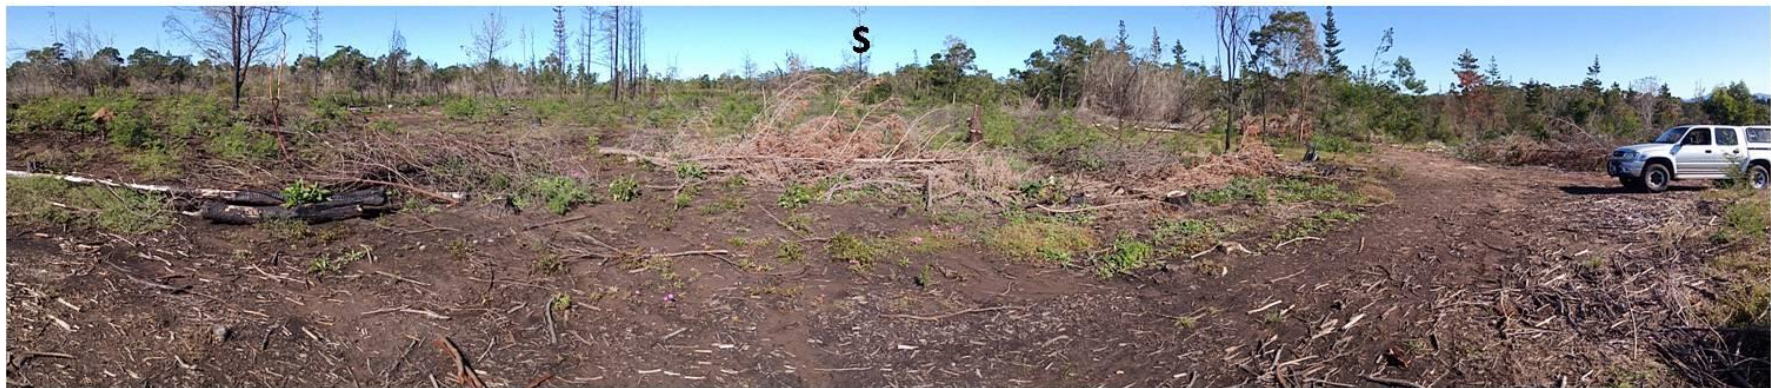
Figure 13. 180° panoramic views from the northern development footprint (top) and toward the northern development footprint (bottom). Note vehicle track, cleared areas and exposed ground surfaces.

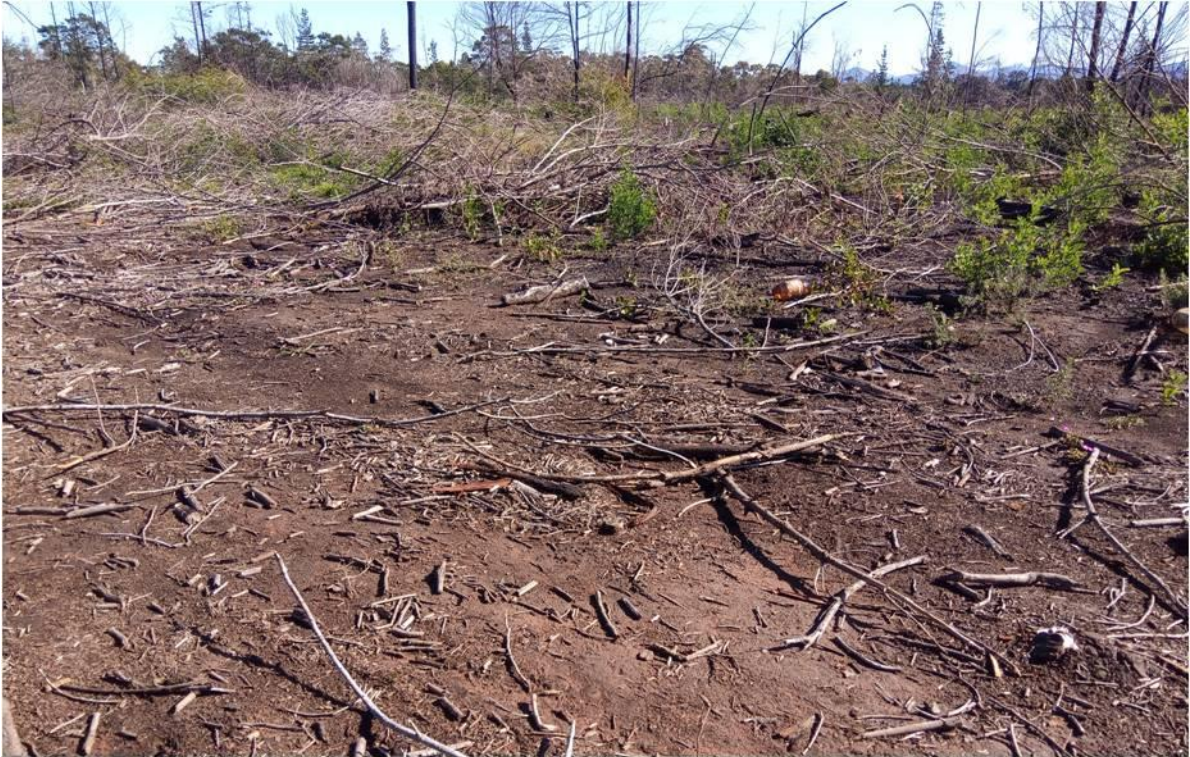
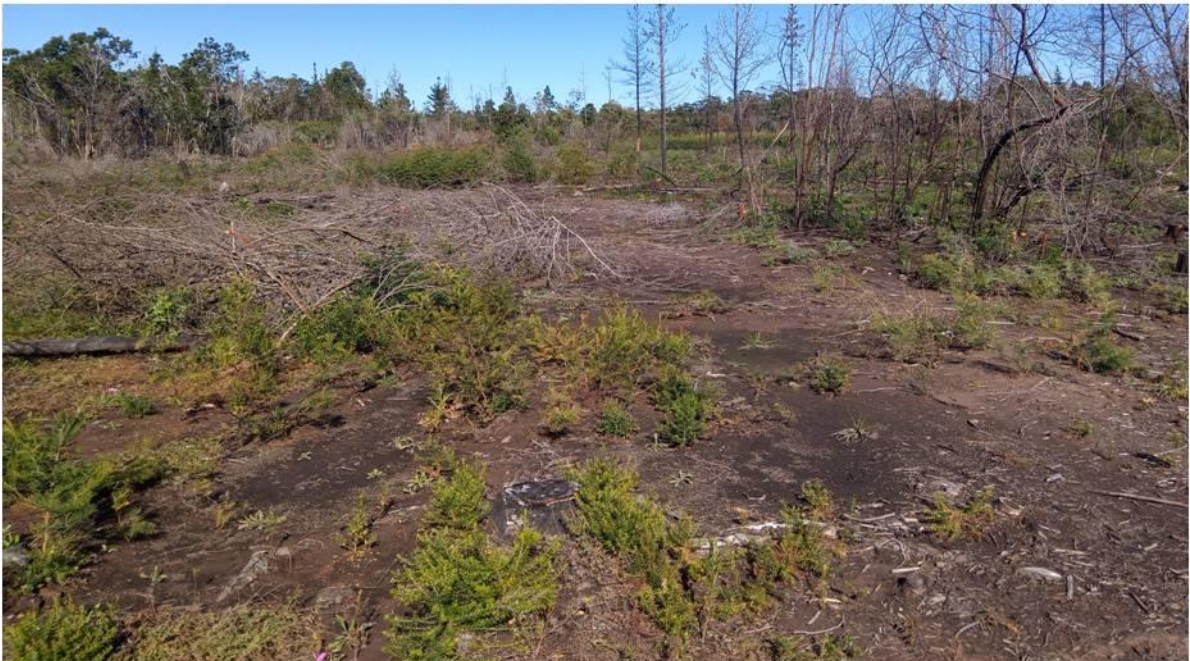
Figure 14. Examples of the northern part of the development footprint with woodcutters' clearings and exposed ground surfaces.

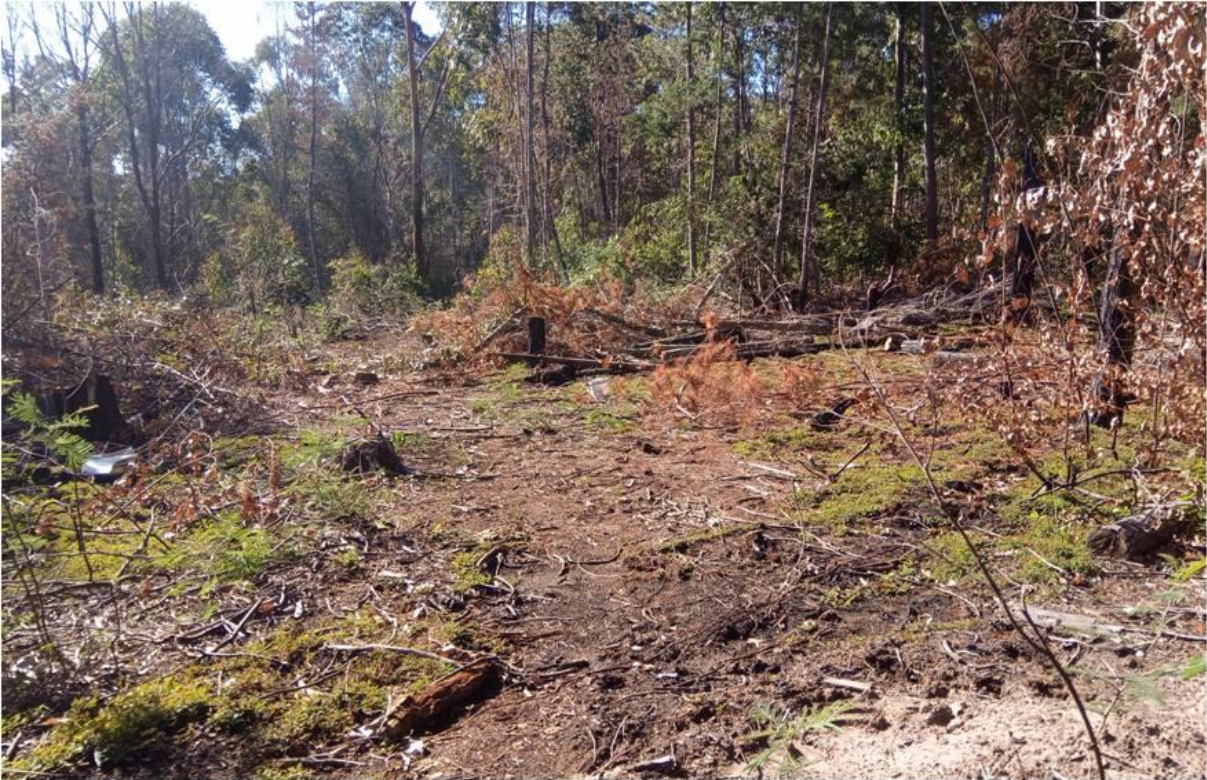
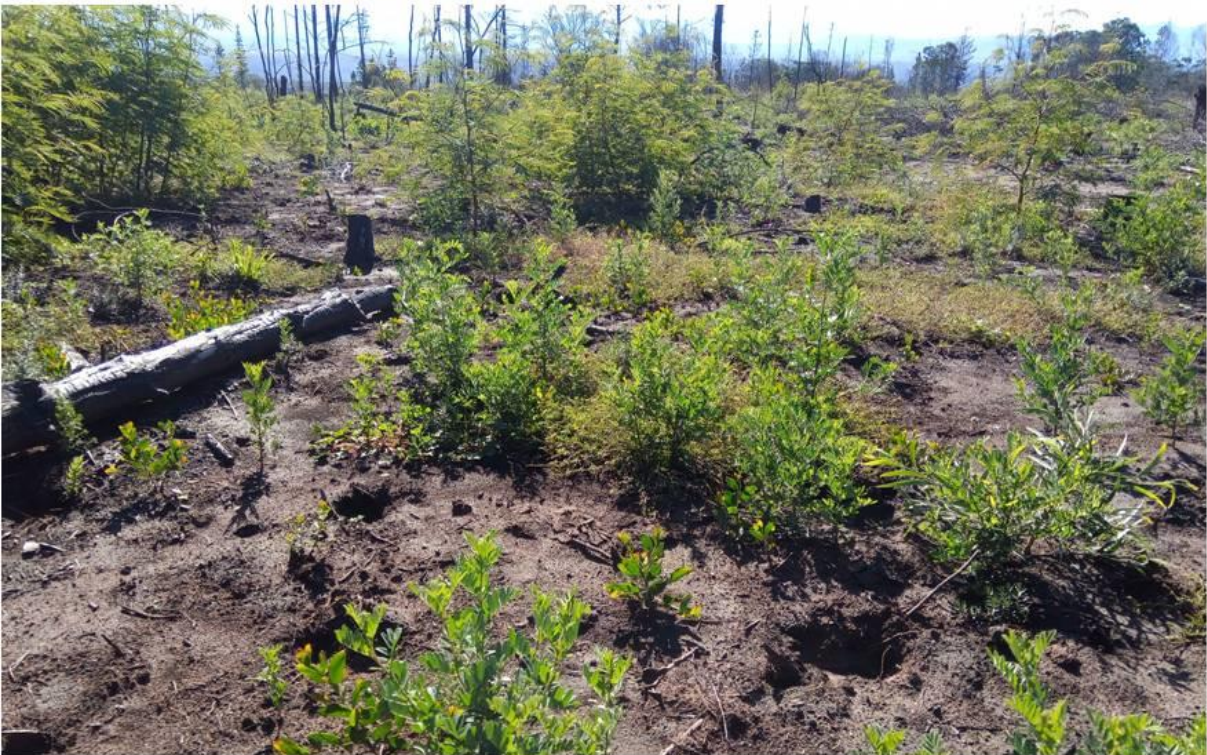
Figure 15. Examples of the northern part of the development footprint with woodcutters' clearings and exposed ground surfaces.

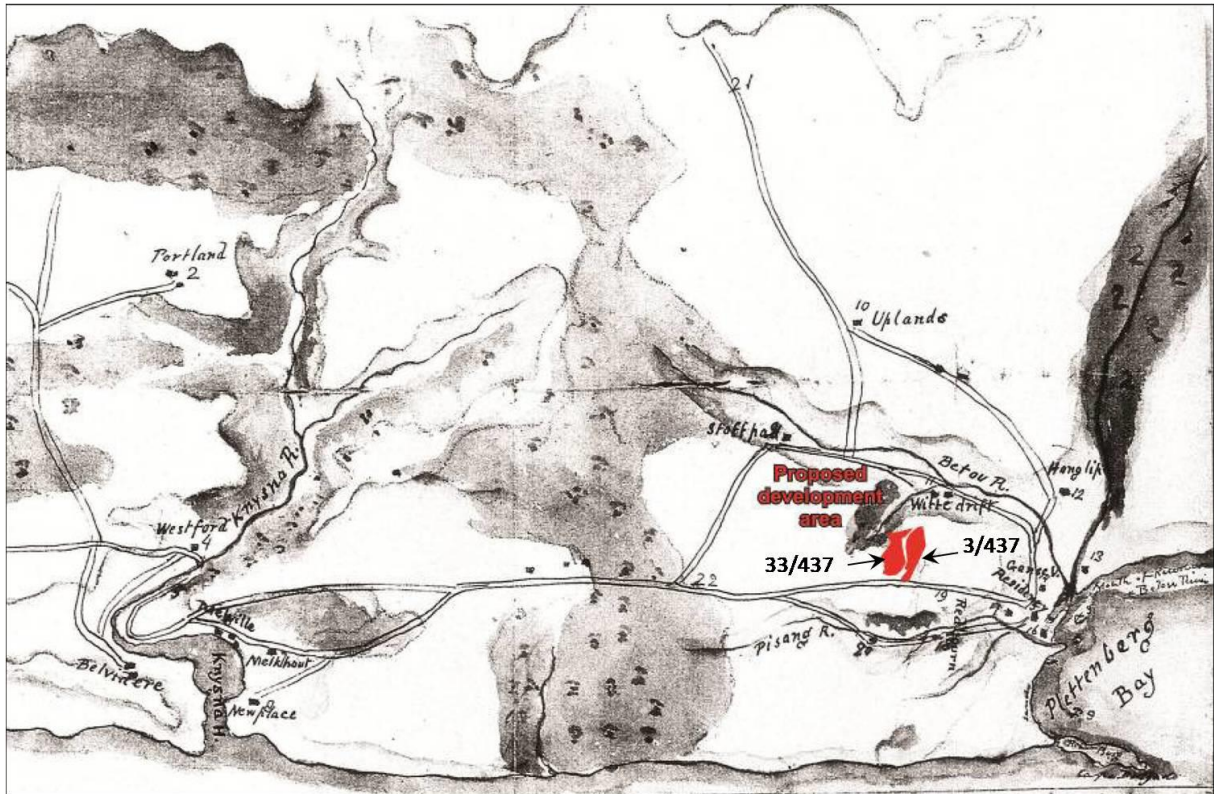
Figure 17 (5). Approximate location of proposed development area transposed onto extract from sketch (not to scale) of the “Country between Knysna and Plettenberg Bay by WH Newdigate, c. 1850-1860 (annotated after De Kock 2014 Pg.7 Figure 5; Source: Plettenberg Bay and The Paradise Coast”, Patricia Storrar, 2001).

Note that in neither of Figures 16 or 17 are structures indicated on 33/437 or in its immediate surroundings. The alleged structures indicated by De Kock (2014 Pg. 8, Figure 6) are not definitively identifiable as structures when the image is enlarged, whereas structures are visible on 3/437 to the east (Figure 18). This author’s walk tracks of 2014 and 2023 covered the locality of the alleged structures and none were seen. Nevertheless, the 1942 image clearly shows that most of 33/437 was cleared for agricultural purposes (Figure 18). Consequently, surface sediments and their contents were disturbed by early farming activities.

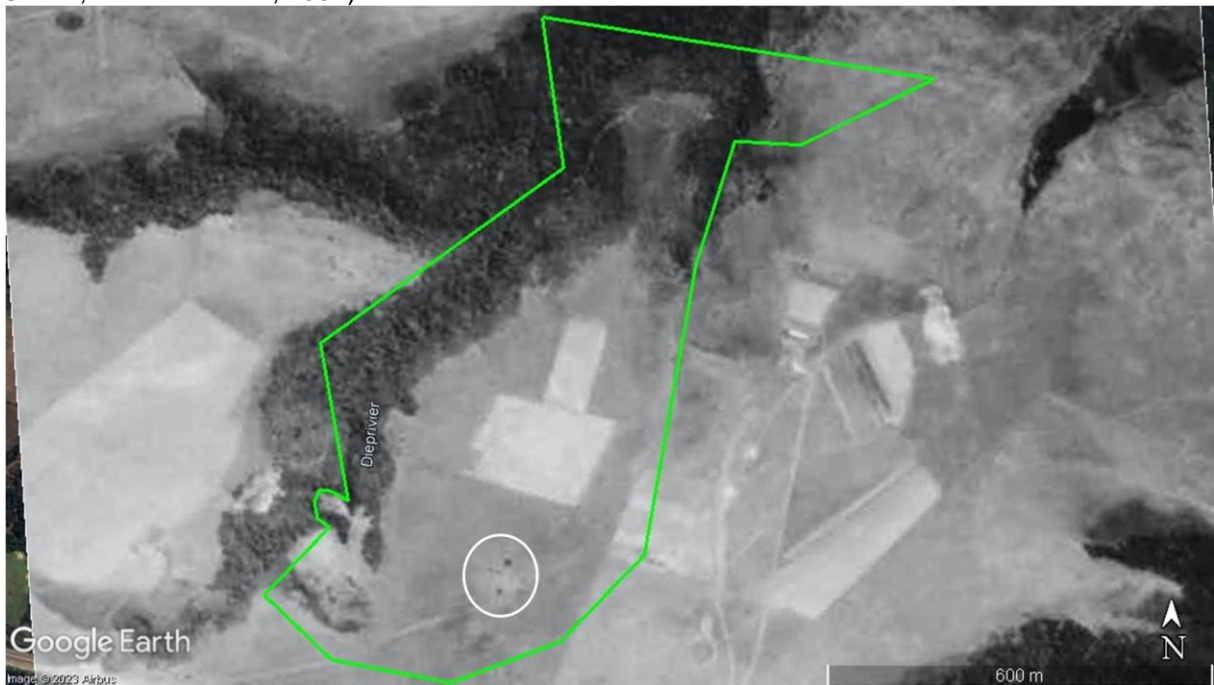
Figure 18. 33/437 boundary (green polygon) overlaid onto 1942 aerial imagery using Google Earth (redrawn after De Kock 2014 Pg.8 Figure 6; Source: Aerial Survey 6, Flight strip 39, Image 10487). The overlay is approximate and not precise. On close scrutiny, the dark “dots” in white ellipse are not identifiable as structures. Note that the bulk of the property was cleared for agricultural purposes.

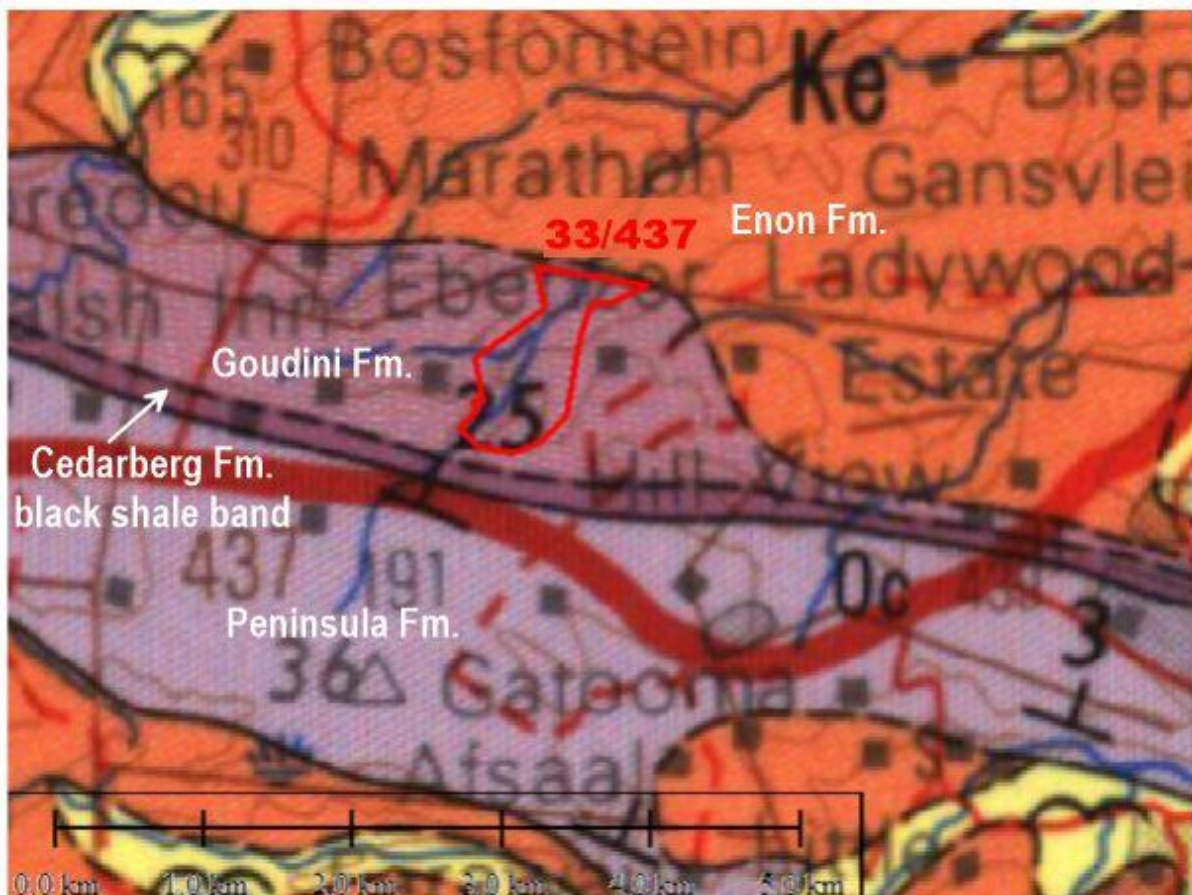
Figure 23. Enlarged portion of 1:250 000 Geological Map (3322 Oudtshoorn; Pether 2023, email).

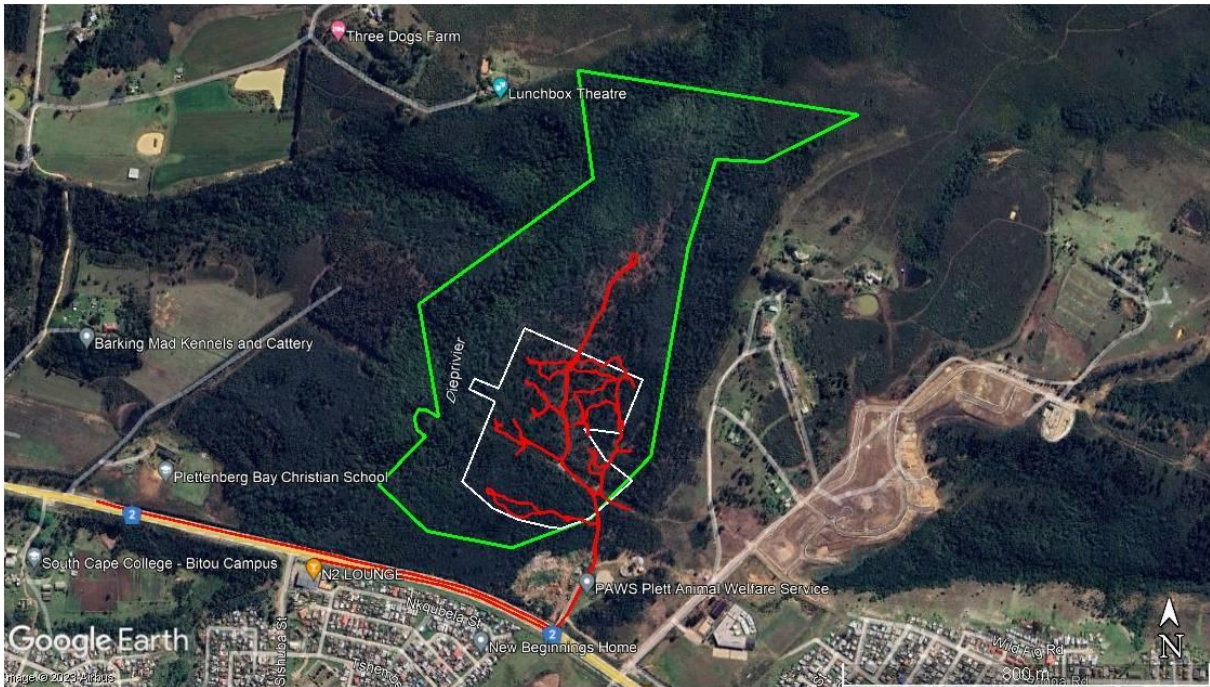
Figure 27: 33/437 (green polygon) with preferred SDP (white polygon) and GPS-fixed archaeological survey tracks (red lines). (A4 version below).

Figure 27: 33/437 (green polygon) with preferred SDP (white polygon) and GPS-fixed archaeological survey tracks (red lines).

Survey tracks and observations were fixed with a hand held Garmin Etrex 30x GPS to record the investigated area its heritage related contents (Figures 26 and 27). A high quality, comprehensive digital photographic record was also made with a Samsung Galaxy A70 and a DooGee S86 cellular phone, including location data for photographs. All GPS and photographic data are available on request.
