**Aquatic Specialist Assessment for a Section 24G and WULA for an  
Enlarged Dam on Farm Buffelsrivier 42/46 and 34/46, George**

**Prepared for Ecoroute**

**Confluent Environmental (Pty) Ltd**

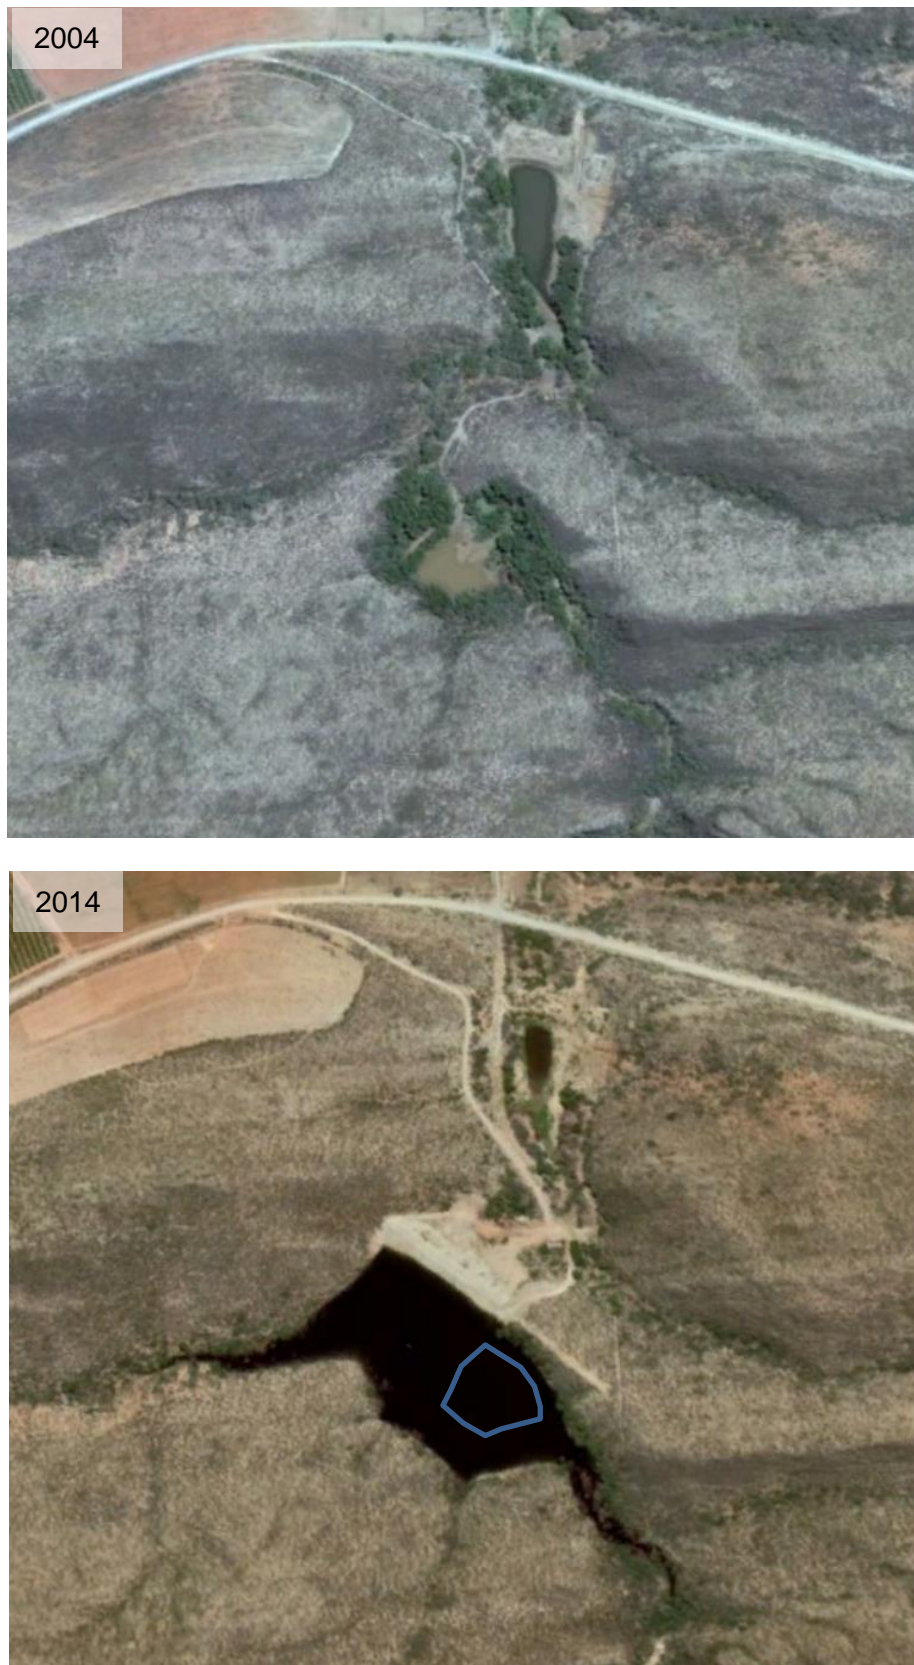
Figure 3. Historical aerial photos of the project area pre- and post-enlargement.

The historical assessment relied upon satellite imagery obtained from Google Earth. The original two dams were clearly evident in the 2004 image (Figure 3). The two dams collectively impound the network of streams arising in the hills forming the extent of their catchment to the south. The image from 2014 indicates when the upstream of the two dams was enlarged, with an overlay of the approximate size of the original dam (Figure 3). The enlarged dam subsequently intercepts water from all the streams except a small inflow immediately upstream of the lower dam. While the upstream dam in its enlarged state has largely replaced the lower dam in terms of storage, a small volume of water is still retained in the lower of the two dams.

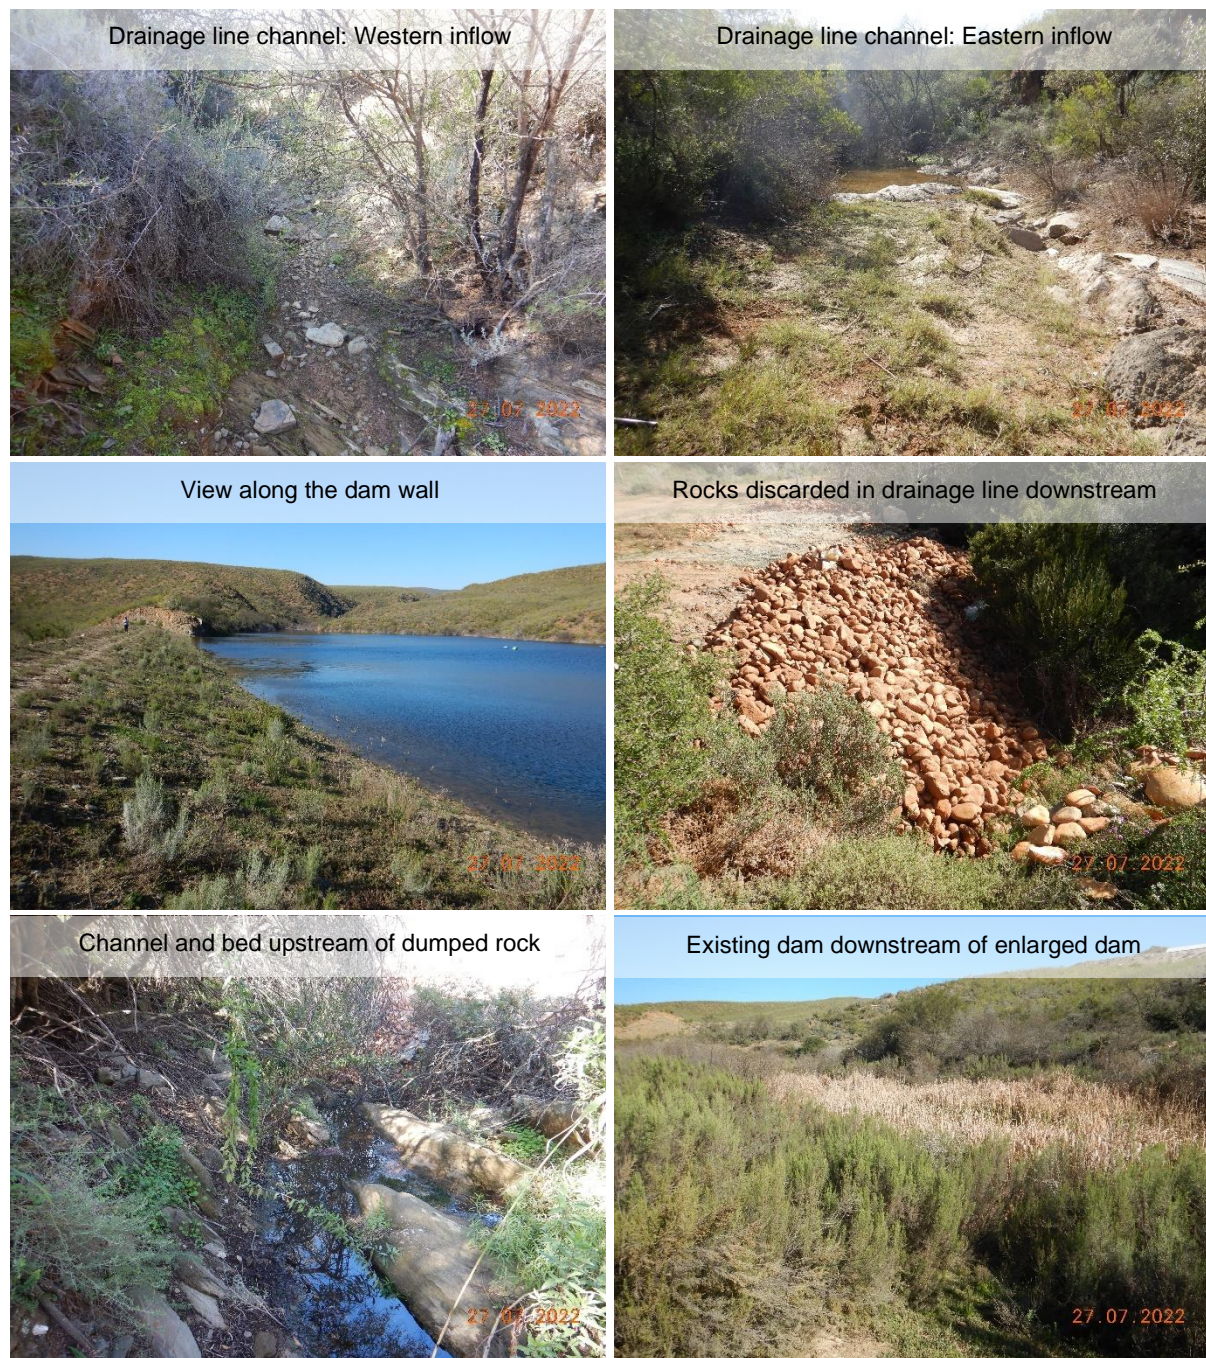
Figure 7. Photos of various aspects of watercourses considered in the IHI PES assessment.

Habitat Modification	Pre-enlargement score	Post-enlargement score	Notes
<b>INSTREAM HABITAT</b>			
Water abstraction	15	15	No significant difference to volumes for abstraction.
Flow	10	15	Likely increase in flow alteration due to enlarged dam.
Bed	5	10	Transformed additional 0.5 ha of streambed for dam enlargement.
Channel	5	10	Transformed additional 0.75 ha of channel for dam enlargement.
Physico-chemistry	5	10	Minor alteration due to transfer from Klein River which is a different catchment.
Inundation	5	10	Additional 1.7 ha inundated for dam enlargement.
Alien macrophytes	0	0	None observed.
Introduced aquatic fauna	5	5	Likely to already have bass / carp.
Rubbish dumping	0	5	Stones dumped in watercourse downstream.
	<b>C, Moderately Modified</b>	<b>D, Largely Modified</b>	
<b>RIPARIAN HABITAT</b>			
Vegetation removal	5	5	Minor vegetation removal
Exotic vegetation	5	5	Minor levels of invasion.
Bank erosion	5	5	Minor bank erosion downstream of dam.

Channel modification	10	12	Dumping of rock into downstream drainage line.
Water abstraction	5	5	Minor impact on riparian vegetation.
Inundation	5	12	Riparian vegetation loss due to enlargement.
Flow modification	5	5	Reduced flows but minor impact on riparian vegetation.
Physico-chemistry	0	0	Unlikely to be any impact.
	<b>B/C Largely Natural to Moderately Modified</b>	<b>C/D Moderately to Largely Modified</b>

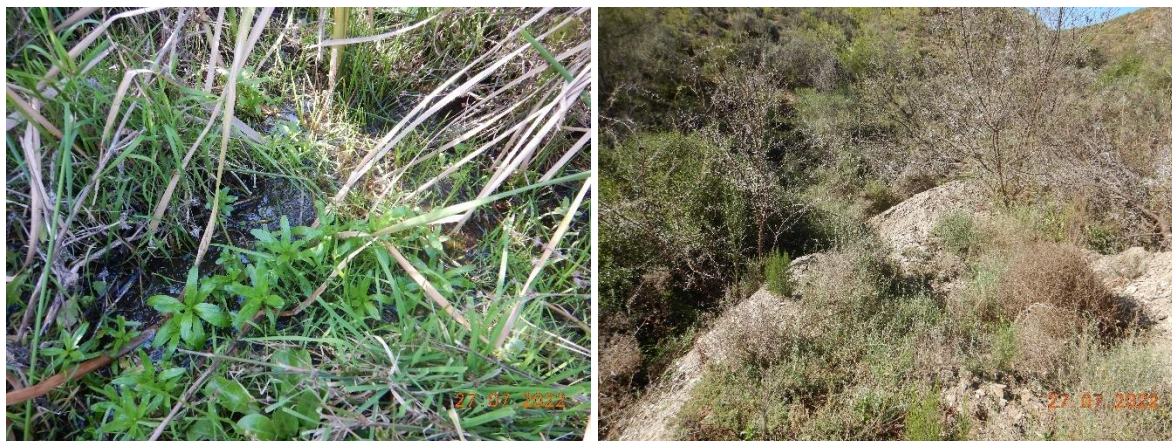
Figure 8. Wetland vegetation and instream flowing water (left) and an area of dumped soil upstream of the wetland.

The wetland is a distinct hydrogeomorphic unit (HGM) but it must be noted that it is a very small section of the eastern tributary between the enlarged and existing dams. It measures approximately 0.1 ha in extent. On the day of the site visit, a shallow (approx. 2 cm deep) film of water was moving through the wetland, and abundant instream wetland vegetation was

-	Sand from enlarged dam's spillway dumped instream
<b>Geomorphology PES Category: B, Largely Natural</b>	<b>Geomorphology PES Category: B, Largely Natural</b>
<b>VEGETATION</b>	<b>VEGETATION</b>
Existing dam and road crossing	Existing dam and road crossing
Shallow flooding by dam	Shallow flooding by dam

-	Area of infilling due to excavated spillway
<b>Vegetation PES Category: B/C, Largely Natural to Moderately Modified</b>	<b>Vegetation PES Category: B/C, Largely Natural to Moderately Modified</b>
<b>OVERALL PES:</b>	<b>OVERALL PES:</b>
<b>B/C, Largely Natural to Moderately Modified</b>	<b>B/C, Largely Natural to Moderately Modified</b>

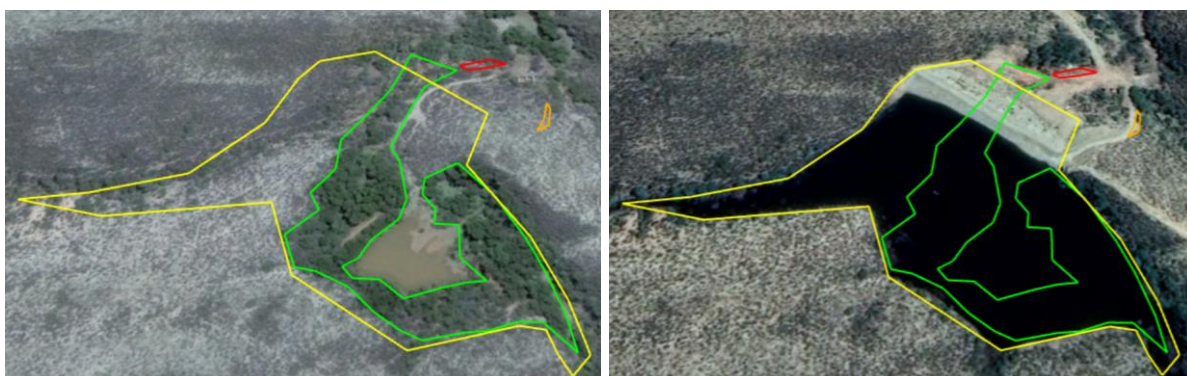
Figure 9. Enlarged dam shown pre- and post-construction with impacted aquatic habitat overlaid. Green = riparian vegetation, yellow = enlarged dam footprint, Orange = sand discard in wetland, and Red = rock discard in drainage line.

Earthmoving vehicles were required to excavate sediment from the enlarged dam's basin, clear vegetation, and extend the dam wall. Approximately 0.9 ha of riparian vegetation was cleared during the excavation, and soil up to 3 m deep was excavated from the dam basin for use in the dam wall. The impacts were considered a **Moderate Negative** (Table 8).
