GEOTECHNICAL SOIL TEST REPORT

Client: Mr Sean Holmes

Project: Erf 301, Wilderness

Date of test: 13.09.2024

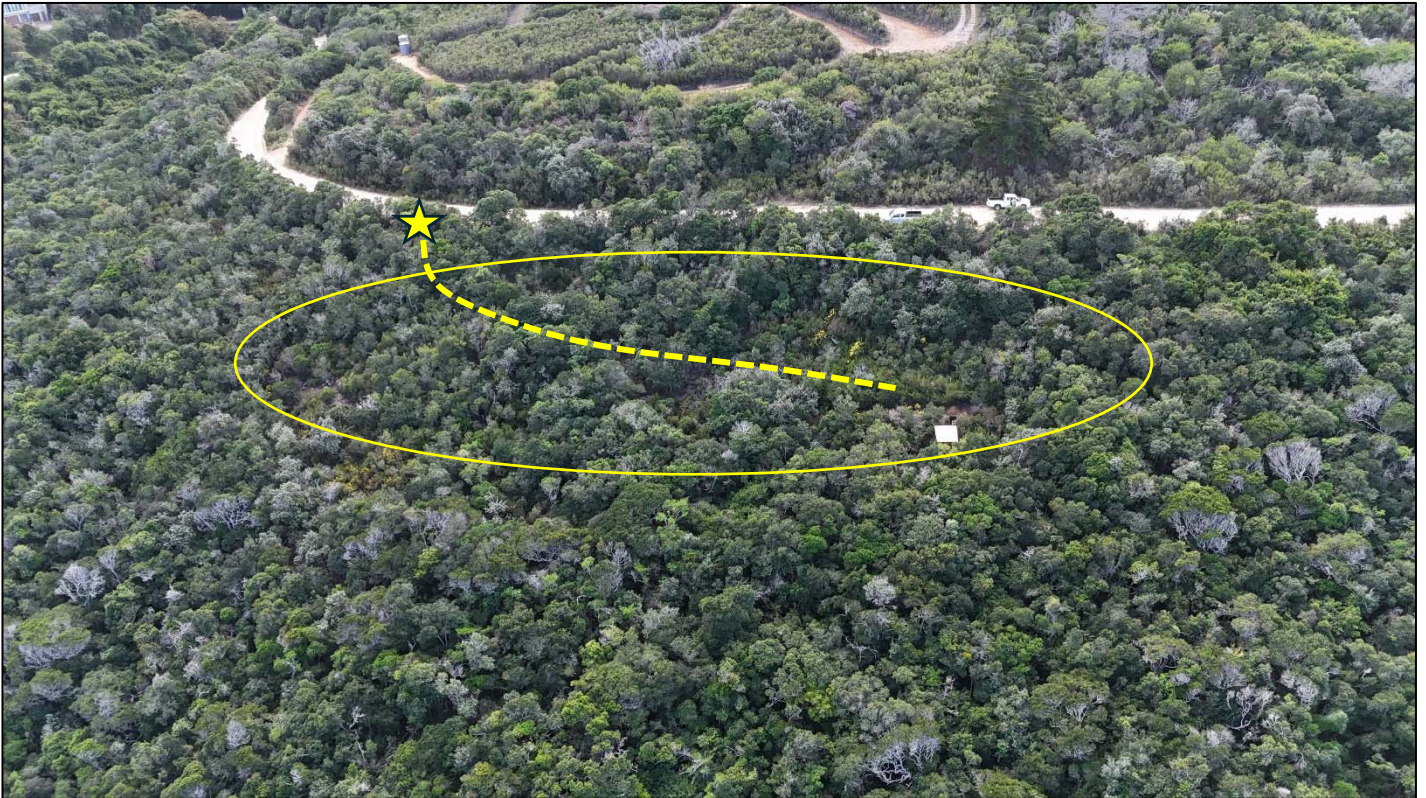
The site for the proposed residential development, consisting of a main residence and 4 smaller dwelling units, was located on ~4ha of vacant land approximately within 2km east of the central business area of Wilderness. Access to the site was gained on foot only from Whites Road along the northern boundary. At the time of investigation, the vegetation cover on the site was very thick, and consisted of indigenous forest and coastal thicket. The natural topography of the site was steeply sloping to the south with an average gradient of 1V:2.5H (~21°). See Figure 1-4.

Figure 1: Oblique aerial view of the site (proposed development area circled in yellow and proposed access point and driveway)

Access road/driveway: The steep site gradient and shallow bedrock may hamper road building, however, where the access road/driveway is planned for the site (as indicated in Figure 1), consideration should be given to minimise its length and width, and avoid a steep decline by following the natural contours as far as possible. The insitu organic-rich topsoil was considered poor quality roadbed material with a tendency to rut, particularly in wet conditions and should be entirely removed along any planned access roads and replaced with suitable gravel fill material (e.g. from cut or imported). It is recommended that allowance is made for importation of some gravel material to supplement material obtained from site. Recommended paved driveway layerworks include 150mm subbase (compacted to 95%MDD) and concrete slabs or interlocking pavers.

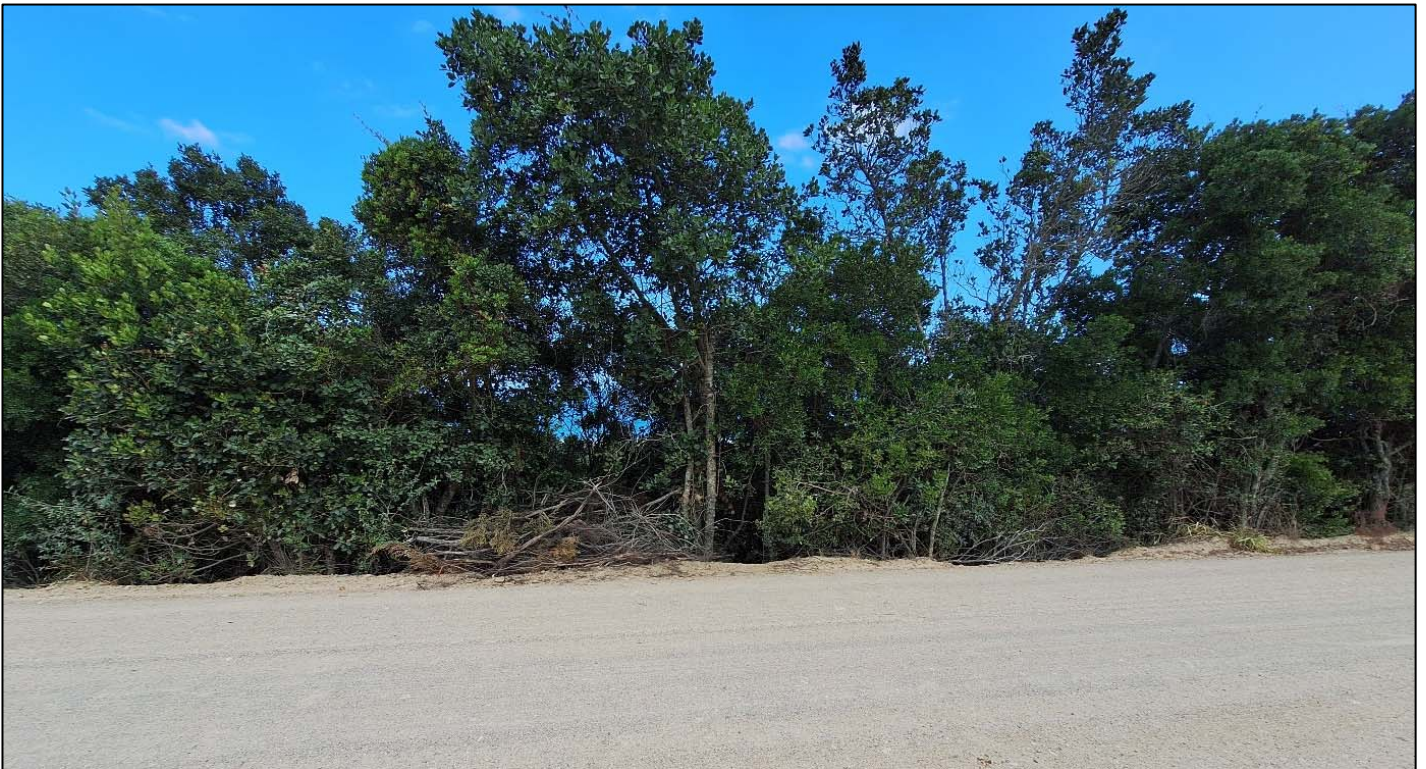
Figure 2: View of the northern boundary of the site entrance along Whites Road

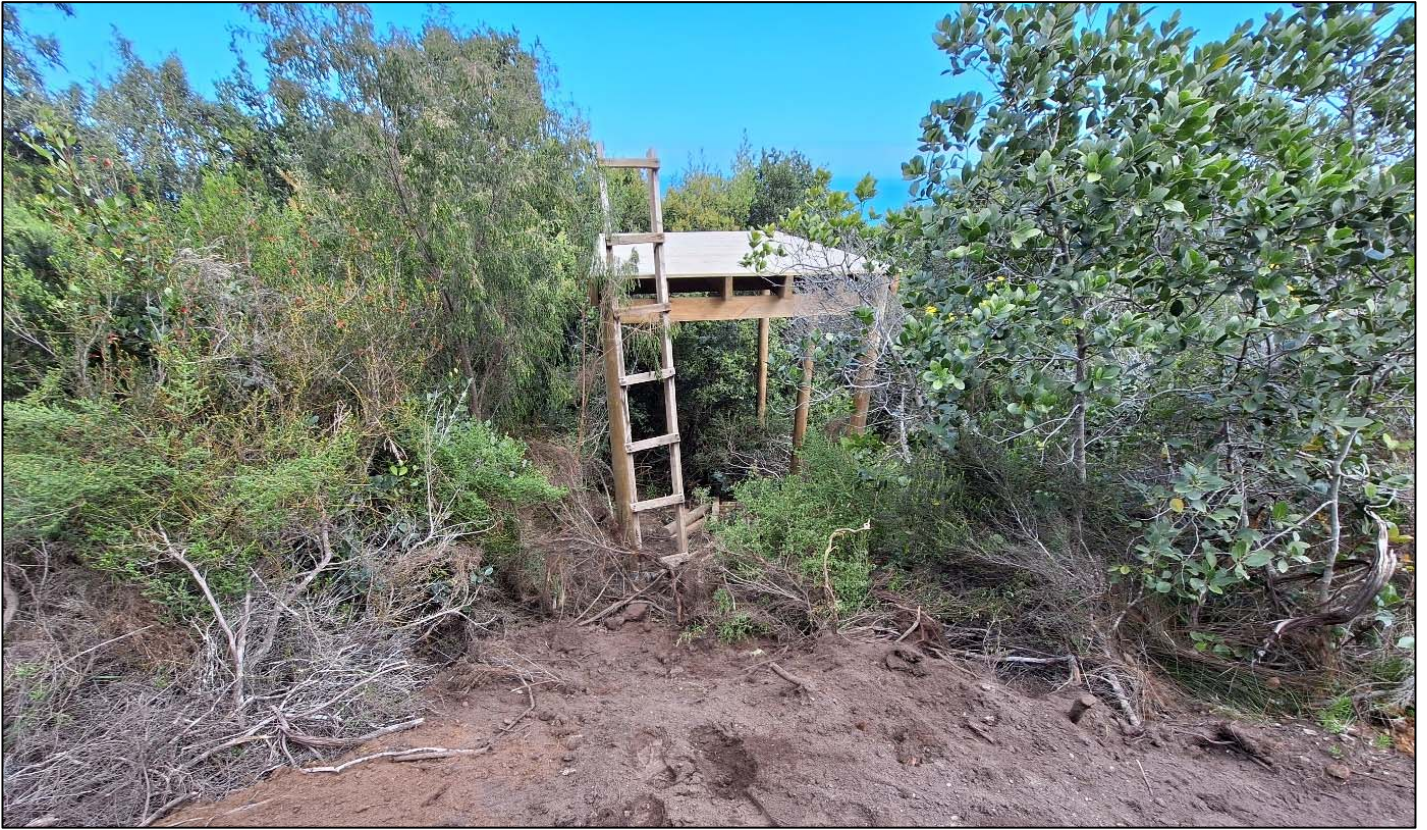
Figure 3: Viewing deck at the proposed main residence site, looking south

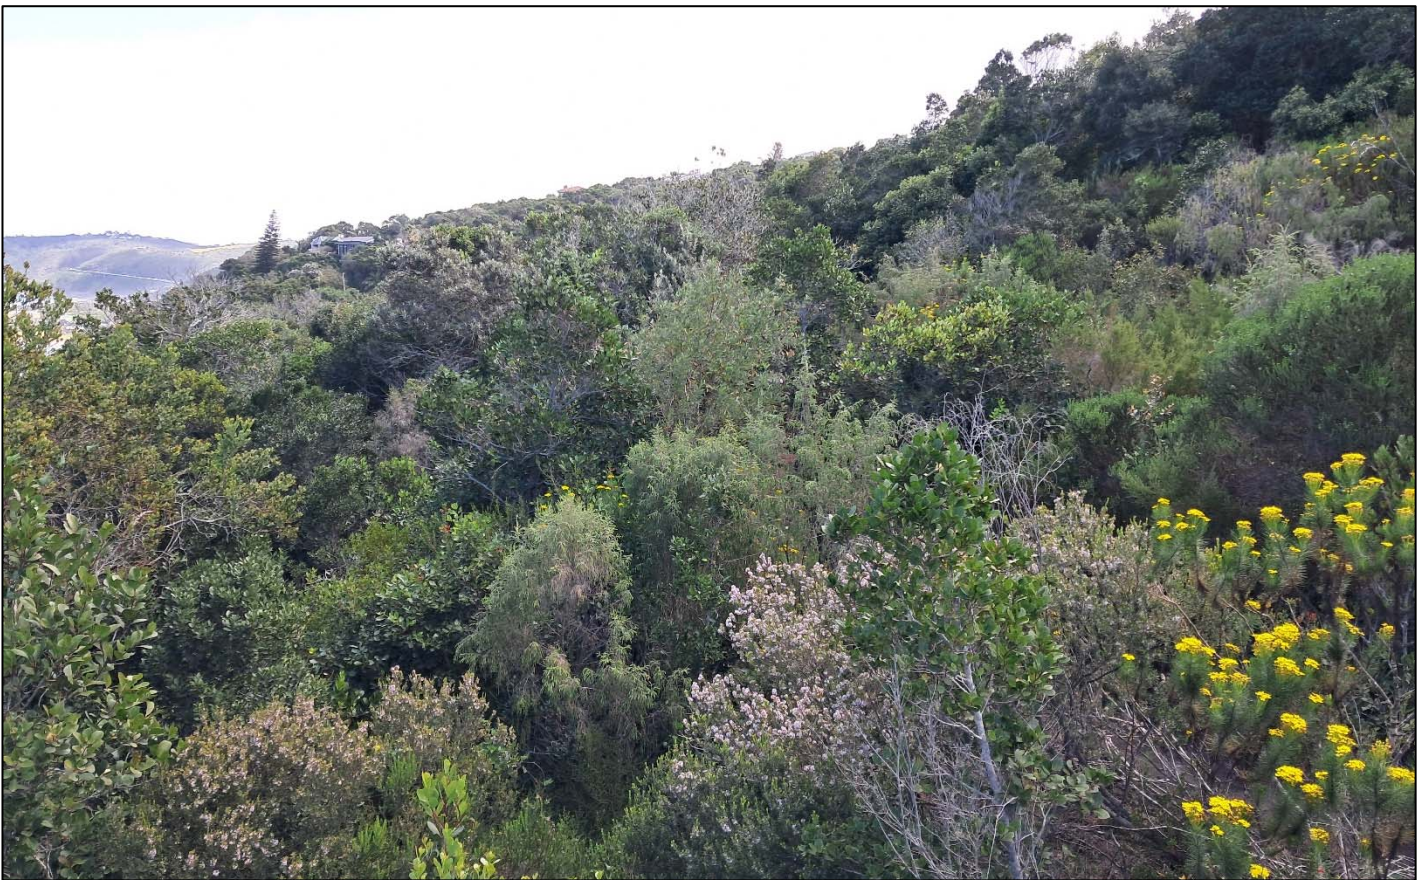
Figure 4: View of the site looking west from the viewing platform

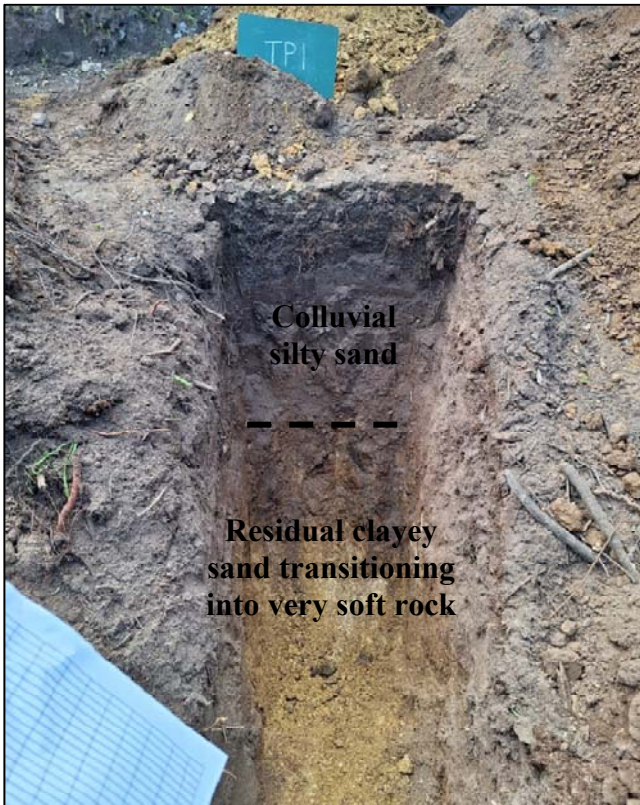
The profile excavated in test pits correlated with the local geology of the area. TP1 and TP2 consisted of silty sand of colluvial origin to an average depth of 1m below ground level, underlain by a thin residual clayey sand horizon, which quickly transitions into very soft granite rock (See Figure 5a). At TP3 and TP4 shallow, hard rock was encountered at a depth of 0.4m below ground level, overlain by similar colluvial silty sand (see Figure 5b).

Figure 5a: Typical profile at TP1 & TP2

Foundations: In order to minimise the impact of development on the site, it is recommended that structures are designed as light-weight structures with suspended floors, supported on posts and pads. Pad foundations should be supported on very dense residual soil or preferably bedrock at an estimated average depth of 0.9m below NGL with an allowable safe bearing pressure of 150kPa. Depth of excavations may vary to ensure all foundations are well founded to avoid any stability issues. Masonry/concrete structures with surface beds and strip footings will typically involve more earthworks and retaining walls. All excavations and foundations should be checked by the engineer.

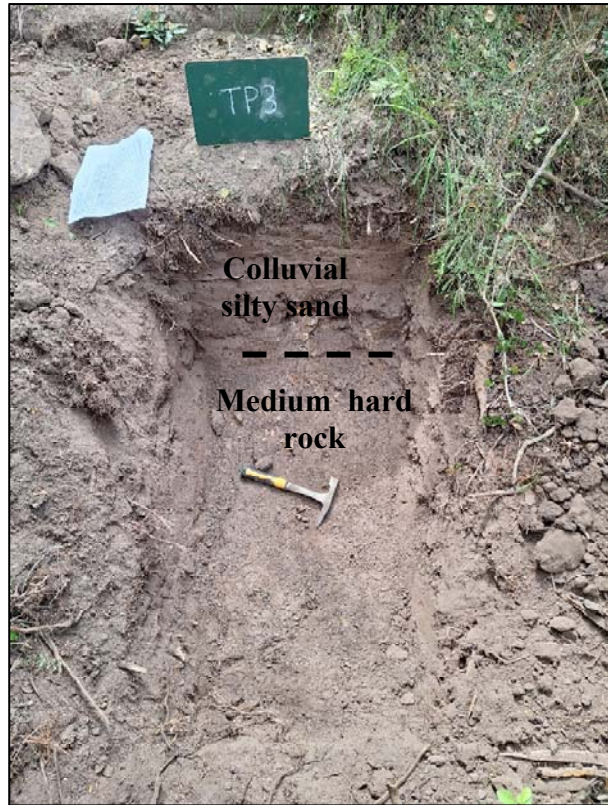
Fig 5b: Typical profile at TP3 & TP4
