# Proposed Development of two residential dwellings on Farm 76/216 Uitzicht, Knysna, Western Cape.

Aquatic Compliance Statement

**Date:** February 2024

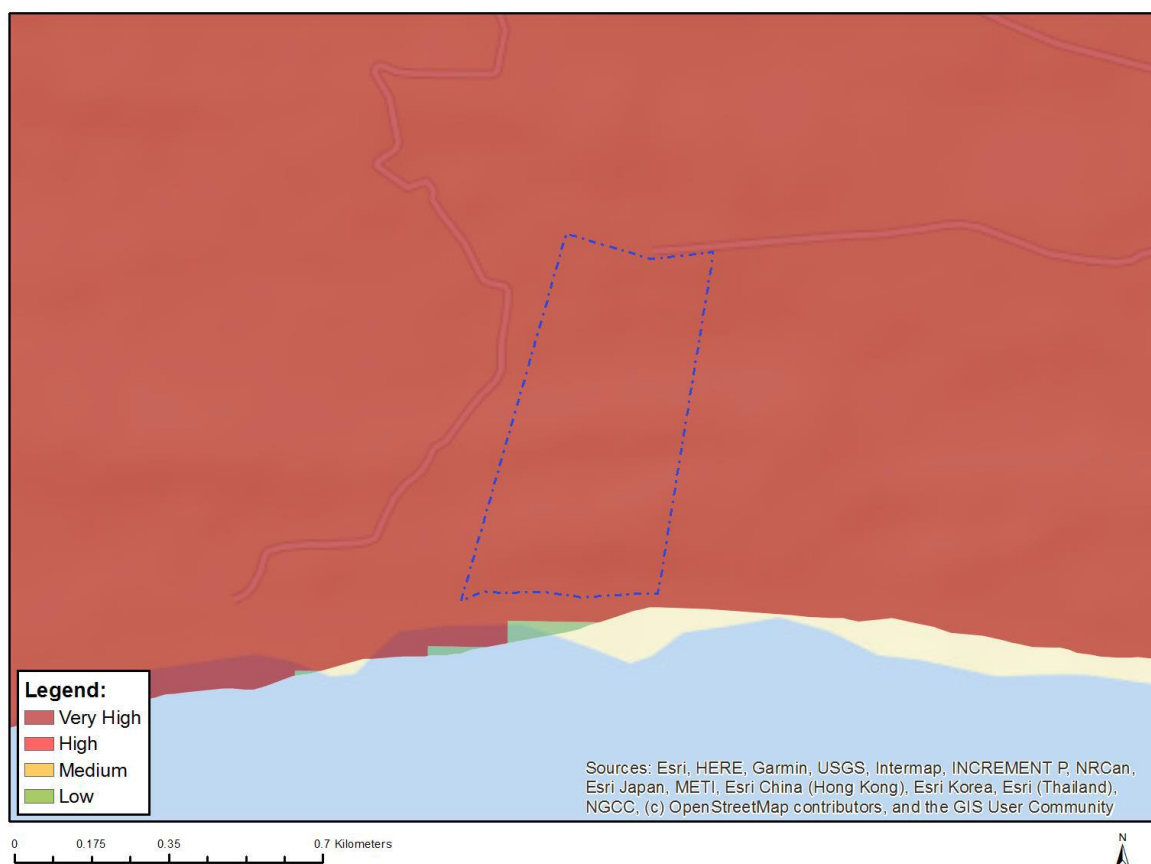
According to the Department of Environment, Forestry and Fisheries (DFFE) screening tool, aquatic biodiversity at the site has a **Very High** sensitivity (Figure 5). The sensitivity features identified about the classification are:

- Freshwater Ecosystem Priority Area (FEPA) Subcatchment
- Strategic Water Source Areas (SWSA) (SW) Outeniqua

Figure 5. Results of the DFFE Screening Tool which indicate Very High Sensitivity of the Aquatic Biodiversity theme for Farm 76/216.

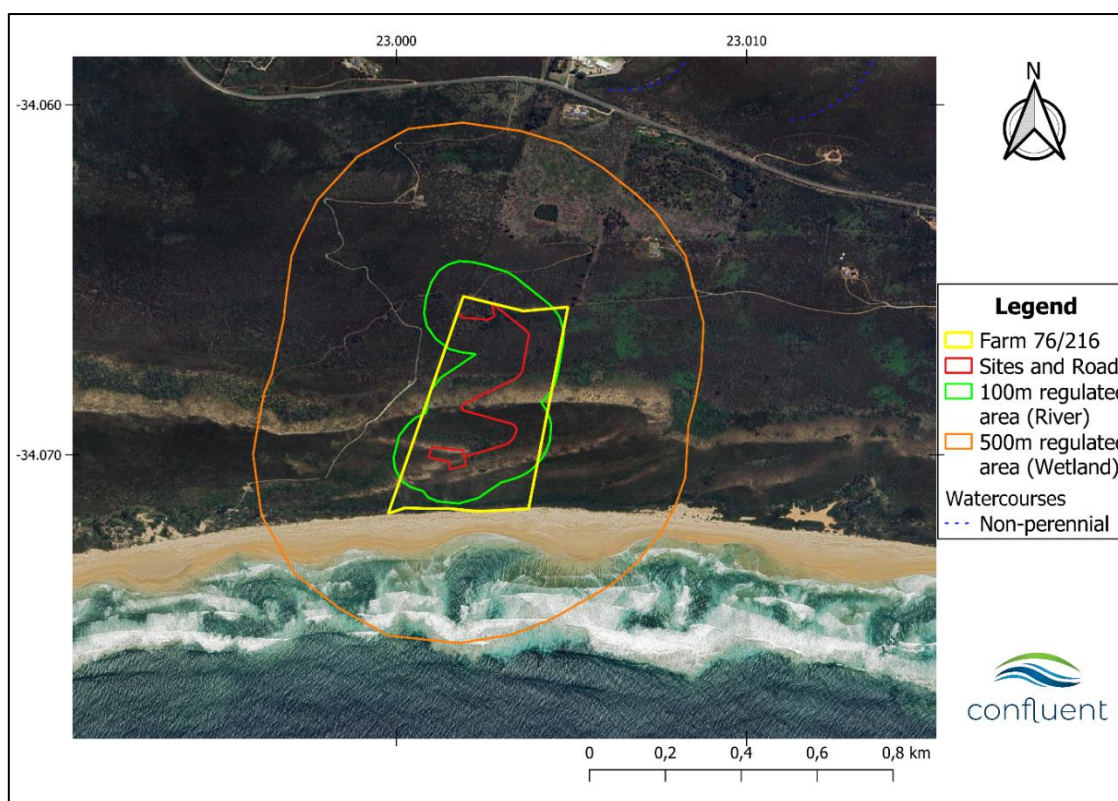
As mentioned above there are no mapped watercourses on the property itself (Figure 7), or within the regulated areas defined by GN 4167 of the National Water Act (Figure 11).

Figure 11: Map indicating no mapped watercourses within 100 m or 500 m from the proposed development site.

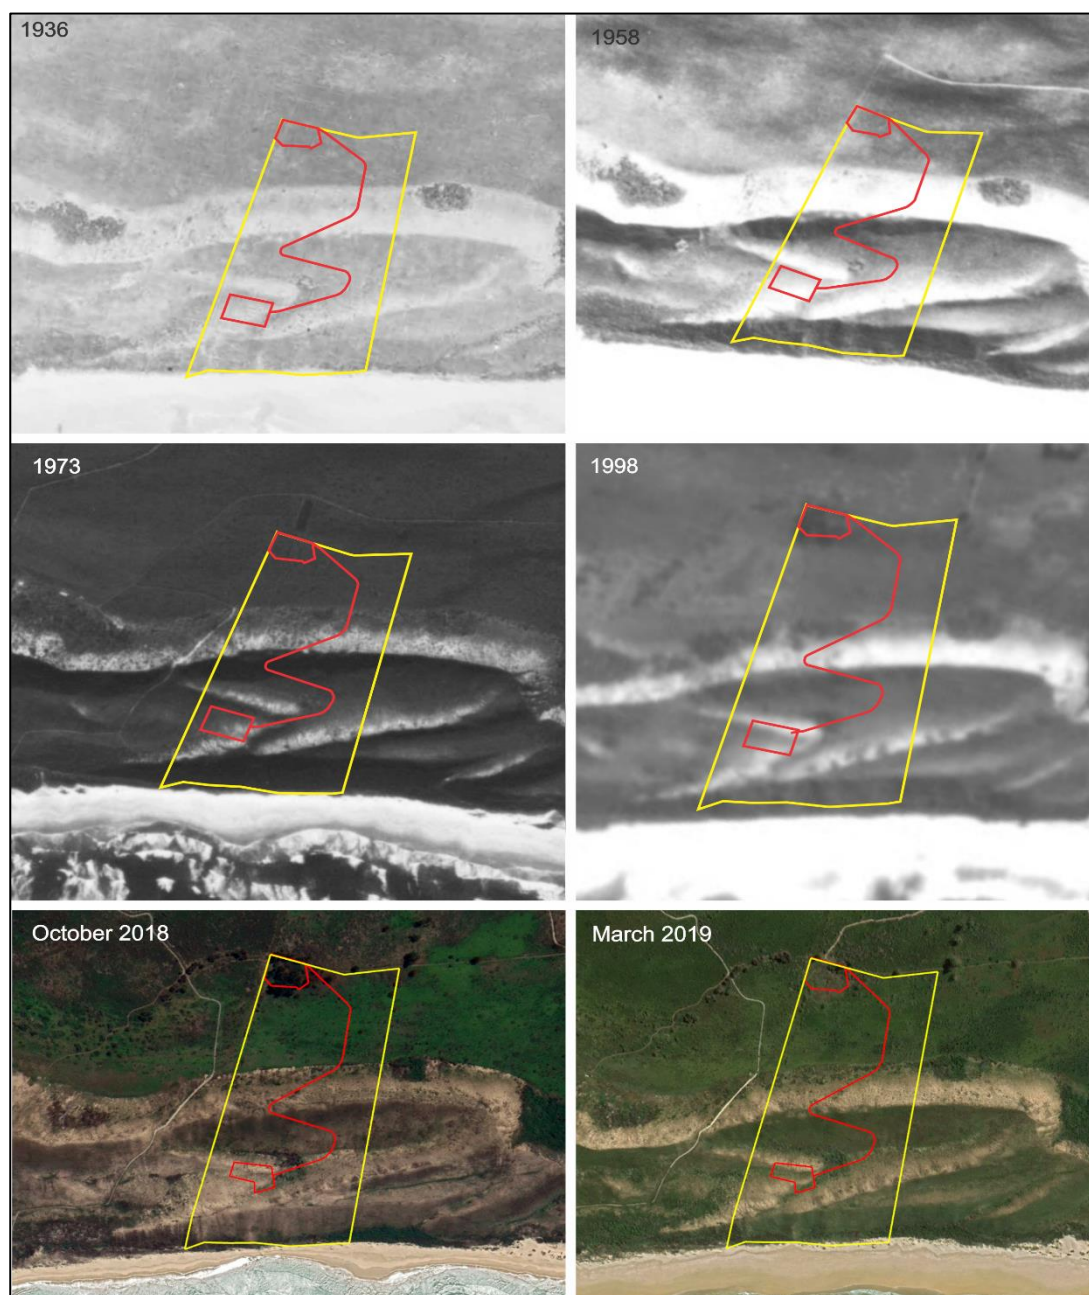
From 1936 till 2023 no development took place at the proposed development site (Portion 76/216). In between the years 1973 and 1998, a patch of pine trees established in the North-west corner of the farm and was cleared in 2019, but has regrown. In 2018 more than half of the farm Southwards was cleared due to the 2017 Knysna fires (Figure 12). Much of this area has since revegetated with predominantly indigenous vegetation but there are present areas of dense pockets of alien invasive Rooikrans (*Acacia cyclops*).

Figure 12. Historical photos showing Farm 76/216 through notable changes between 1939 and 2019 (CD:NGI & Google Earth imagery).

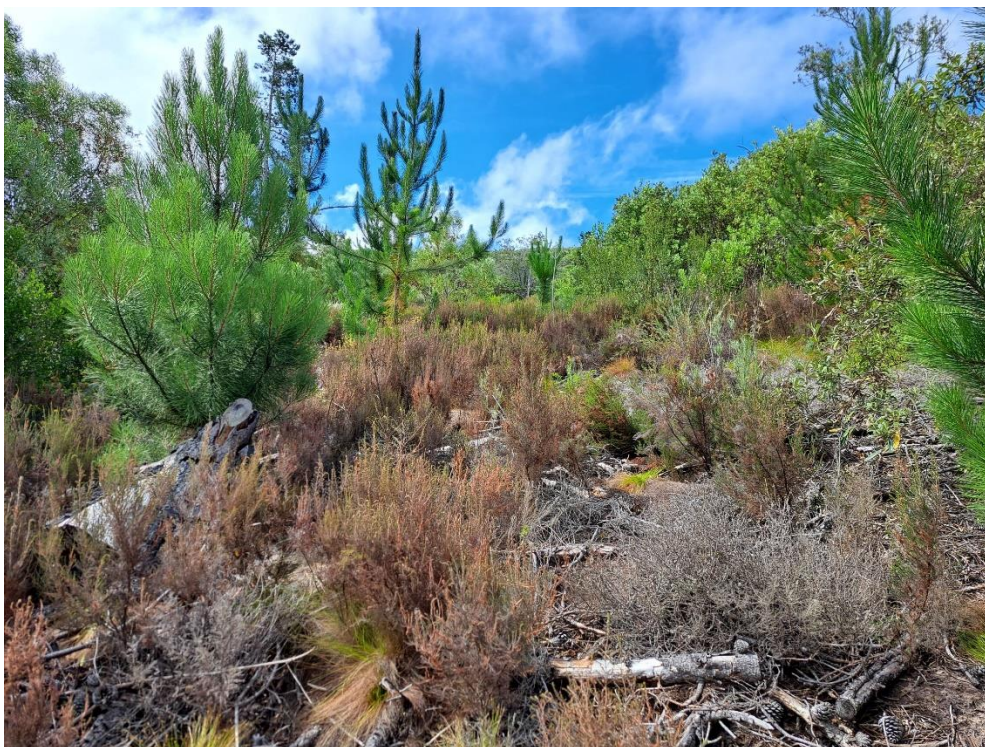
No watercourses as per definitions provided by the National Water Act were observed on the site. However, this finding is limited to the areas directly assessed as indicated during the site visits (Figure 13). Should the layout change substantially then this report would need to be reviewed for applicability and possibly be updated. The northern section of the property is positioned on a more level area which slopes steeply away to the south. The proposed location of the dwelling at this point has no watercourse features and consists of fynbos invaded by several alien plants dominated by pine and *Eucalyptus*. A typical picture of vegetation at this point is provided in Figure 14.

Figure 14: Typical vegetation in the vicinity of the proposed northern dwelling. Fynbos vegetation

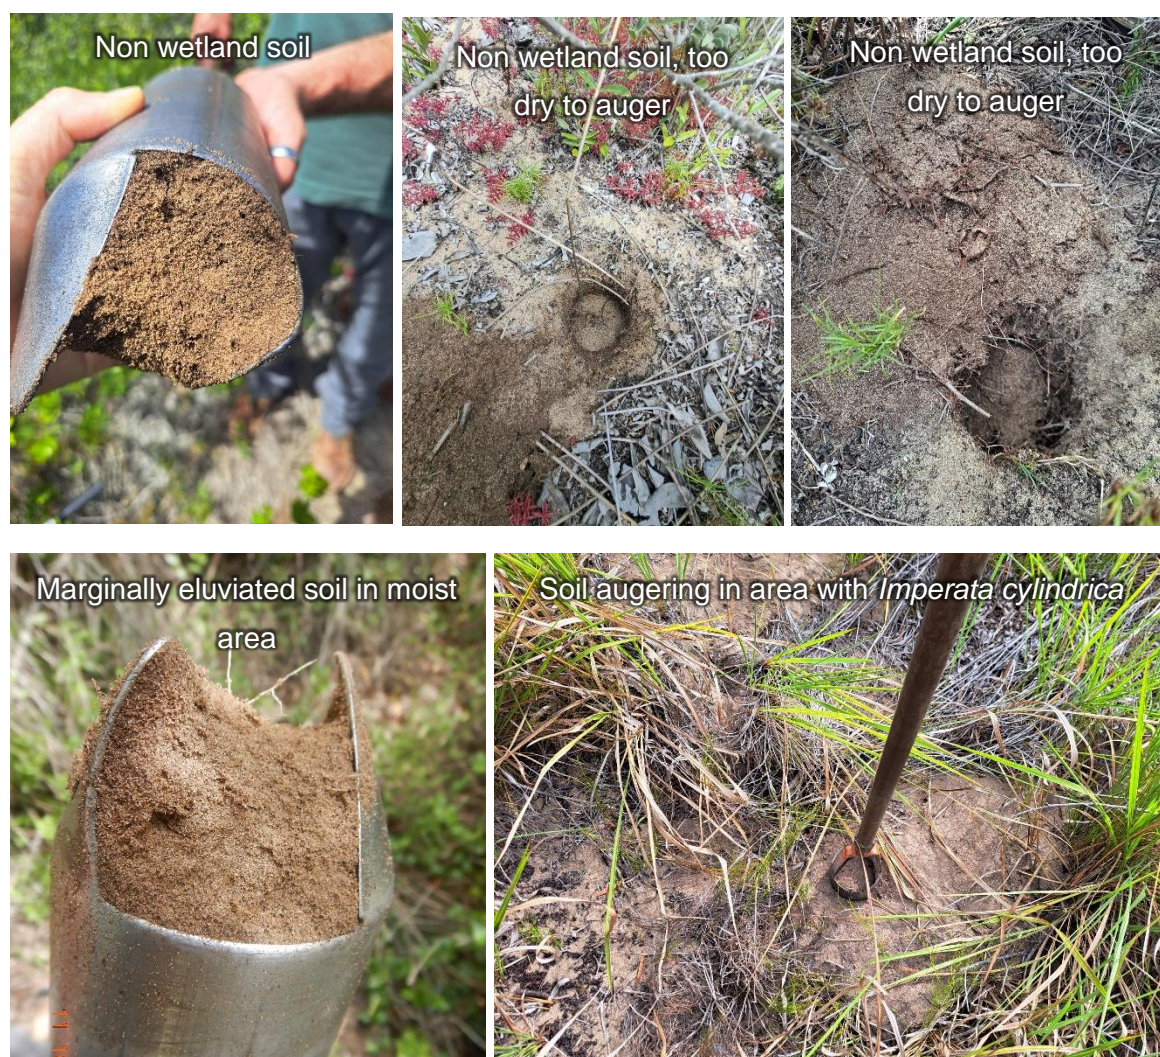
Soil auger samples were taken on both site visits at several locations in valley bottoms where dune slacks could occur. The locations of soil auger samples is indicated in Figure 13. Soils in all cases were found to be very sandy. No significant mottling or gleying was observed in any of the samples. Higher soil moisture was observable in samples from the more northern of the two valley bottoms near the road footprint than at other points. However, there had been high rainfall for the preceding months prior to the first site visit in October, which is also one of the peak months for rainfall in the area. During site visits in December, the soil could not even be effectively augered as it simply fell out of the bucket and was too dry and well drained to collect samples.

Figure 15: Examples of soil auger results from various locations augured on the site.

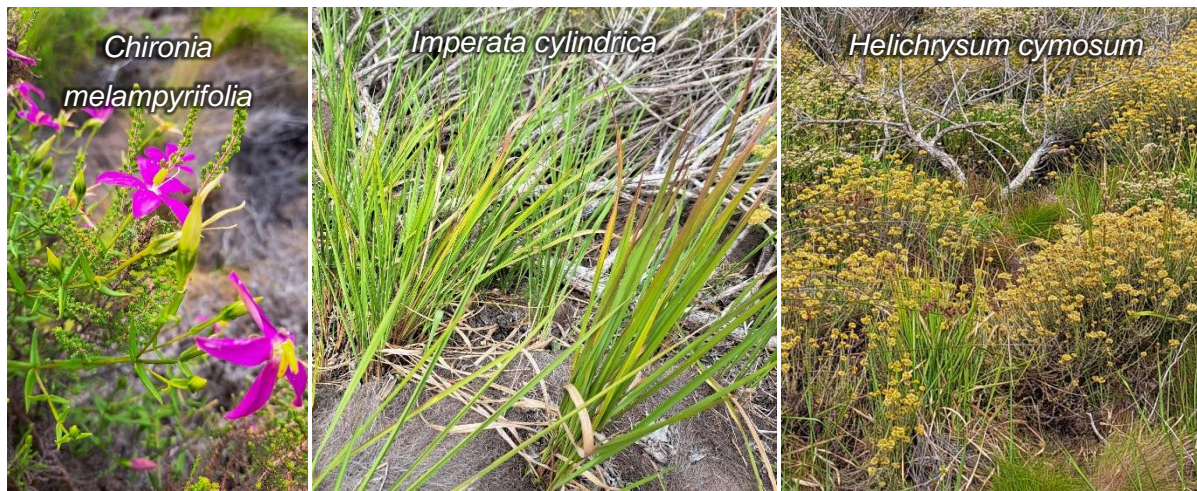
While no vegetation strictly associated with wetlands was observed anywhere on the site, the two valley bottom areas had patches of plant species associated with moist, sandy soil conditions. These included Cogon grass (*Imperata cylindrica*), Fume everlasting (*Helichrysum cymosum*) and isolated plants of Stream chiron (*Chironia melampyrifolia*; Figure 16 & Figure 17). Both *I. cylindrica* and *C. melampyrifolia* are known from damp, moist, sandy habitats and could be present in a wetland in sandy conditions. *Imperata cylindrica* is known as an indicator of the transitional zone between wetlands and terrestrial zones, indicating the outer most limits of a wetland (van Ginkel & Cilliers, 2020). *Helichrysum cymosum* was generally widespread in the valley bottom and can occur on a range of soils with a general preference for damp areas. However, the isolated nature of their occurrence between more dominant non-wetland plants in this instance is more indicative of periodic moist conditions as opposed to a definable wetland feature.

Figure 16. Plants often associated with moist to wet areas in sandy areas, although *H. cymosum* occurs on a range of soil types.

These plants were interspersed throughout the valley-bottom, co-occurring with plants identified in Figure 16.

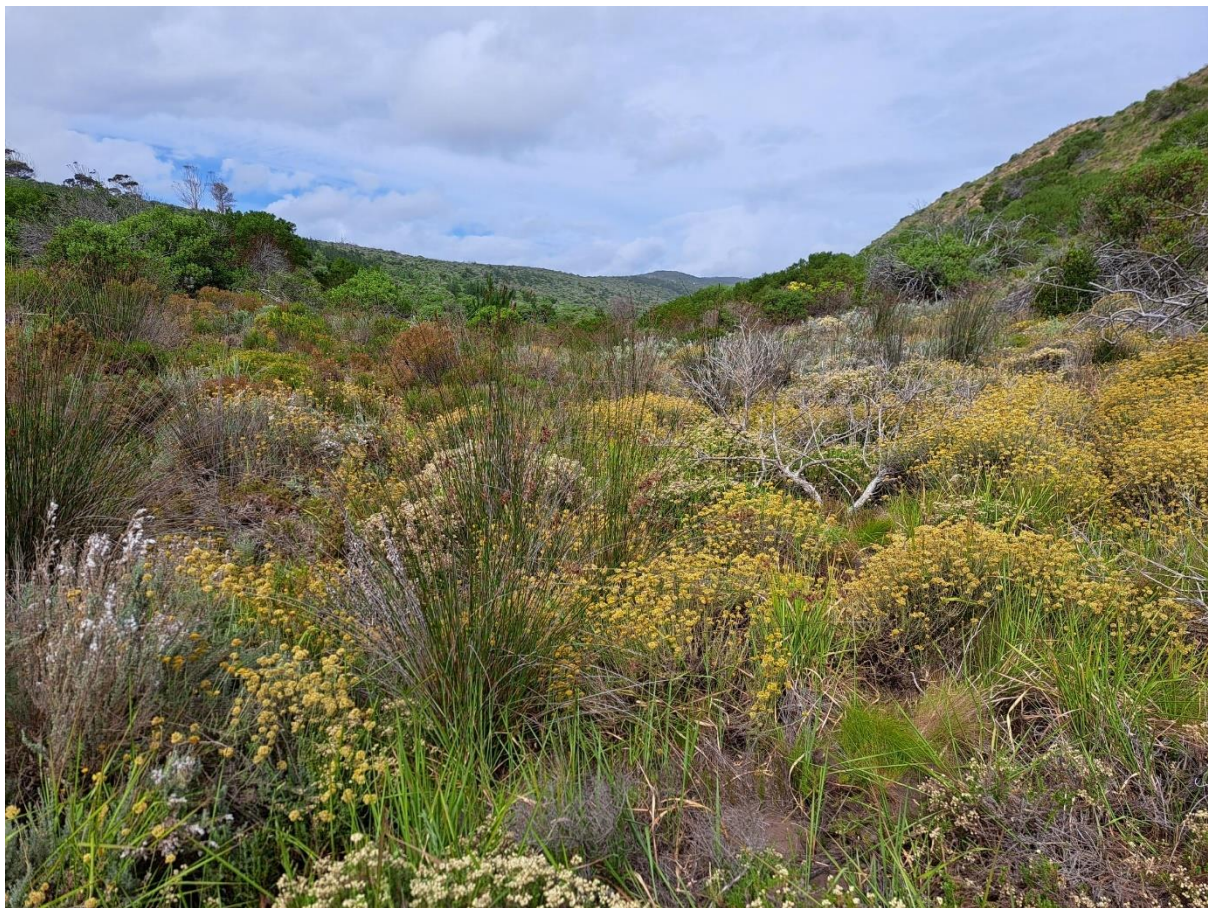
Figure 17. Typical vegetation in the valley bottom between dunes at the site. This location was close to the proposed access road route.

Dominant terrestrial plants in the valley bottoms included Sprawling snake thistle (*Cullumia decurrens*), Silver everlasting (*Helichrysum petiolare*), Sunshine cone bush (*Leucadendron salignum*), and Thatching reed (*Thamnochortus insignis*). Large shrubs / small trees included the coastal camphorbush (*Tarchonanthus littoralis*), and Current rhus (*Searsia tormentosa*).

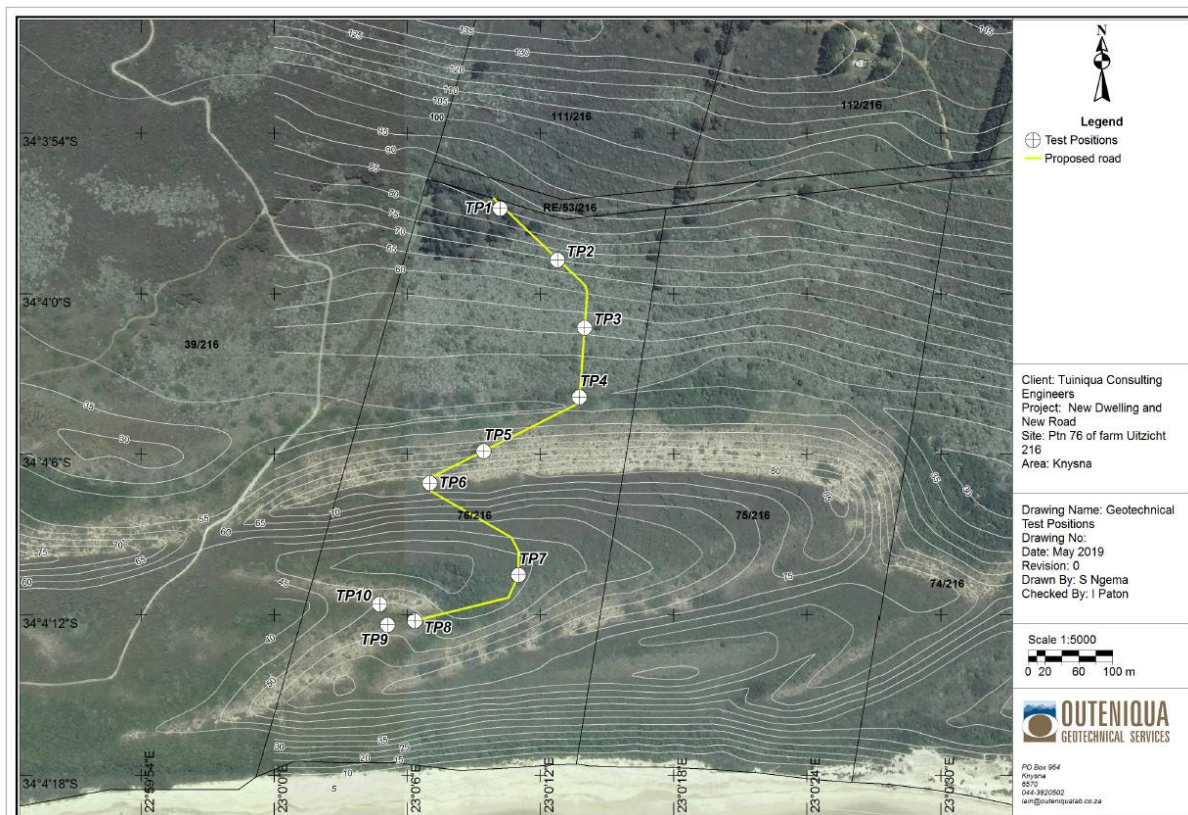
### 6.1 Location of Test Pits in Geotechnical Report

A geotechnical report was compiled for the site (Outeniqua Labs, May 2019). Test pits were dug at the proposed location of the two houses and at points along the proposed road. Test pits (TPs) 4 and 7 were located in valley bottoms (See Appendix 1 for map) which coincided with areas where dune slack wetlands could occur. Both test pits were dug to a depth of 2 m at which point no water was found. The soil in the upper 80 cm at TP4 was described as moist, dark red brown, very loose to loose, intact silty fine sand and roots. Soil in the upper 70 cm of TP7 was described as moist, dark red brown, very loose, intact, silty fine sand and roots, transported. Below 80 cm both soil profiles were underlain by light brown cohesionless fine sand. The sidewalls of the test pit collapsed due to the cohesionless nature of the soil, which is what also made soil augering difficult. The geotechnical report concluded that there were no signs of any poorly drained areas or marshy surface conditions. The sands have a high permeability and are well drained, although seasonal seepage or wet surface conditions could occur in natural areas of drainage (ie. Valley bottoms).
