**Botanical Impact Assessment for  
disturbed sites on Outeniqua Game Farm  
(farms 373 & 420)  
in the Mossel Bay district.**

**This report was prepared during June 2019 by:**

**Regalis Environmental Services CC  
P.O. Box 1512  
6620 Oudtshoorn  
Tel: 044-2791987  
Email: [janvlok@mweb.co.za](mailto:janvlok@mweb.co.za)**

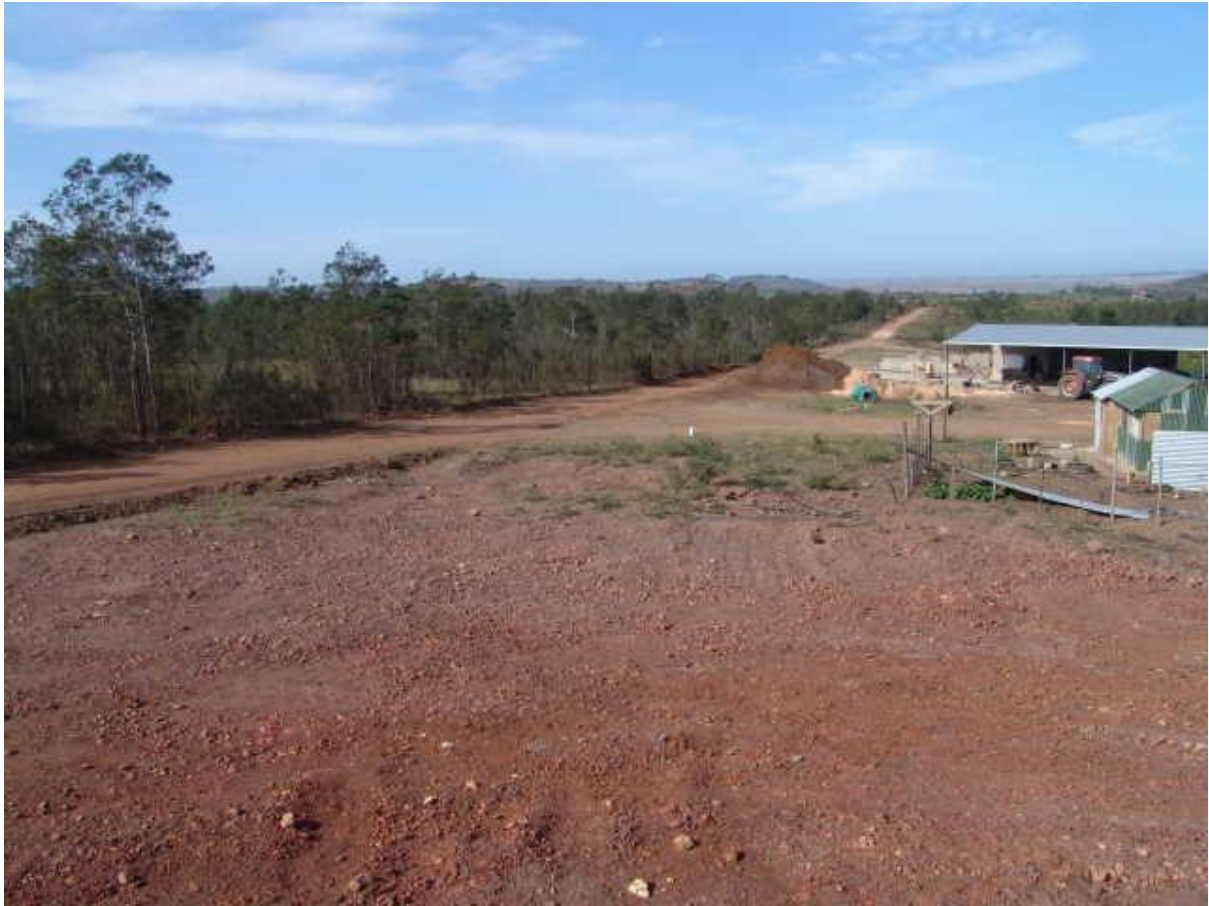
At **Site 7** (mapped as Swellendam Silcrete Fynbos) an area of at most 1 ha was cleared to establish a reservoir, a shed and general work area. It is very difficult to establish the exact nature of the vegetation that was cleared, but the remnant vegetation on the similarly flat area immediately to the east of the site is probably the best reference vegetation. This reference site was clearly also an old agricultural land that became overgrown with Blackwattle. Only a few grass species (*Cynodon dactylon* and *Eragrostis curvula*) and early pioneer shrubs (*Anthospermum aethiopicum*, *Athanasia trifurcata* and *Metalsia acuta*) managed to establish amongst the Blackwattle on the old lands. The flat area south of this site was not ploughed earlier and is richer in species, but the species present in this southern area indicate that the vegetation was probably also highly disturbed as only the following species were recorded here:

**Photo 5:** The ca. 1 ha area cleared at Site 7. Note the dense stands of Blackwattle to the left of the road that is probably the best reference site for the cleared vegetation.
