Proposed Development of Tourist Facilities on Portion 104 of Farm 216, Uitzicht, Knysna, Western Cape.

Aquatic Biodiversity Site Sensitivity Verification and Impact Assessment.

Prepared For: Eco Route Environmental Consultancy

Date: 24 July 2024

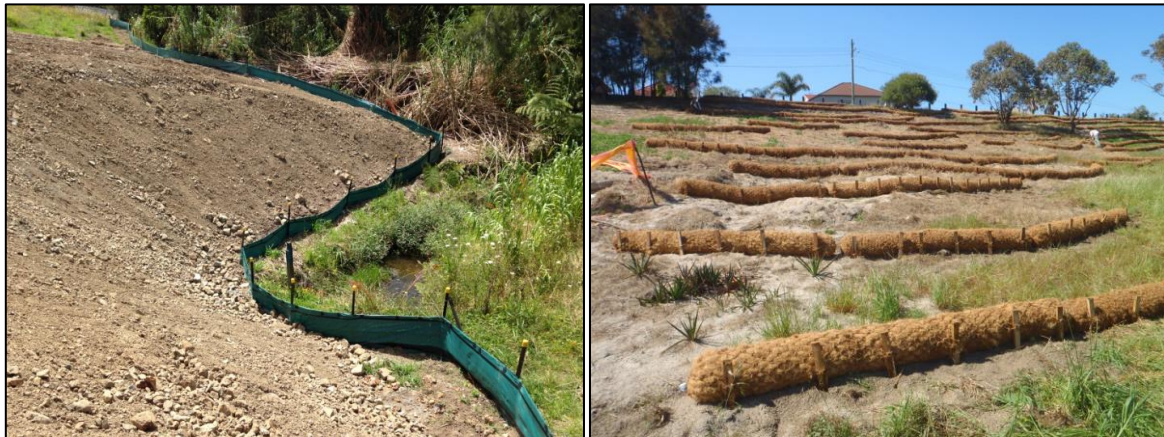
Figure 20: Examples of silt fences (left) and coir logs (right) used to trap sediment mobilised from steep slopes.

- Do not clear vegetation outside the proposed development footprint.
- Only use one access road for each camp unit.
- Use the existing road as far as possible.
- Install silt fences or sediment barriers around the perimeter of the construction site to trap sediment-laden runoff and prevent it from entering the estuary.
- Implement phased construction to minimise the area of exposed soil at any given time and reduce the potential for erosion.
- Apply mulch or erosion control mats on exposed slopes and disturbed areas to stabilise soils and reduce erosion rates.
- The 36 m buffer must be maintained and demarcated as a no-go area.
- The laydown areas must be constructed on flat surfaces with a minimum distance of 20 m from the buffer.

- All stockpiles must be covered at the end of the day.
- Install temporary drainage controls such as swales or berms to manage runoff where necessary.
- All materials used during construction must follow the best practice guidelines set out for each product.
- Check weather reports ahead and prepare the site when rainfall is predicted. Discontinue any earthworks on the site during rainfall.
