**PROPOSED MEDIUM TO HIGH DENSITY RESIDENTIAL DEVELOPMENT ON RE / ERF 2074, MARINE WAY,  
BITOU LOCAL MUNICIPALITY, WESTERN CAPE**

# Proposed Residential Development on RE/2074, Plettenberg Bay, Western Cape.

## Aquatic Compliance Statement

**Date:** February 2024

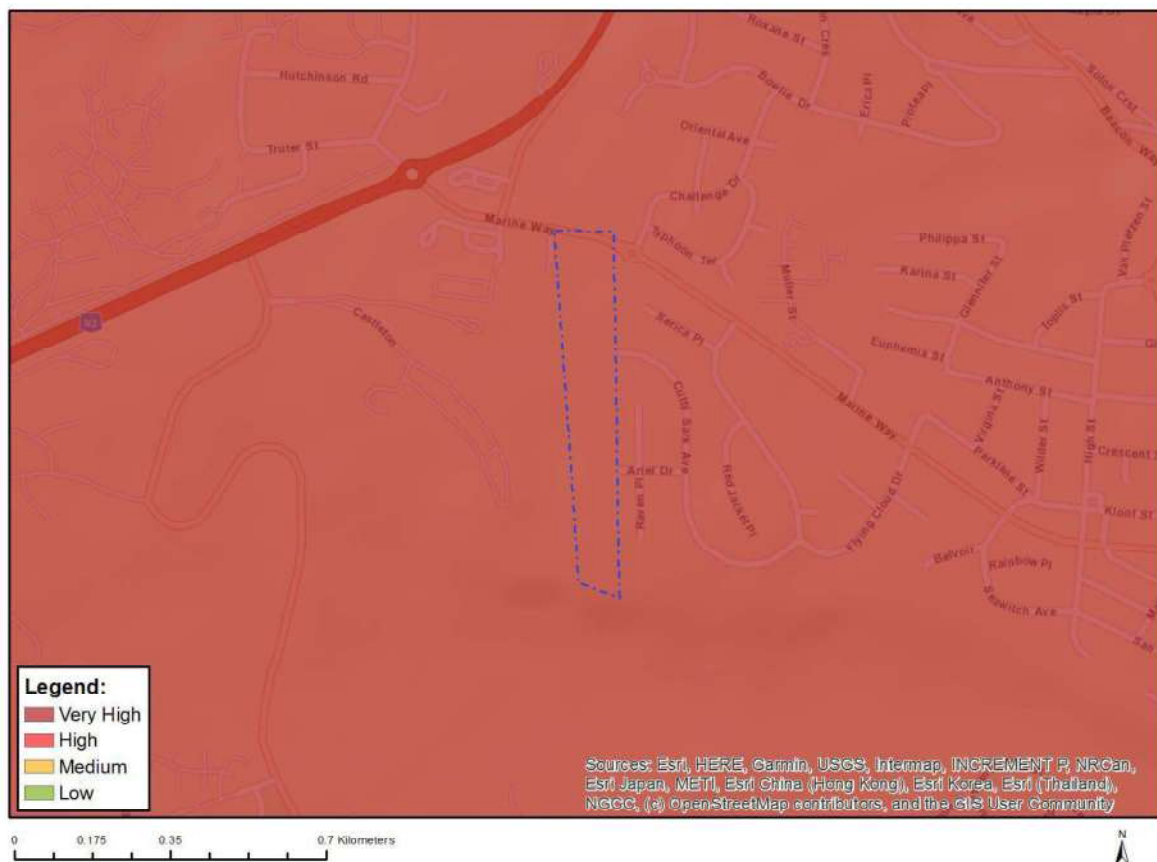
Figure 2. Results of the DFFE Screening Tool which indicate Very High Sensitivity of the Aquatic Biodiversity theme for the preferred development site on Erf 2074.

According to the Department of Environment, Forestry and Fisheries (DFFE) screening tool, aquatic biodiversity at the site has a **Very High** sensitivity (Figure 2). The sensitivity features upon which this rating is based are:

- Ecological Support Area 1: Aquatic
- Freshwater Ecosystem Priority Area Sub catchment

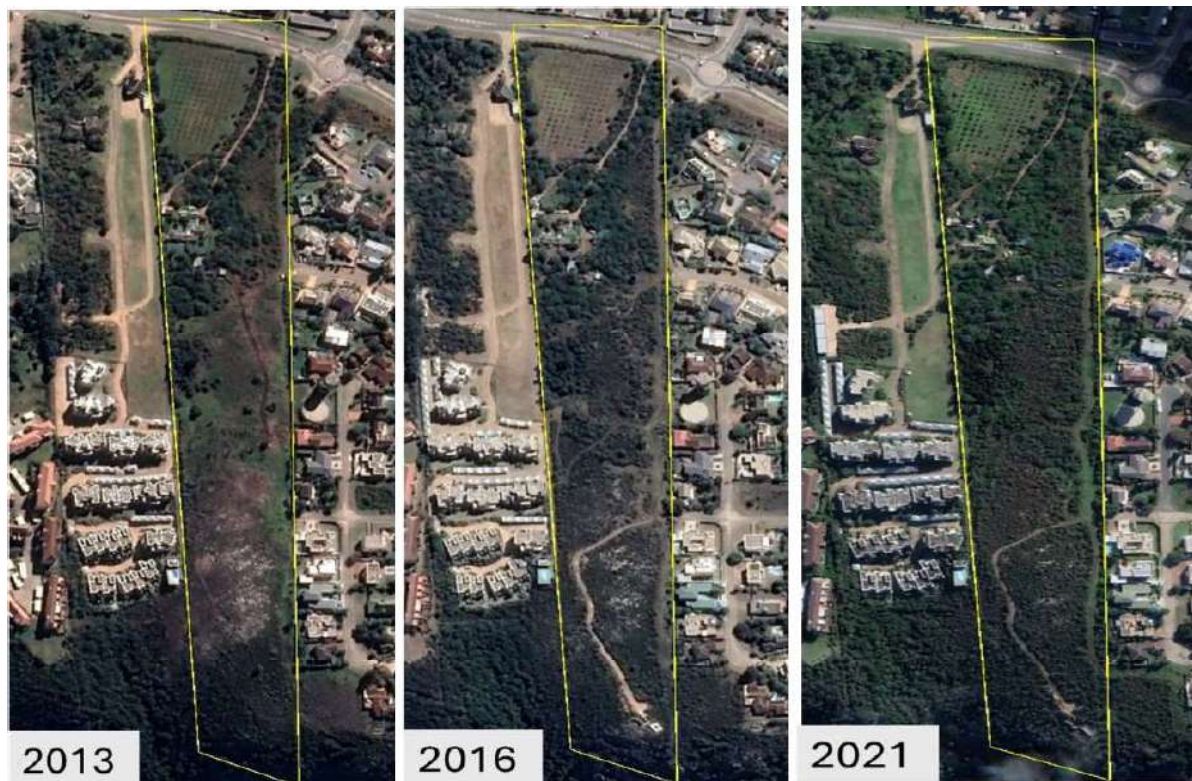
Figure 8: Historical photos showing RE/2074 through notable changes between 2013 and 2021 (CD:NGI & Google Earth imagery).

Between 2013 and 2021 the most notable changes are densification of vegetation and the development of a new road to the south of the property where construction of a small building foundation commenced on the cliff edge. This building was never completed, but the road is still there (Figure 8).
