# Aquatic Biodiversity Impact Assessment

## Proposed Residential Development for Portion 91 / 304 Matjesfontein, Plettenberg Bay

**Prepared For:** EcoRoute  
**Author:** Dr. Jackie Dabrowski  
Confluent Environmental Pty (Ltd)  
7 St. Johns Street,  
Dormehls Drift,  
George, 6529  
**Contact** jackie@confluent.co.za  
083 256 3159  
**SACNASP:** 115166 (Aquatic Science)  
**Date:** February 2025  
**Version:** Version 4 (Updated SDP,  
mitigation measures & stormwater  
plan)

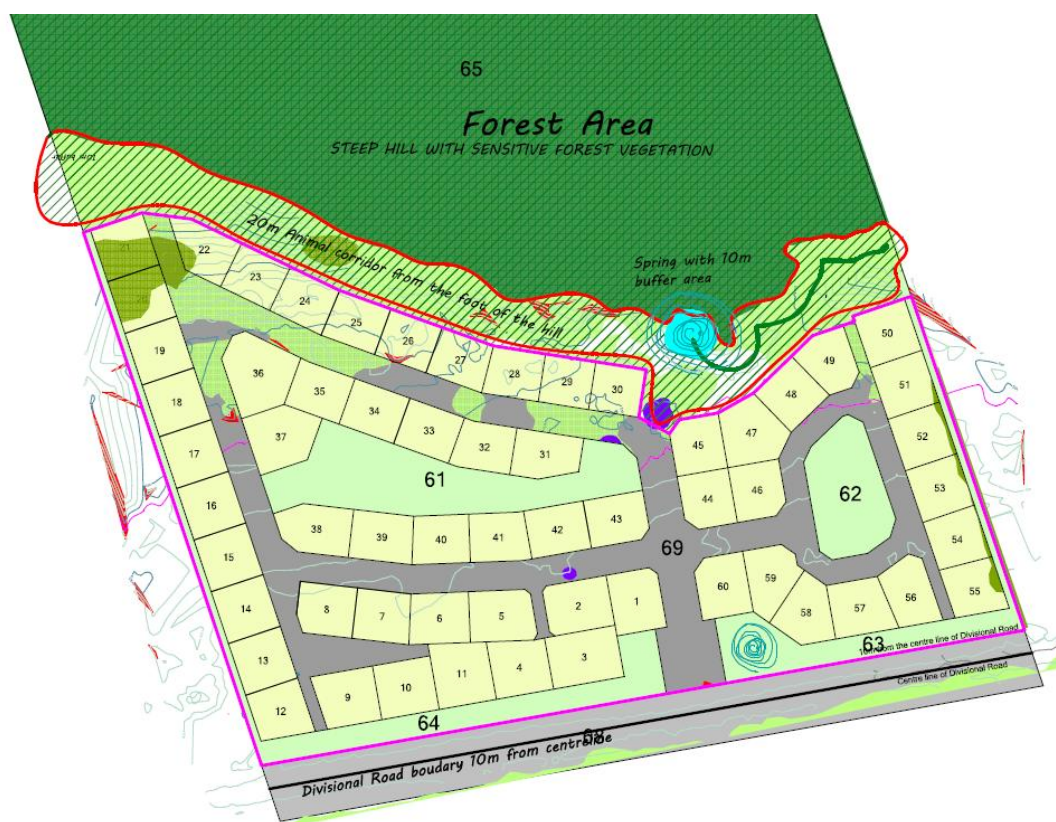
Figure 3. Preferred lower density development (January 2025). This SDP has been modified to pull Unit 50 back from the wildlife corridor which was recommended in a previous version of this report.

Two alternative development layouts were provided for assessment. A higher density alternative development and a lower density preferred development. The alternative layout is group housing with 73 erven (Figure 2), while the preferred layout is slightly lower density with 60 residential 2 erven with an average size of 510 sqm (Figure 3).

The abovementioned features are all plotted in relation to the preferred layout and presented in Figure 19. In most cases the layout provides a greater corridor than 20 m and the area around the pond is more extensive than the 10 m buffer. The only major 'pinch point' is the erf located on the north-east of the development indicated as **plot no. 50** in Figure 3.

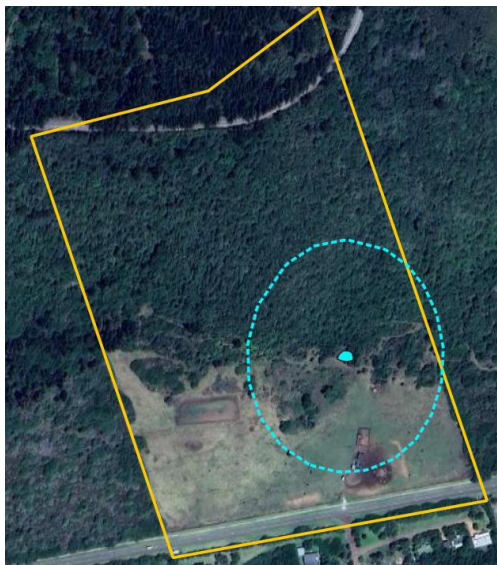
The image on the left shows a delineated pond excavated in front of a spring on the site and a 100m buffer indicating the development area (clear of vegetation) is within the regulated area of the watercourse.

The regulated area of a spring is defined as the outer edge of the 1:100 year floodline or delineated riparian habitat, whichever is the greatest distance, measured from the middle of a river, spring, natural channel, dams and lakes. In the absence of a determined 1:100 year floodline or riparian area, the area within 100m distance from the edge of a watercourse where the edge of the watercourse is defined by the extent of open water in this case.

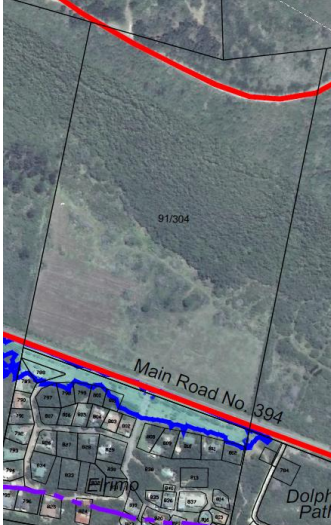
<p>Development is not supported in areas below the 1:50 and 1:100 year floodline. Lines indicated are: dark blue = 1:100 year floodline, and light blue area is an 'island' below the 1:50 year floodline. The purple line is the 100m urban coastal setback line.</p> <p><i>The proposed development area is located outside of all these features, and is therefore not flagged from a heightened flood risk perspective.</i></p>

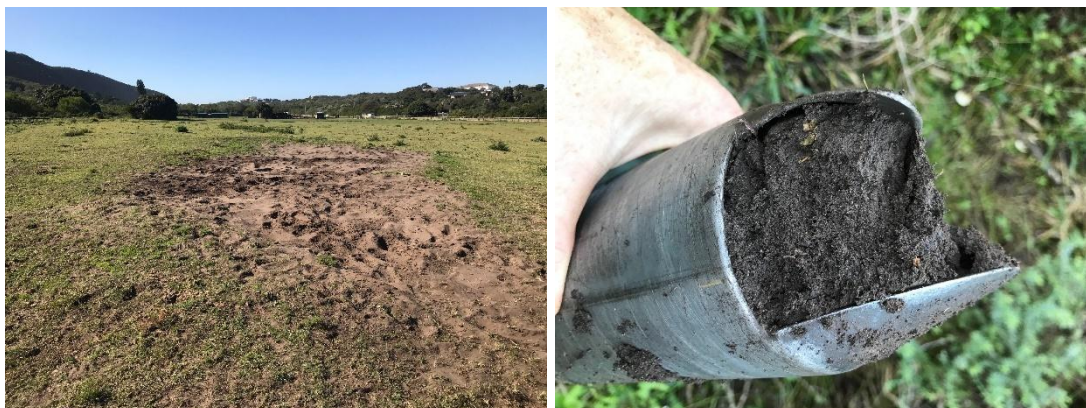
Figure 15. Sandy soils present at the site with no indicators of permanent or seasonal saturation (28 June 2022).

Soil augering at the site indicated deep, sandy, well drained soil with no textural change at 50 cm which could promote the development of wetland habitat (Figure 15). This is consistent with the mapped soil type in the area which is described as soils with limited pedological development (young soils with minimal organic matter), and a low clay content (< 15%).
