# Aquatic Biodiversity Impact Assessment for Proposed Multi-use Development on RE/1627, Sedgefield, Western Cape.

**Prepared For:** EcoRoute  
**Author:** Dr. Jackie Dabrowski (PhD)  
Confluent Environmental Pty (Ltd)  
7 St. Johns Street,  
Dormehls Drift,  
George, 6529  
**SACNASP:** Pr. Sci. Nat. (Aquatic Science &  
Ecological Science) – 115166  
**Date:** March 2025  
**Version:** Version 3 – Adjusted SDP

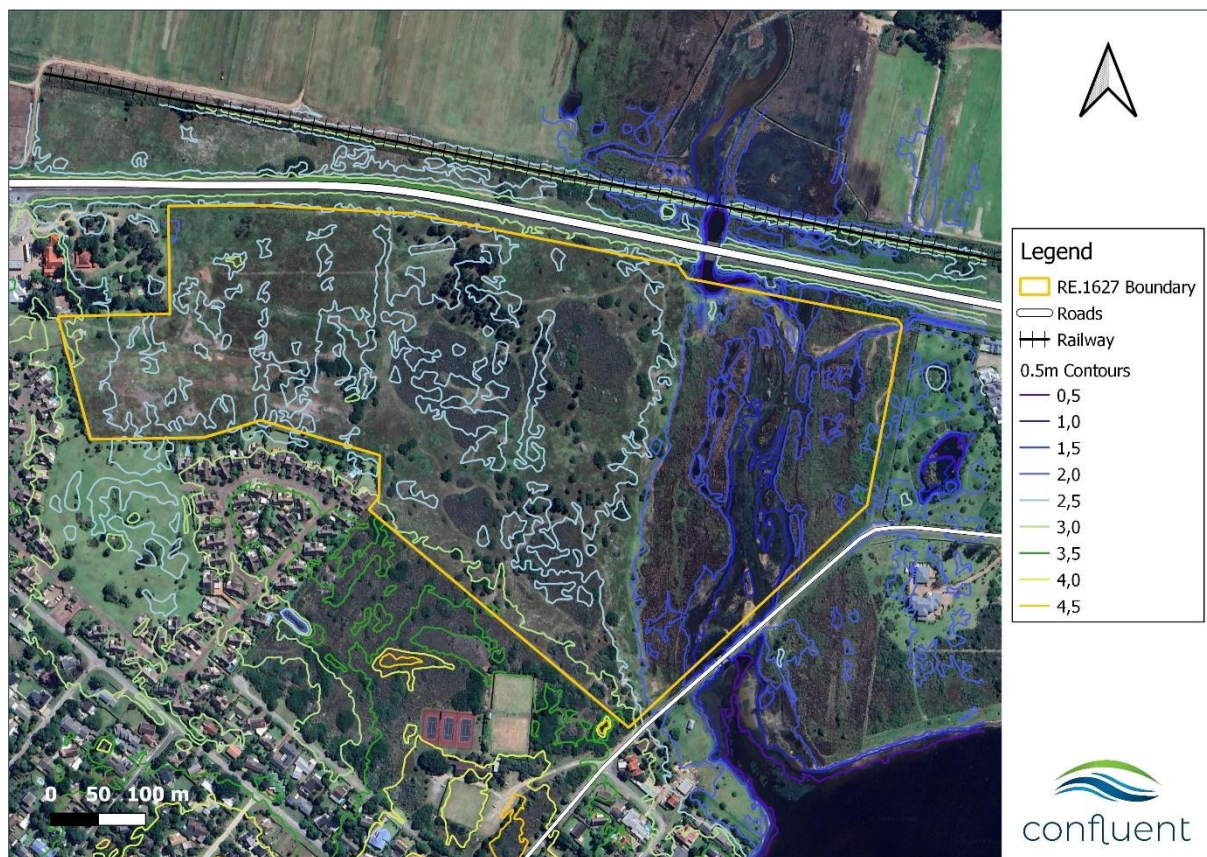
The site is low-lying with the Perdespruit ranging between 1-2 m.a.m.s.l. and most of the adjacent area to the west where development is proposed around 2.5 m.a.m.s.l. (Figure 1)

Figure 1. RE/1627 in relation to transport infrastructure (roads and railway) and 0.5m site contours.

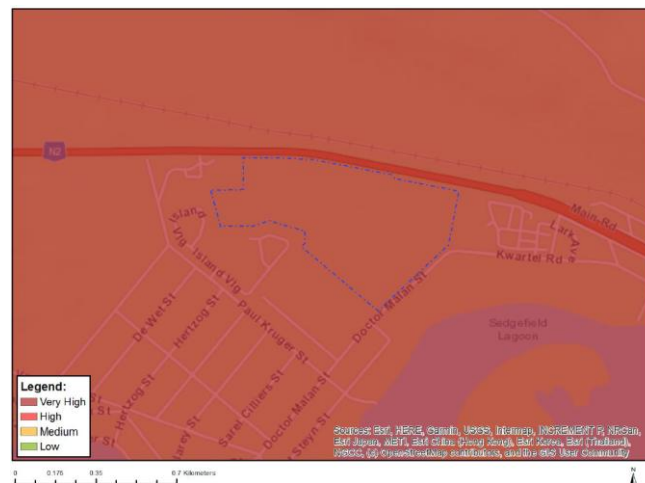
According to the screening tool the sensitivity for aquatic biodiversity is **Very High** (Figure 6) due to the following features:

- Critical Biodiversity Area 1 (CBA1): Aquatic
- Swartvlei Estuary
- FEPA Subcatchment
- Strategic Water Source Area (SWSA) Outeniqua
- Wetlands, Estuary

Figure 6. Results of the Aquatic Biodiversity Theme Screening Tool.

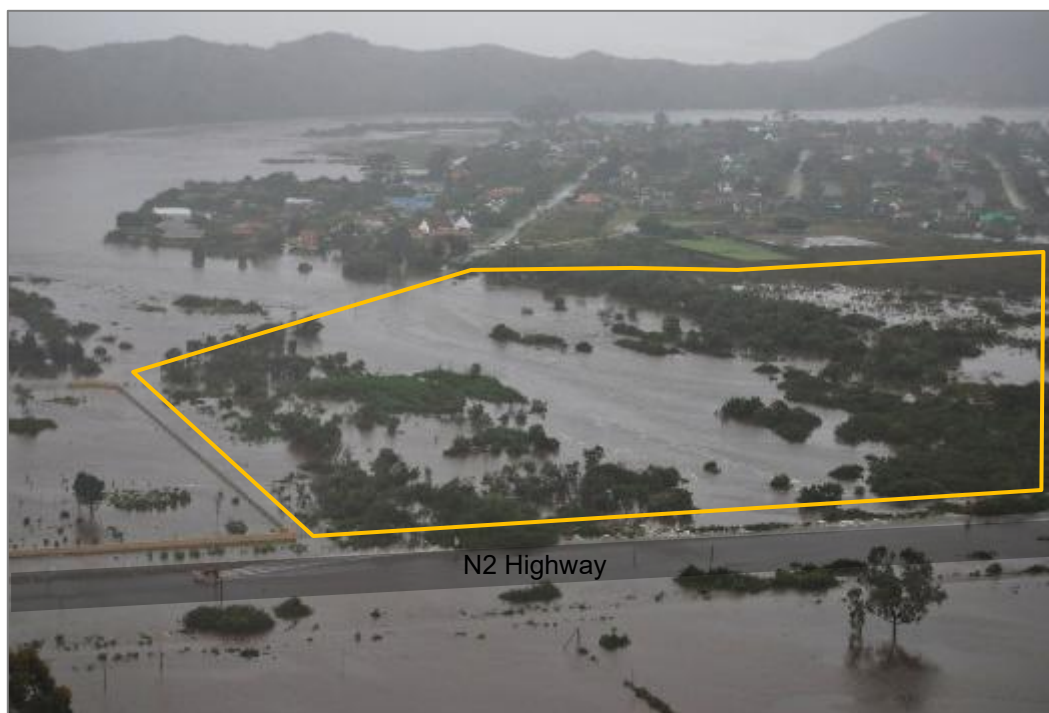
Figure 8. Photo of part of Sedgfield during flooding in 2007. View looking south shows the N2 Highway and the general area of RE/1627 (yellow area).

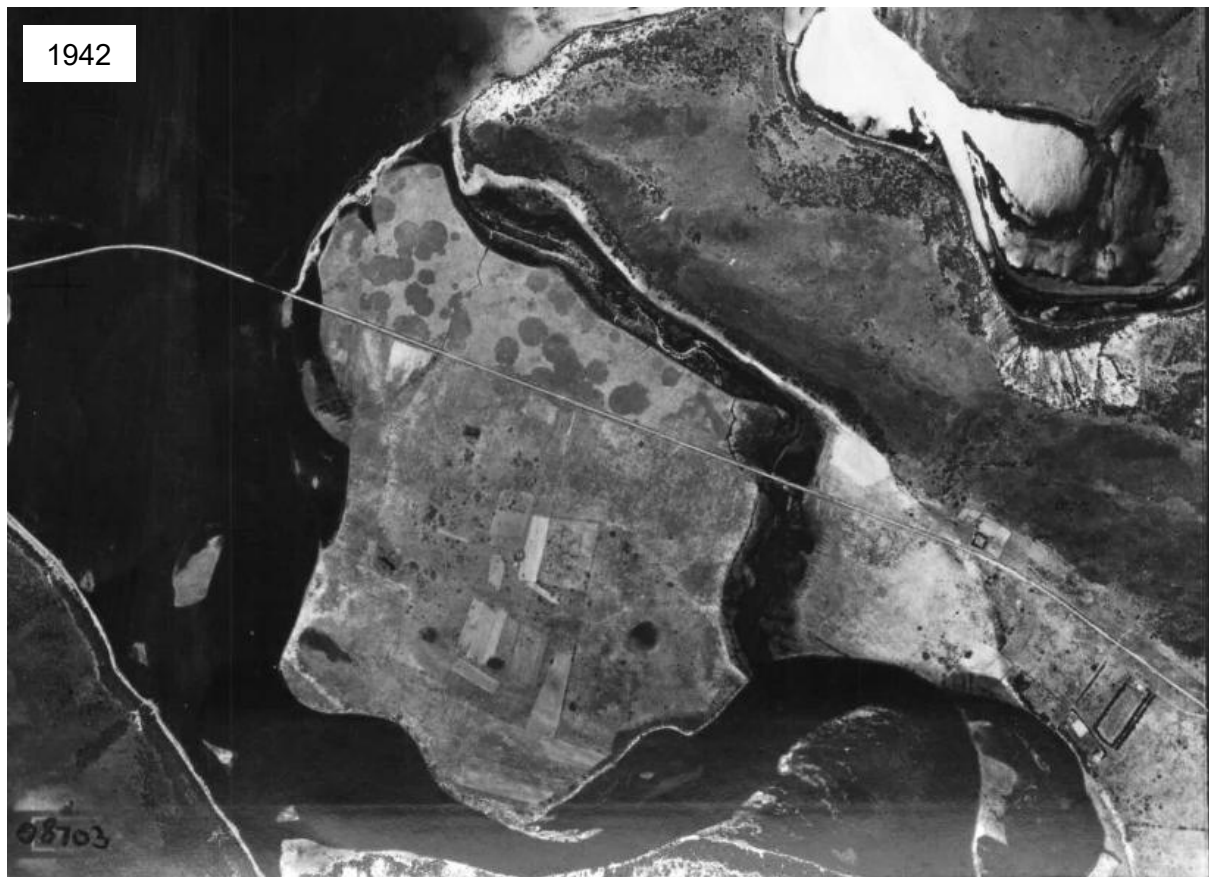
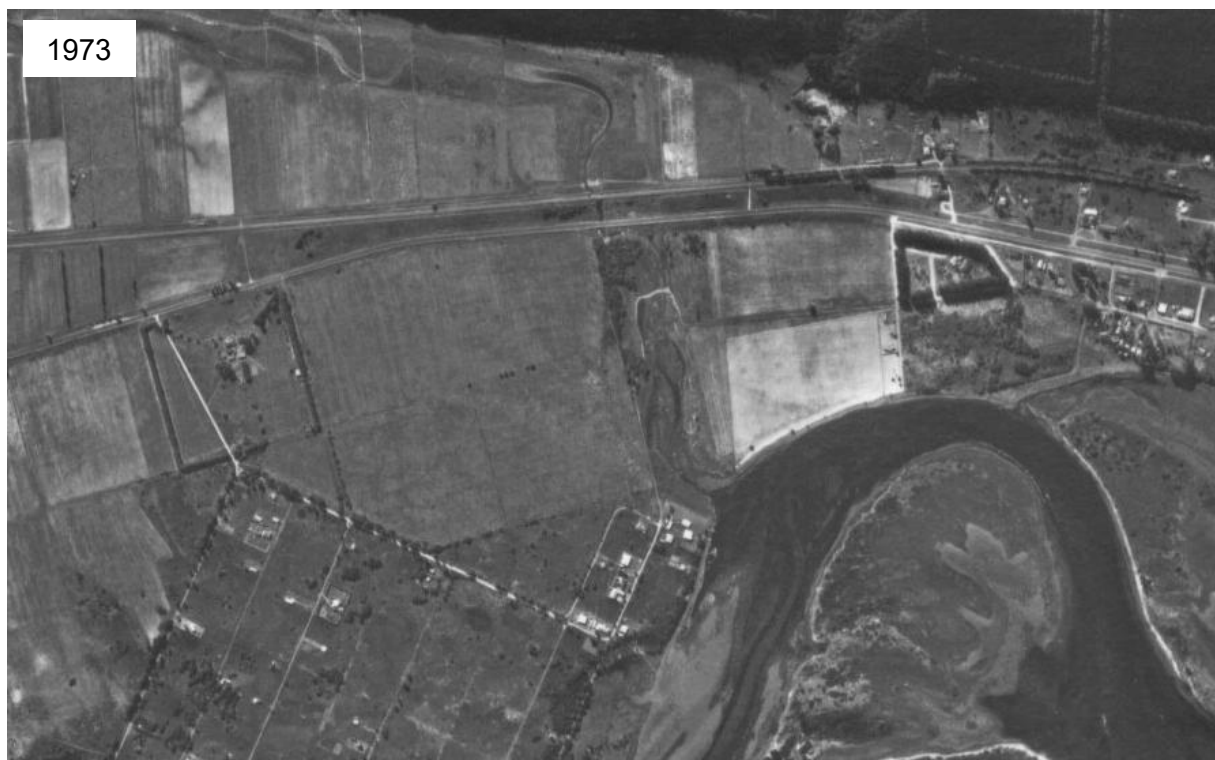
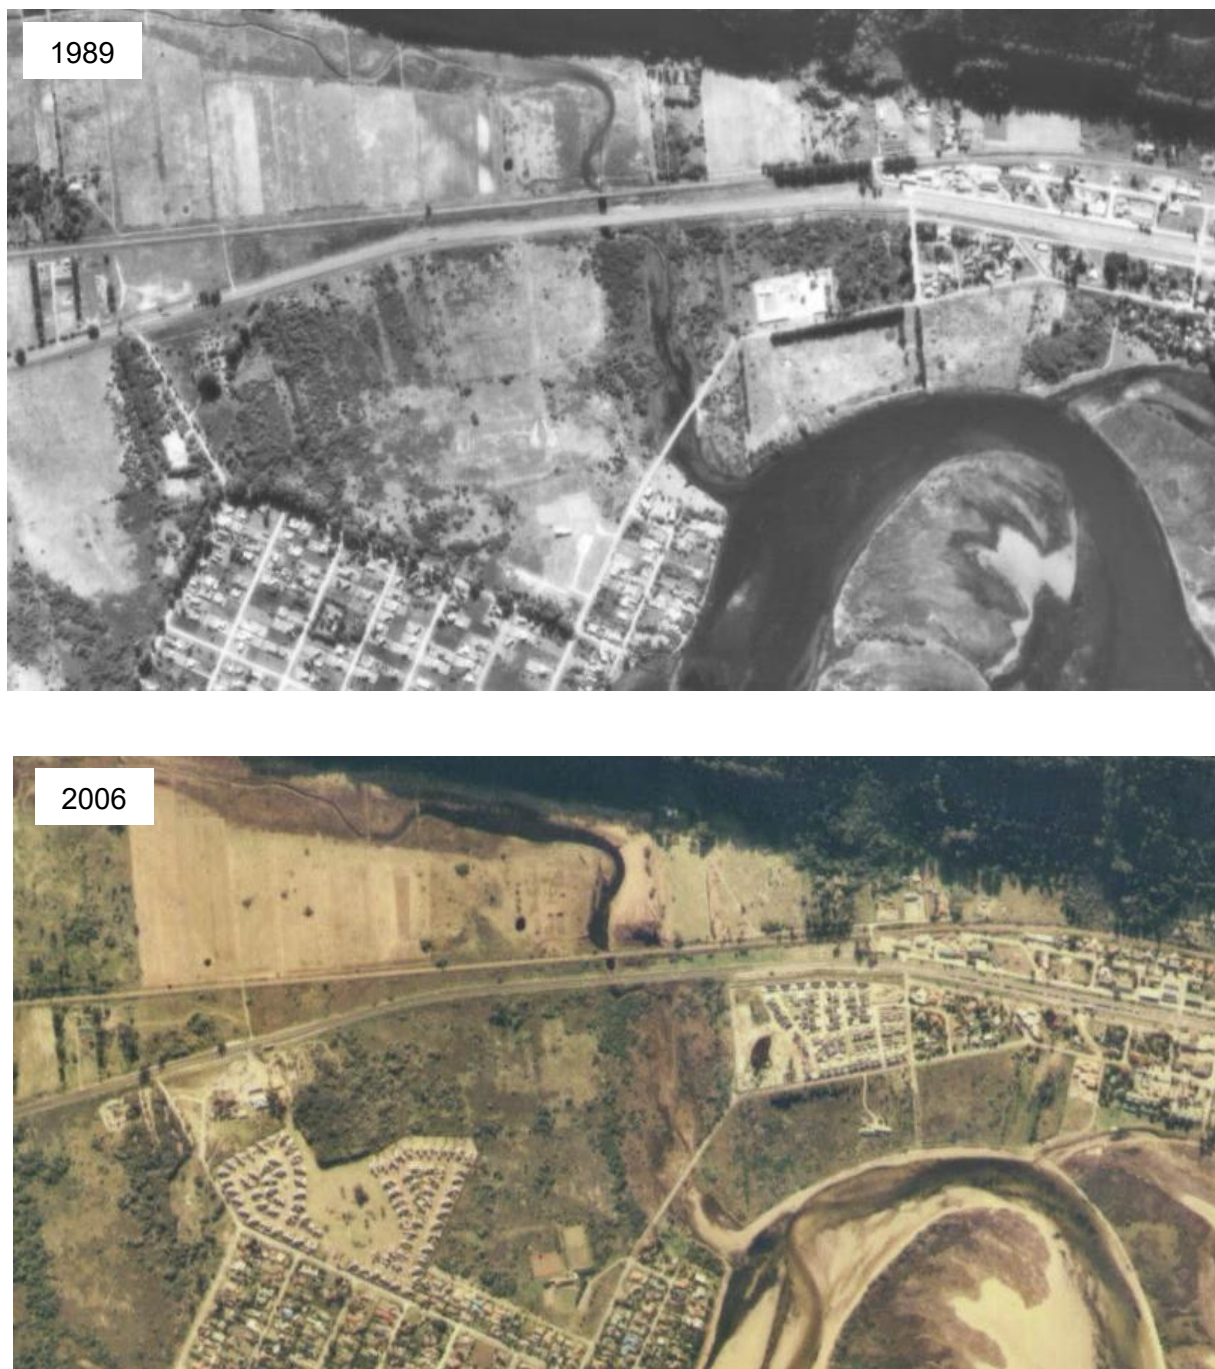
In 1942 little of present-day Sedgefield was developed (Figure 12). The road can be used as reference in this image as the N2 highway is still in this position. The Perdespruit was a far more distinct arm of the estuary in 1942, and minor agricultural fields were the only observable modification. In the following decades natural vegetation at the site was cleared for agricultural activities on either side of the Perdespruit. This is evident in a historical photo from 1973. The fields appear to have been abandoned over a decade later, as the 1989 image shows encroachment by bushy vegetation throughout the fields and into the Perdespruit. The road crossing the Perdespruit to the south of the property (Dr Malan) appears on the 1989 image for the first time. Bush encroachment is further advanced by 2006 and likely consisted of a large proportion of alien vegetation (Figure 12).

Figure 12. Historical aerial photos of the site in 1942, 1973, 1989 and 2006.

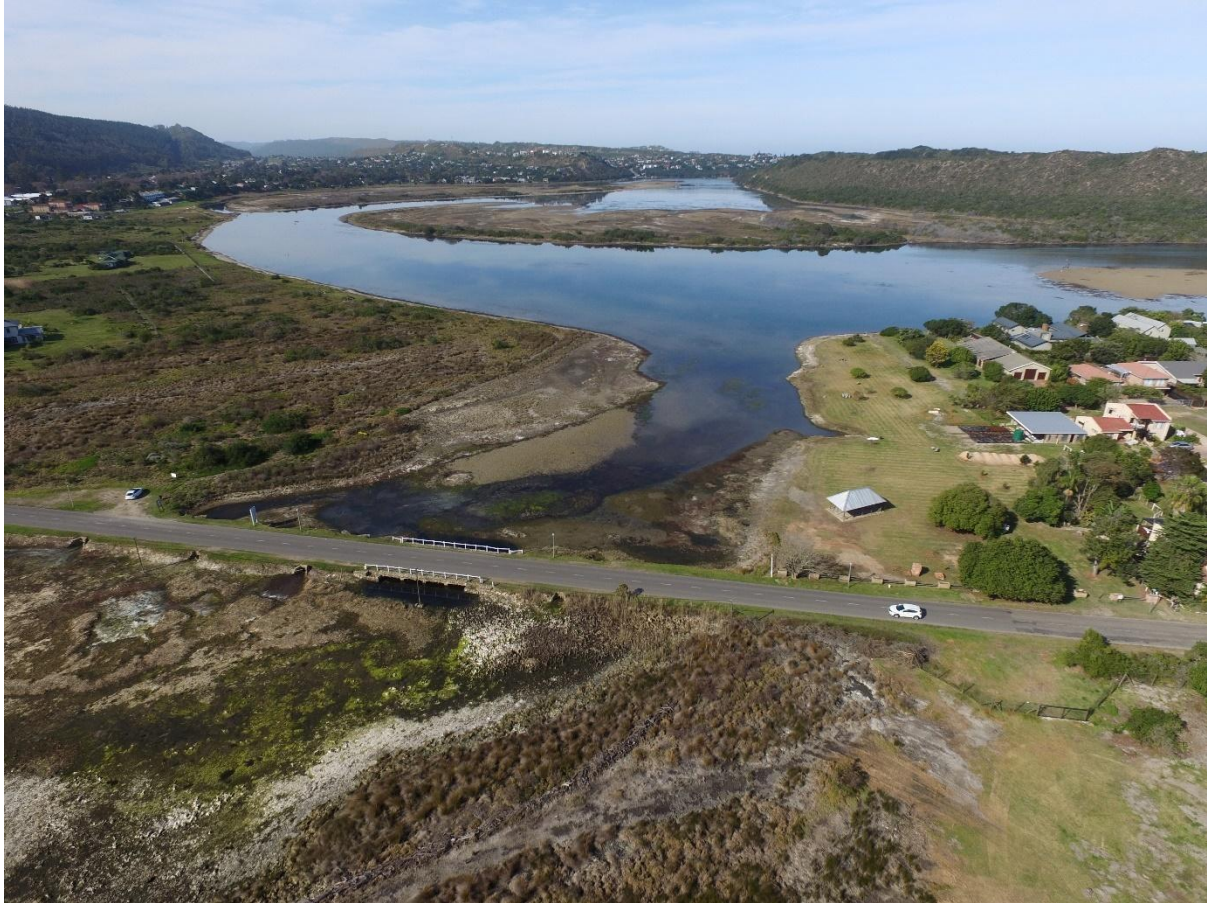
Figure 13. Flow restriction point at Dr Malan Street crossing. Note the difference in sedimentation upstream compared to downstream of the bridge.

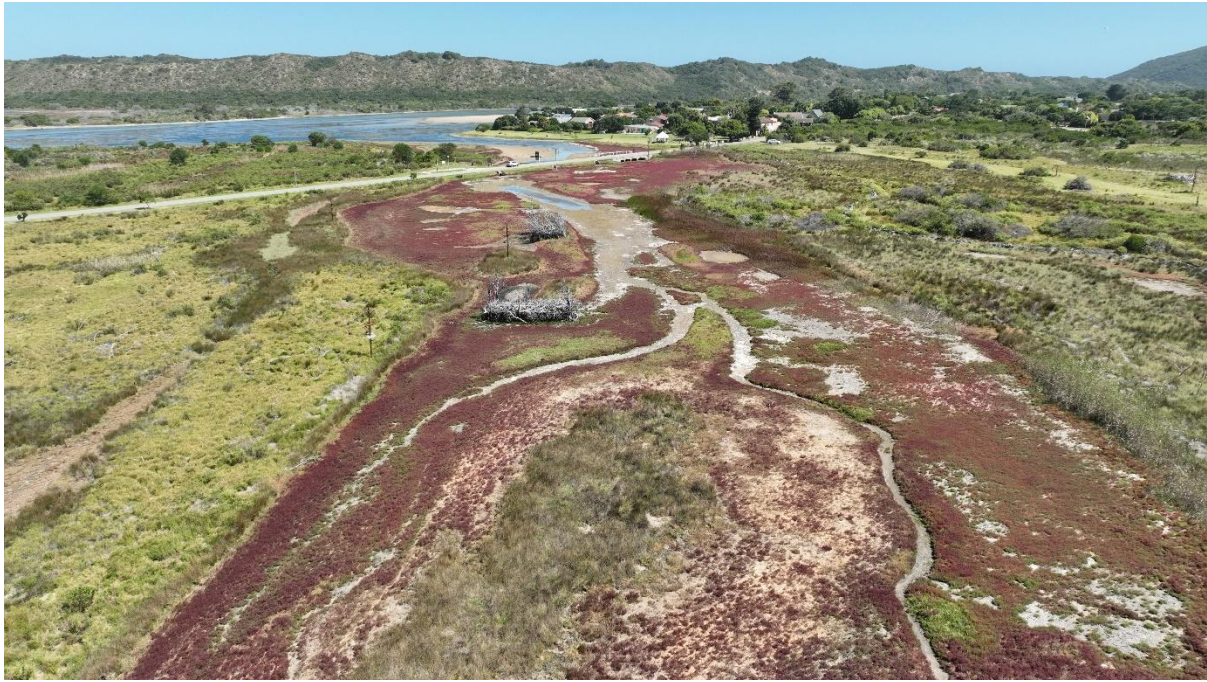
Figure 14. Perdespruit during open mouth conditions with low water levels showing distinct red colour of *Salicornia* sp. dominated areas of salt marsh.

**Hydrology** of the system is mostly influenced by open / closed mouth conditions, and to a lesser extent by tidal flows in both directions. The site has been assessed during both closed and open mouth conditions (February 2024; Figure 14). During closed mouth conditions, water levels were about as high as they will get under the normal mouth management regime (without flooding) as the mouth was breached by SANParks approximately a week later (June 2021). Hydrology is the parameter most negatively affected with multiple factors resulting in reduced flows, flushing and the gradual drying out of the system. These factors include:

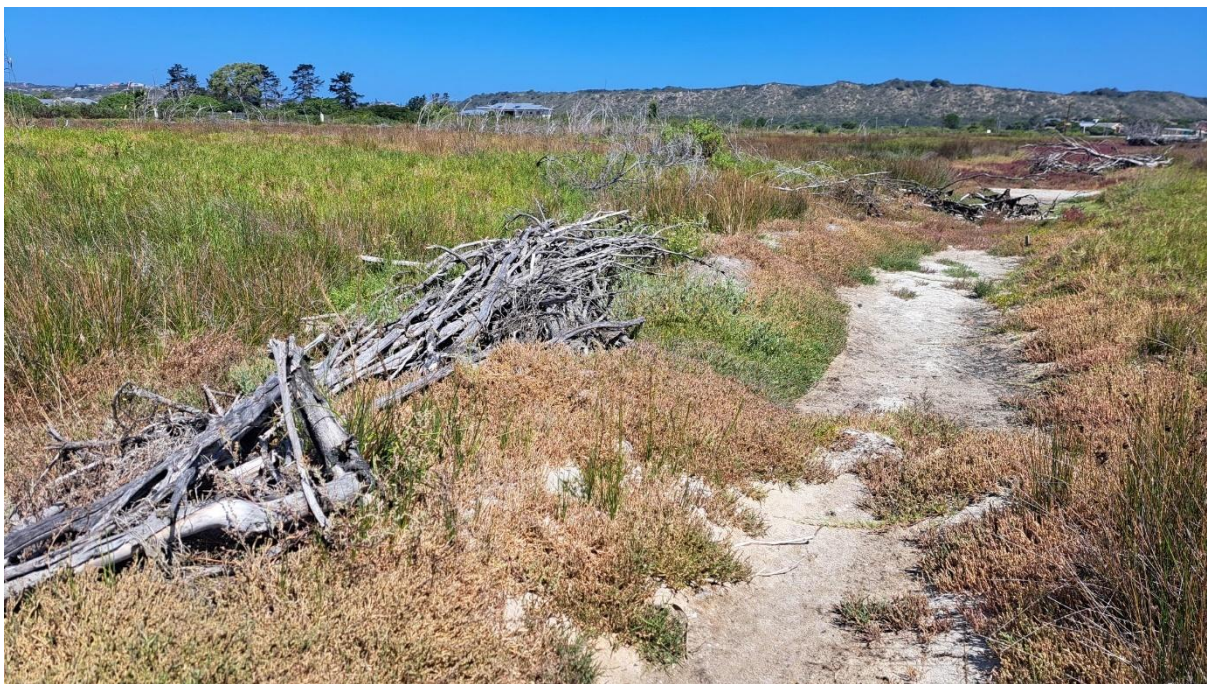
Figure 15. Woody debris from alien clearing piled in estuarine habitat.

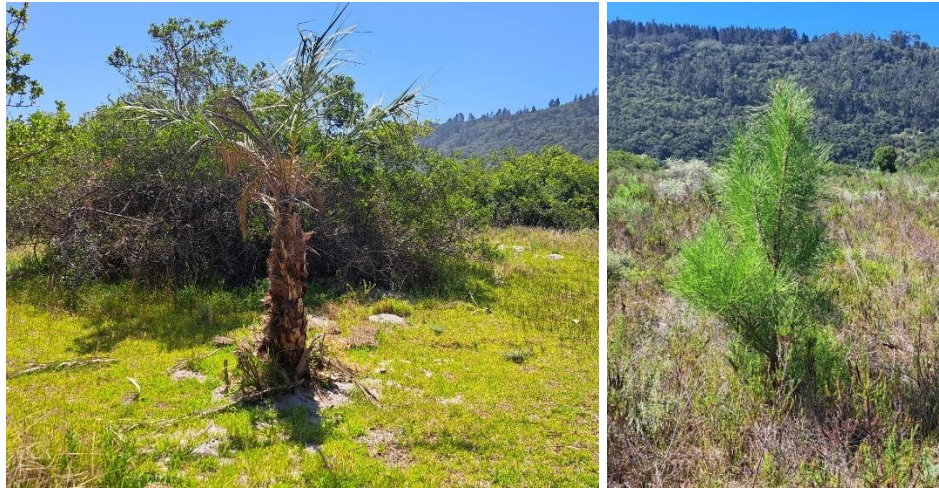
Figure 16. Exotic palm trees planted in estuarine buffer area (left) and emergent alien pine trees in fynbos (right).

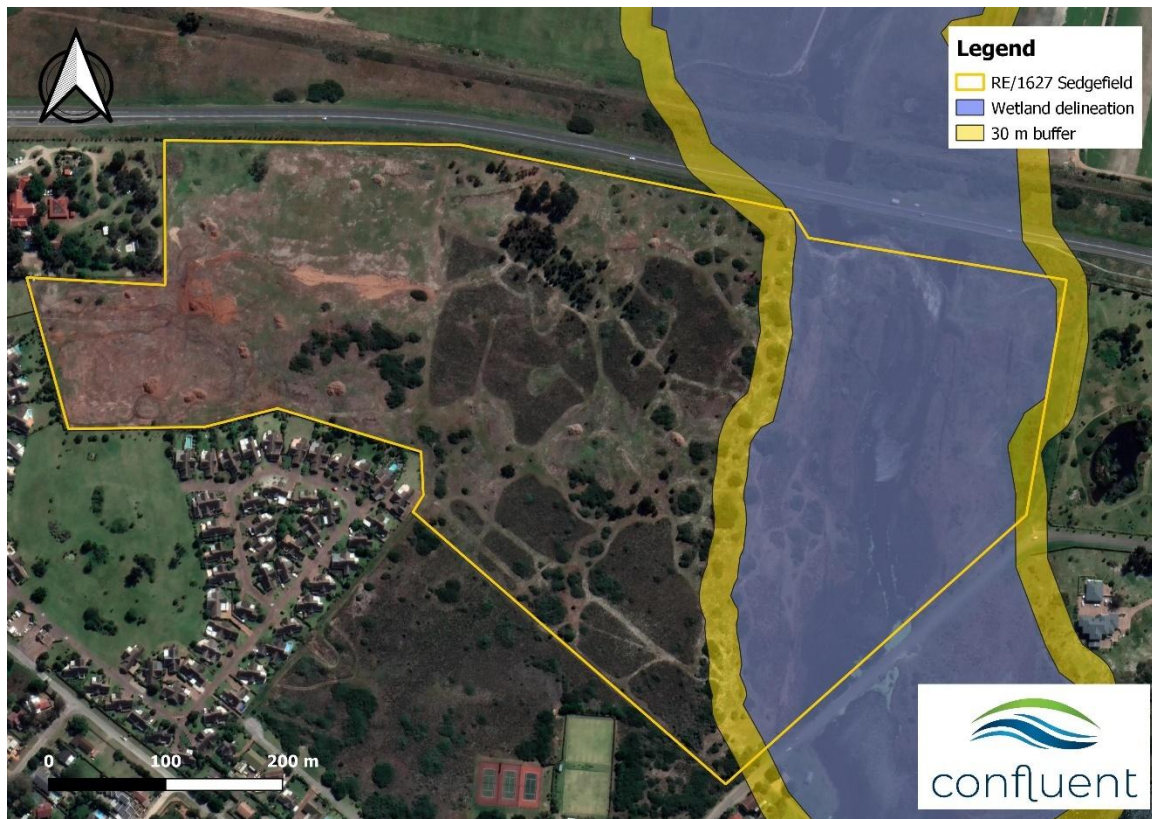
The estuarine area was delineated using methods prescribed by DWAF (2005) which are primarily for the delineation of wetlands but are also applicable to estuarine systems. The delineation relied heavily on the presence of hydrophytic plants because sandy soil present at the site does not reliably show typical indicators of saturation such as mottling. The buffer area was determined using the detailed site-based model for estuaries developed by Macfarlane & Bredin (2017) which is the more detailed of the two available models. The buffers are then mapped from the edge of the delineated estuarine area.

The recommended buffer is **30 m** from the delineated edge of the wetland / estuarine area which is indicated in Figure 17. This buffer is applicable in both the construction and operational phase of development.

Figure 17. Delineated wetland area and associated 30 m buffer for RE/1627 Sedgefield.

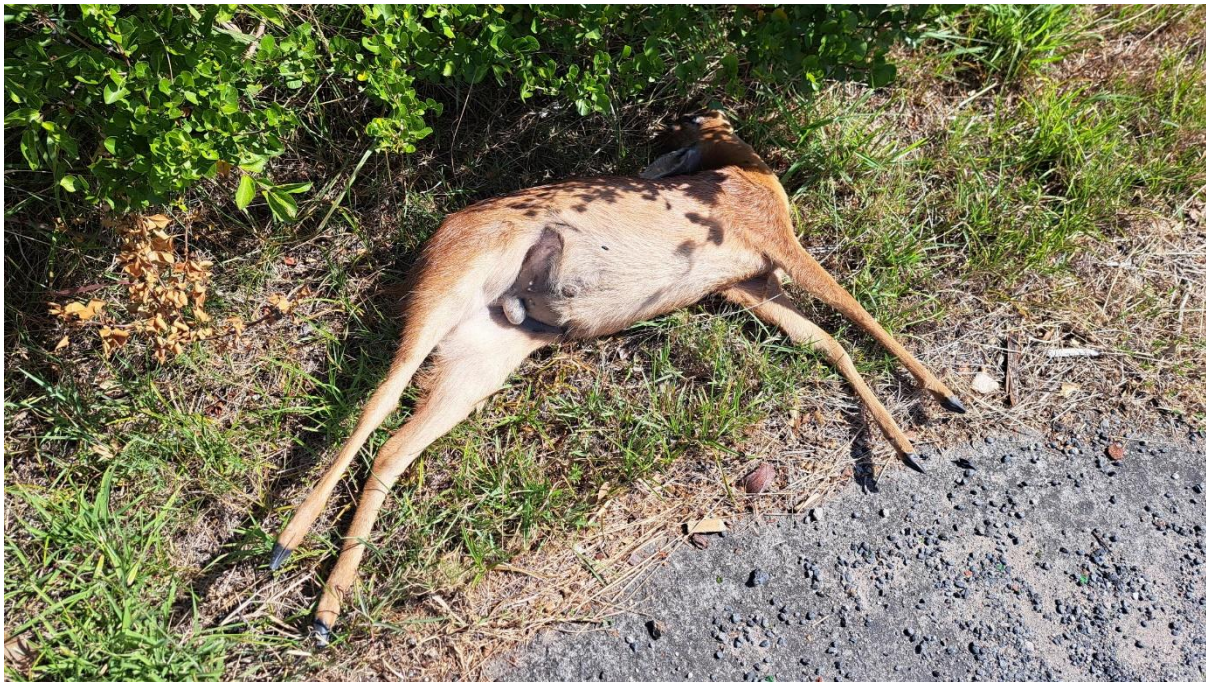
Figure 20. Dead bushbuck next to the N2 Highway on the western extent of Sedgefield as the road enters the town, taken on 24 March 2024.

'The Island' (as it's known) of Sedgefield is undergoing increasing development which is reducing the extent of remaining natural areas and connections between them. Terrestrial animals unable to fly or swim already have a significant barrier to their dispersal in the form of the N2 highway (Figure 20).

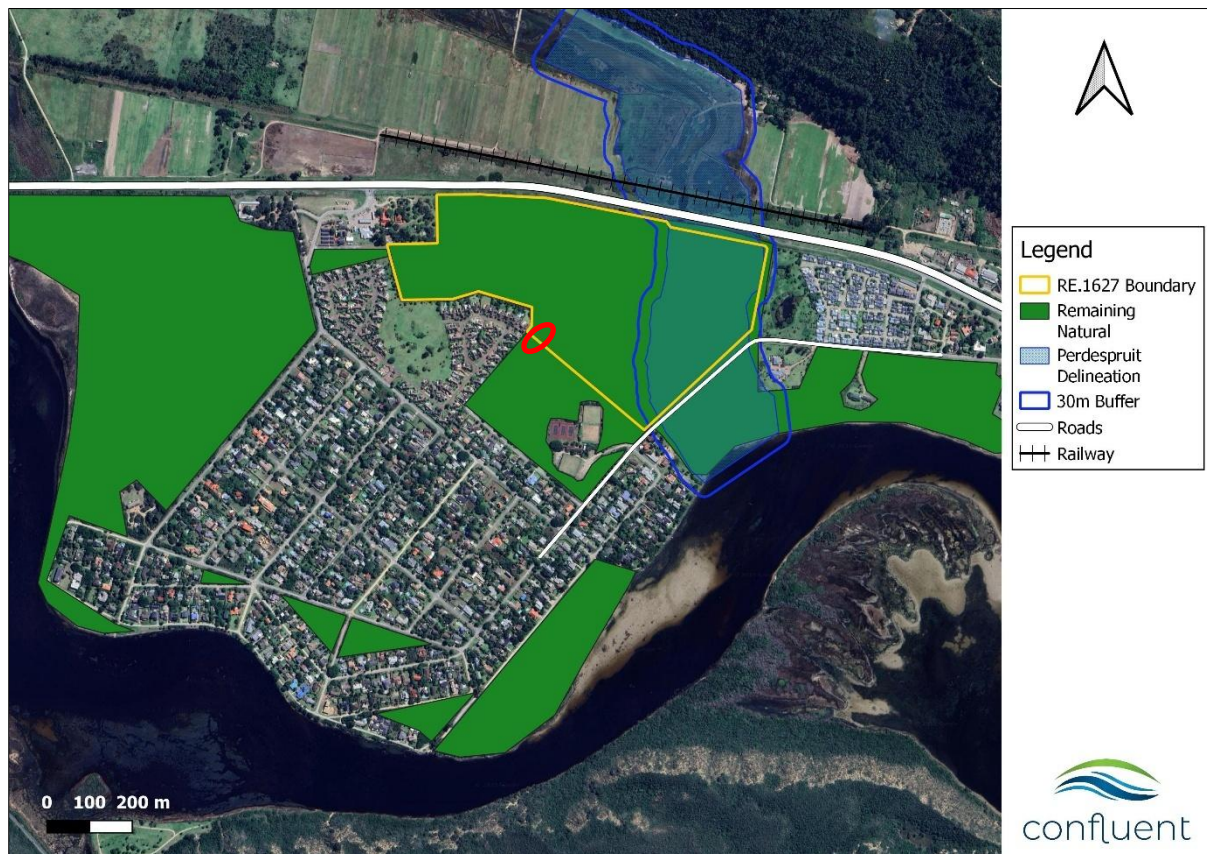
To better understand the cumulative impacts of habitat fragmentation presented by the proposed development a basic map of the remaining 'untransformed areas' which are in a mostly natural vegetated state was compiled. These are presented in Figure 21. What is not depicted at a fine scale are all the existing fences and roads which intersect these areas creating barriers to wildlife movement. This picture must therefore be interpreted in the context of RE/1627 only. As can be seen there are a few larger fragments of untransformed land interspersed with a few smaller, isolated fragments on the Sedgefield 'island'. While animals such as tortoises and birds may still be present on smaller fragments, the priority should be to maintain connections between larger fragments. RE/1627 is one of the largest fragments, and development on this site will significantly increase habitat fragmentation and restrict access by wildlife to the Perdespruit. But there are some opportunities to mitigate this to an extent which are highlighted by encircled red areas in Figure 21 and discussed in the following section.

Figure 21. Relatively untransformed areas remaining on 'The Island' of Sedgfield. Red oval indicates the proposed location of a wildlife corridor to restore and maintain connectivity between RE/1627 and the neighbouring municipal Erf 2058, the tennis club.

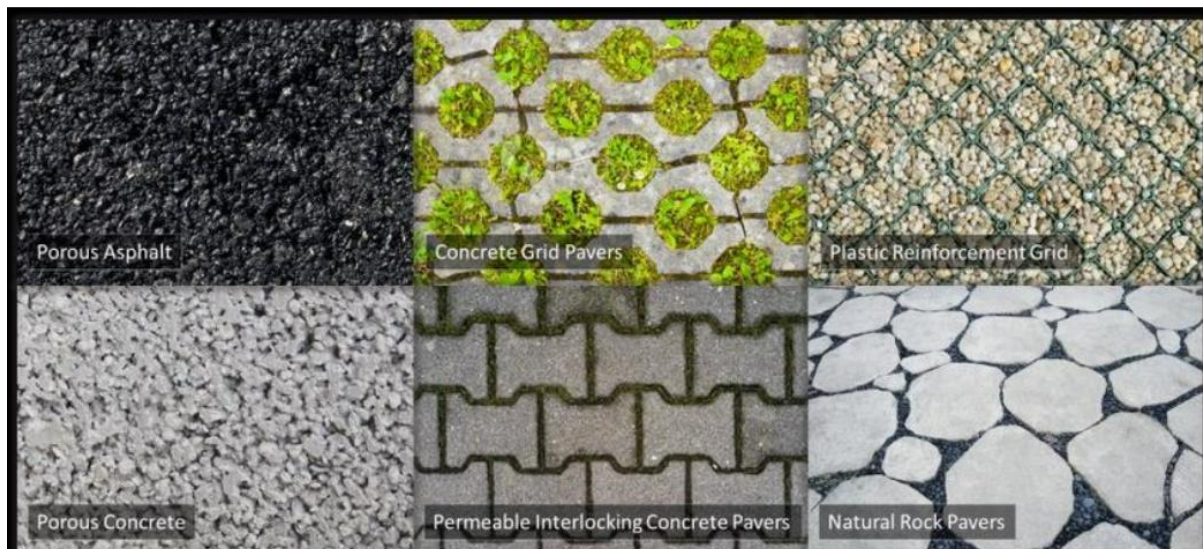
range of suggested products are provided in as an example of methods to improve water infiltration instead of runoff. The use of pervious materials such as bark, gravel or grass pavers is recommended on as many parking areas, roads, and pathways (Figure 24).

Figure 24. Examples of permeable surface which should be used as an alternative to impermeable paving or road surfaces wherever possible.
