# **PUBLIC MEETING - 18 July 2025**

## **NEMA and Water Use Activities**

**Farm Portions 420 and 373, Outeniqua Game Farm**  
**Mossel Bay Municipality**

**DEADP 24G Consultation: 14/2/4/1/D6/28/0004/20**  
**BOGMA reference: 4/10/3/K10D/Outeniqua Game 420 & 373, Mossel Bay**

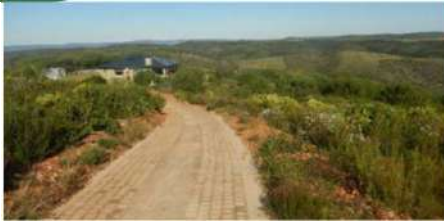
***CR Garden Route Granite Fynbos vegetation observed around dwellings and roads on Outeniqua Game Farm.***

1 - The fynbos surrounding the dwelling is in a natural condition, with stands of invasive Rooikrans (Acacia cyclops) only becoming dominant nearby the dwelling itself. This stand of invasive Rooikrans has existed prior to the construction of the dwelling.

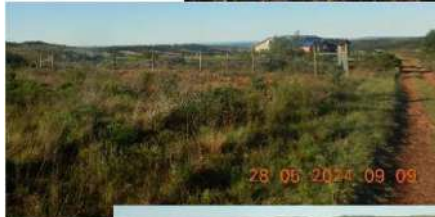
4 - Dwelling four has a large fenced off area around it. This fence should be taken down in order to minimise the area of influence of this dwelling in CR fynbos vegetation.

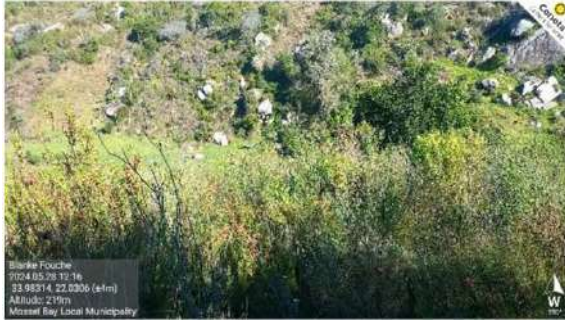
6 – Northernmost dwelling, Area 2 - A small senescent patch of fynbos is present south of this dwelling.

CR Garden Route Granite Fynbos vegetation observed around dwellings and roads on Outeniqua Game Farm.

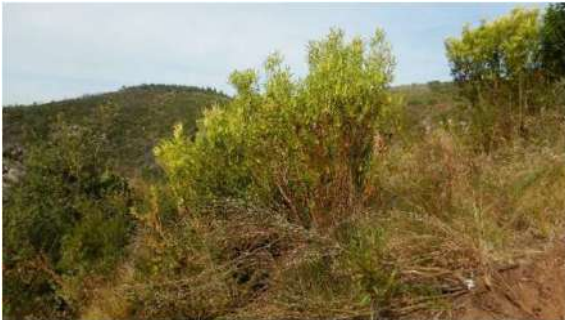
7 - Southernmost dwelling, area 2 -

A highly sensitive invaded patch of fynbos is present south of this dwelling. This is also where Sensitive species 142 was observed. The image on the left illustrates *Leucadendron salignum*.

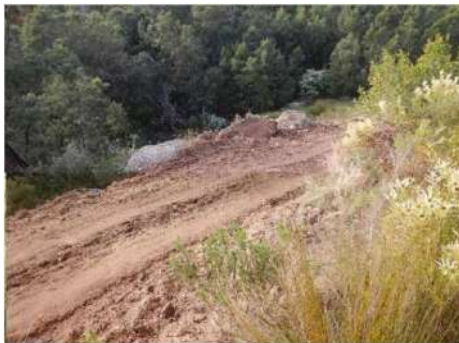
8 - Southernmost dwelling, area 2 -

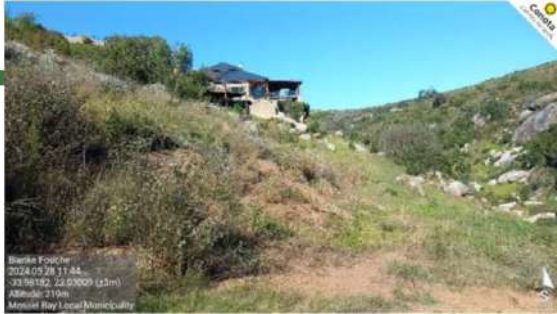
### 11 - AREA 2 - Northernmost dwelling

The dominance & composition of species here has shifted. The area here is dominated by graminoids, with only a few fynbos and thicket elements persisting north of the dwelling.

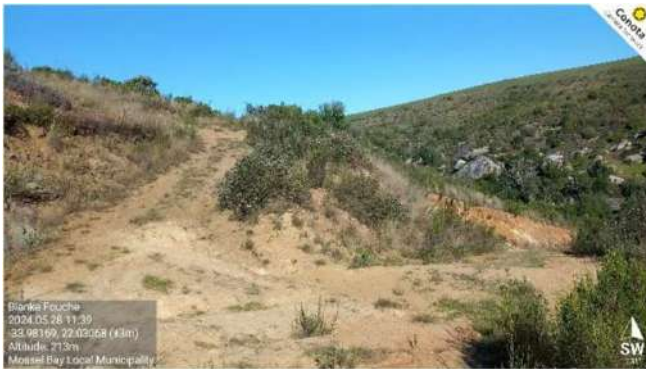
### 12 - AREA 2

#### Illegal wide meandering road

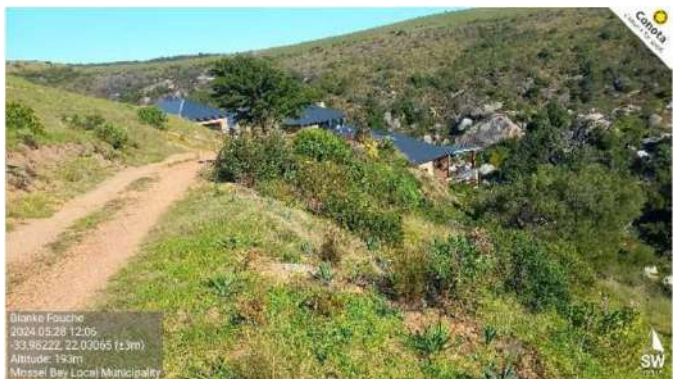
### 13 - AREA 2 Southernmost dwelling

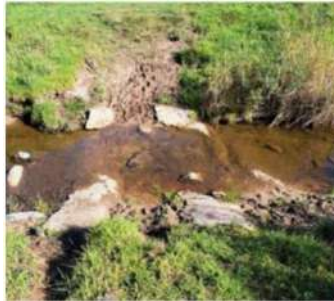
### 14 - AREA 2 - crossing x1 in Aquatic report

A road crossing the rocky watercourse. Kikuyu grass is visible adjacent to the River. If the illegal widened road leading to this crossing is rehabilitated, then this crossing can also be rehabilitated.

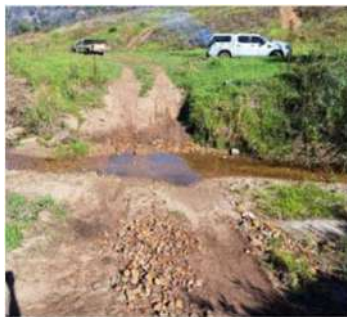
### 15 - AREA 2

Flagged as crossing x2 in Aquatic report

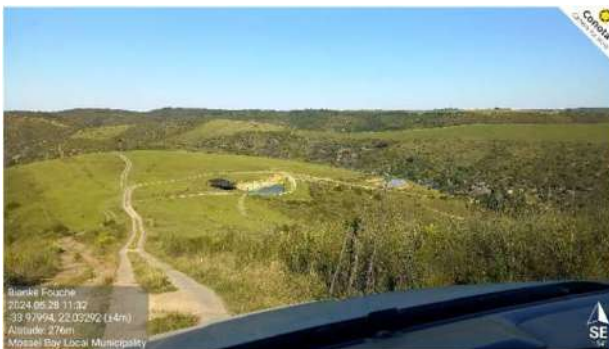
### 17 - AREA 2

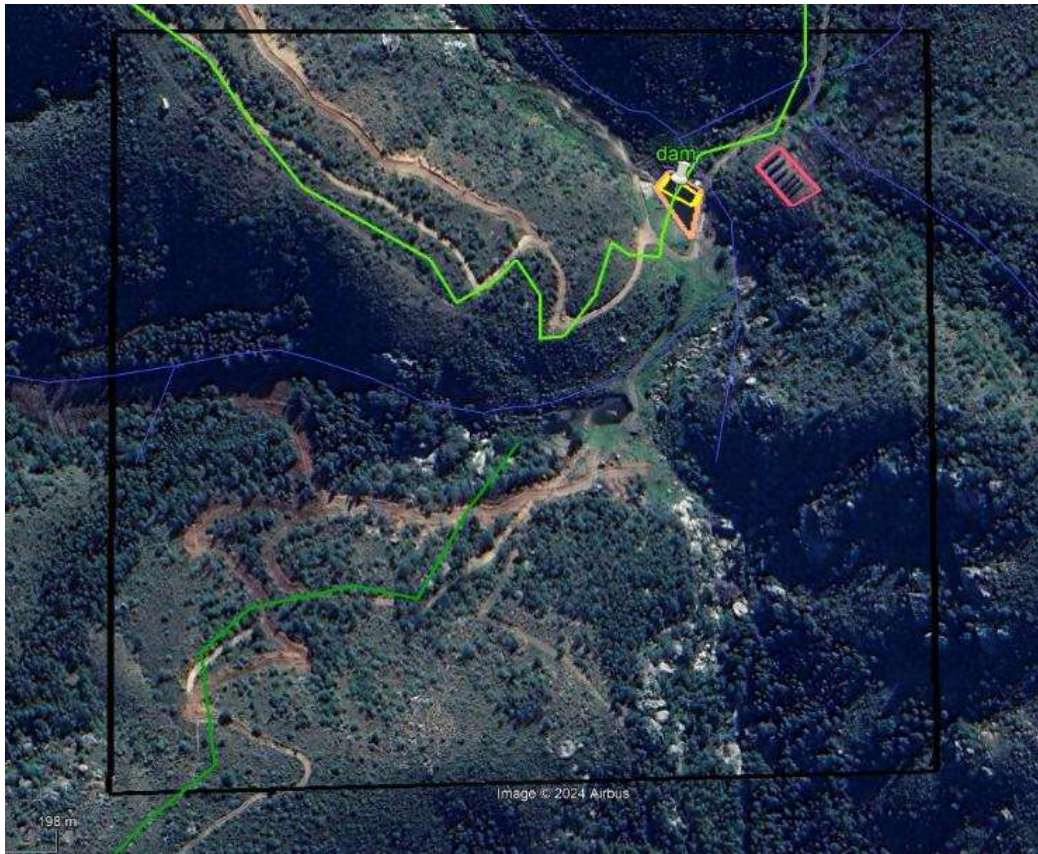
Weir and dam area; existing roads (prior to 2005) show in green providing indication of disturbances in the area (2016 onwards)

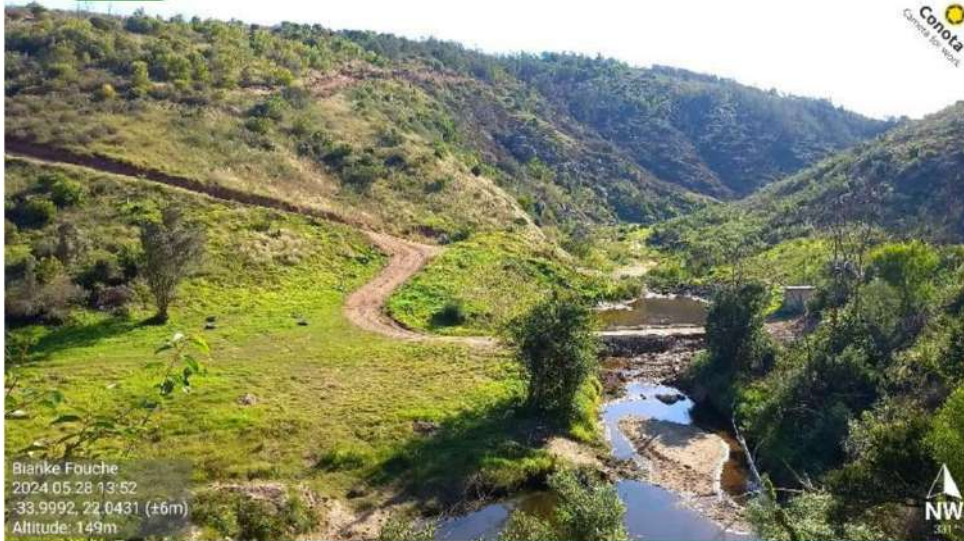
L0 - AREA 3 - A slope that has been maintained clear of black wattles for a few years – fynbos is starting to recover due to ongoing clearing effort here.

A view of the valley and small instream dam. Follow the rehabilitation plan outlined in the aquatic specialist report for this area.

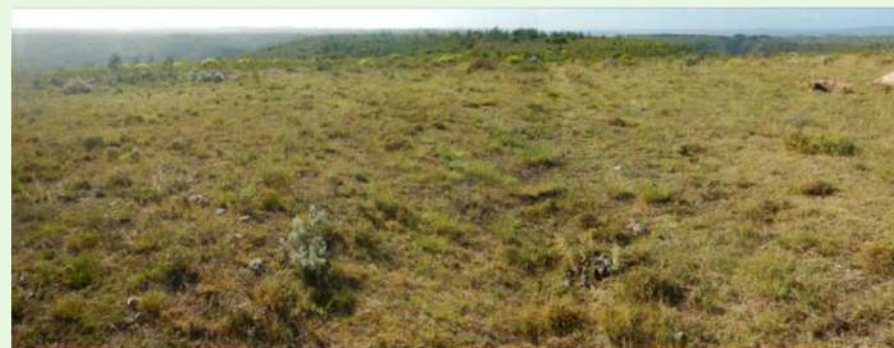
| 1 | 4,98ha | <p>Small past-use field; still in transformed state. Beyond the small area surveyed, there is a greater area that was flagged as agricultural in the 2023 census map on CFM; however, this section was confirmed to be Garden Route Granite Fynbos during the site assessment and is not suitable for agriculture.</p> <p>The transformed area here accounts for ca. 0.71 ha of transformed agricultural past-use area. The unsuitable fynbos area here, as mapped in the agricultural map is ca. 4.27 ha.</p> |

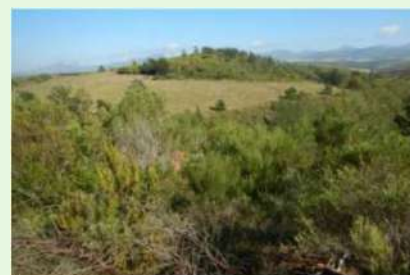
| 2 | 1.55 ha | <p>Transformed agricultural past-use field. Surrounding this dryland field is Rooikrans (<i>Acacia cyclops</i>) invaded fynbos.</p> |

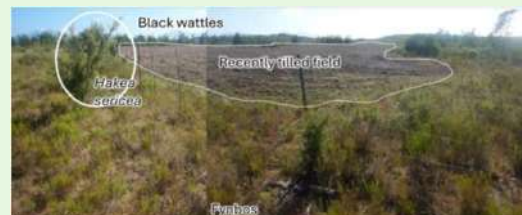
| 3 | 2.01 ha | <p>In-use agricultural field observed on OGF Portion 373. This had recently been tilled at the time of the site assessment in January of 2025.</p> |

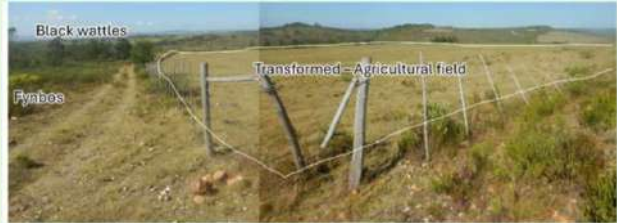
| 4 | 2.87ha | Past-use field; no signs of irrigation. This field is currently just a dryland pasture and is surrounded by pristine fynbos that contains some stands of invasive wattles in places. | |

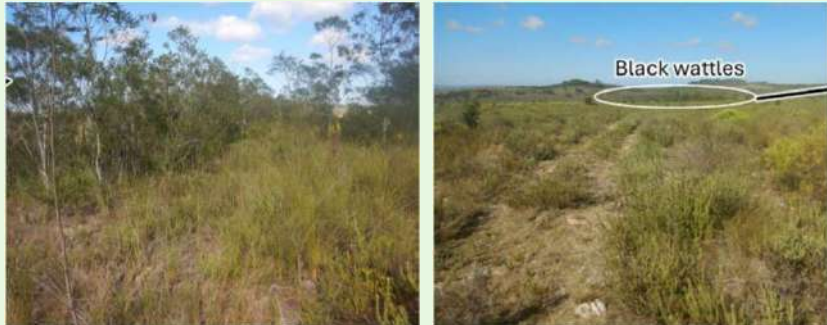
| 5 | 0.5 ha | Area 5 was pointed out as an area that would be considered favorable for further agricultural expansion. The vegetation in this area is still fynbos, consistent with Garden Route Granite Fynbos. The southernmost point of this proposed future area is defined by a stand of black wattles. However, fynbos persists in this stand of wattles. Due to the sensitive nature of the fynbos, and the fact that OGF is essentially considered as a CBA 1, this section covering ca. 0.54 ha may not be transformed for agriculture. | |

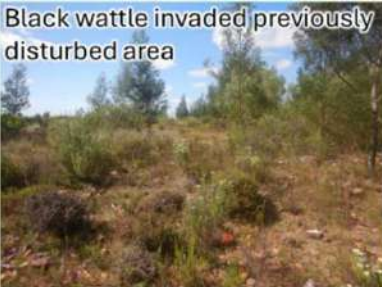
| 7 | 0.34 ha | Small area where some past disturbance noted. Despite being heavily invaded by both Rooikrans and black wattle, this section has excellent rehabilitation potential and may not be transformed for agricultural use. | |

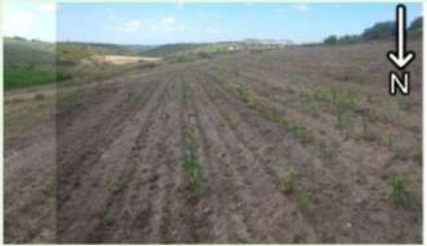
| 9 | 3.56 ha | In use agricultural field planted with Maize. This field is surrounded by pristine fynbos that may not be further impacted. | |

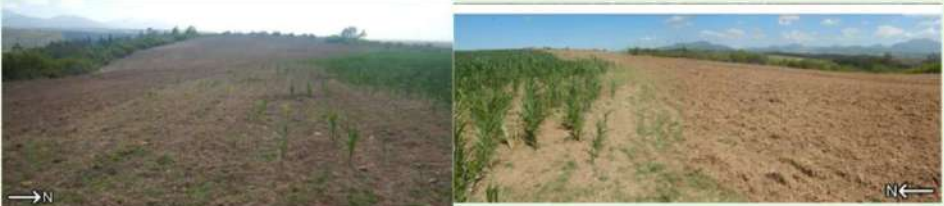
| 10 | 2.5ha | A recently ploughed area adjacent to the fields planted with Maize. | |

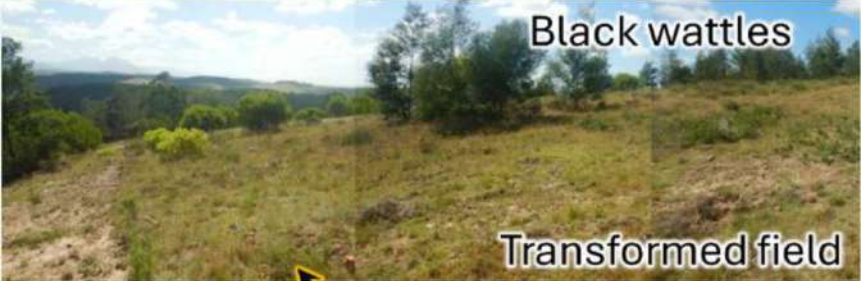
| 11 | 2.48 ha | Next to the ploughed field there is a transformed dryland Past-use field. This field is bounded along the south by a long stretch of area that is heavily invaded by black wattle (area 12). | |

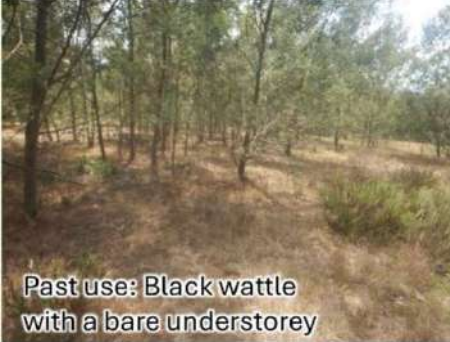
| 12 | 3.14 ha | The heavily invaded black wattle area represents an area that was transformed historically. Most of the wattle invaded area contains no, or minimal understorey coverage. The edges of the wattle invasion host some fynbos elements | |

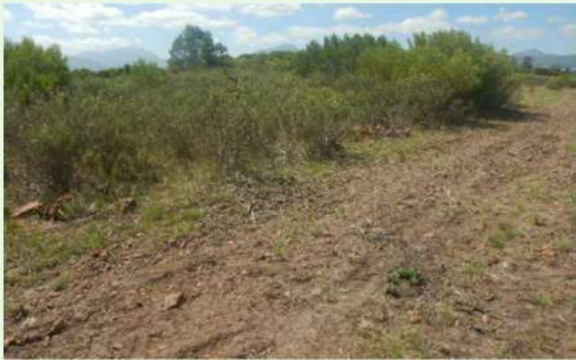
| 13 | 2.85ha / 9.2 ha | The narrow strip of land between the wattle-invaded area and the maize fields is covered in fynbos (2.85 ha). However, due to its limited width, significant invasion by both Rooikrans and black wattle, and its lack of importance for landscape connectivity, this area is considered a potential site for agricultural expansion. This would only be considered if the currently designated In-use and Past-use agricultural areas do not provide sufficient space for the proposed irrigation zones to be supplied by the planned dam. | | |

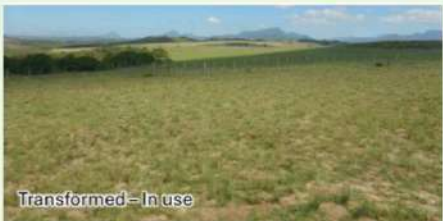
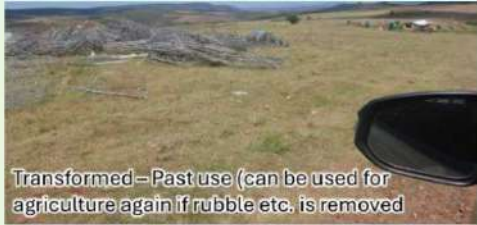
| 14 | 35.27 ha | This area represents a large section of transformed land on Portion 373 of OGF. Most of this area is considered as In-use agricultural areas (30ha), with the section containing infrastructure and other materials mapped as a Past-use transformed area (5ha). | | |

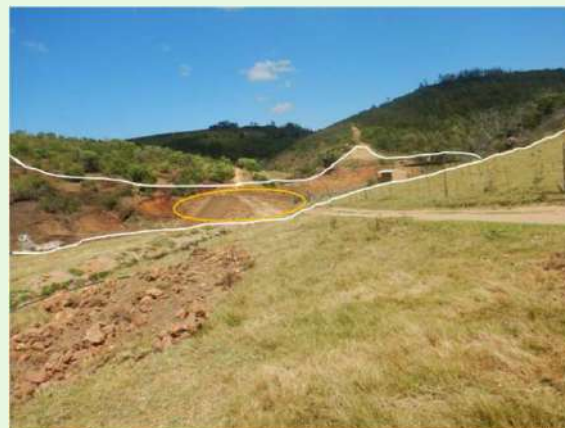
**16**    **0.89ha**    A section of transformed lawn / fields exists adjacent to a small dam. While some clearing was also visible adjacent to the dam, this can be rehabilitated; only the lawn areas are included as In-use agricultural areas here (ca. 0.89 ha).

**17**    **30.73 ha**    A view looking eastwards over the Past-use dryland pastures. The majority of the Past-use areas mapped on Portion 420 of OGF look very similar to this image.

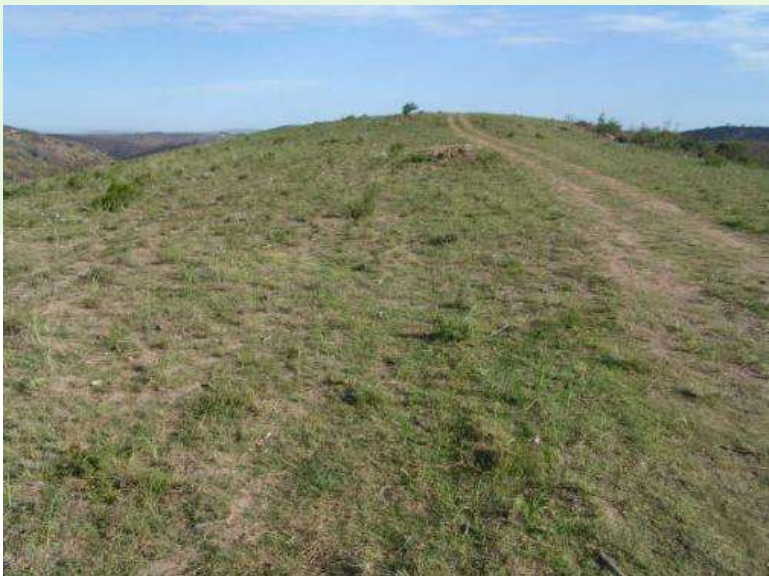
| 4 | 10.7 ha | <p>This is a past-use dryland field overgrown with <i>Acacia cyclops</i> and <i>Acacia mearnsii</i>; no signs of irrigation. Looks similar to area 3.</p> | <p>Past useOnly dryland; lion and cheetah enclosure proposed for this area. Plan shows 17.6 ha and requires clearing of vegetation not mapped as past use. Retain footprint of enclosure to past use area (i.e. 10.7ha)</p> <p>Manage as per cheetah and lion enclosure management plan.</p> |

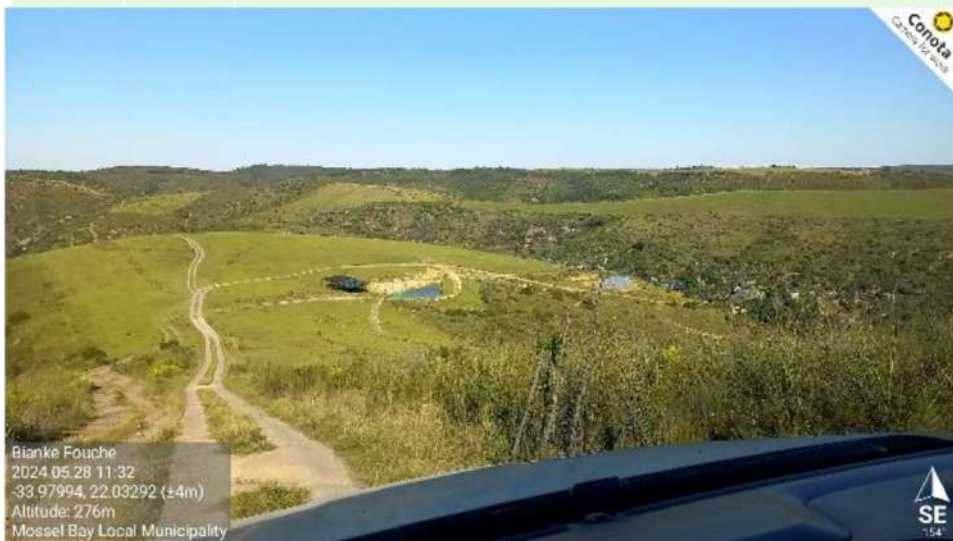
2024 assessment – Area 2

| 5 and 6 | 5.9 ha | Corresponds to Area 2 of Terrestrial biodiversity section assessed in 2024. Tracks, reservoir, dwellings, road-crossing, infilling.<br>A 4X4 track was upgraded to access the riverine area where Blackwattle ( <i>Acacia mearnsii</i> ) is being eradicated. In 2019 it was found that most of the upgraded road does not exceed the allowed width of 4 m, but several curves had to be established in the very steep section of this road. In these road bend areas one can argue that the road width exceeds 4 m. The natural vegetation on the north-west facing slope was noted to not be in a healthy ecological condition. The area was clearly subjected to a high burning frequency and severe grazing pressure by domestic stock. | 2024 assessment – Area 2<br>2019 assessment, the infilling area is marked with a red arrow. Note the cleared Blackwattle area above the arrow. The <i>Pelargonium</i> cf. <i>capitatum</i> plants are the three green shrubs to the right of the arrow. (2019 assessment)<br>Road crossing, 2024 assessment | Past use / in use<br><b>Rehabilitate roads in areas as required. Increase biodiversity in this area through active re-vegetation. Prioritise for AIS removal. Dryland management only. Manage as per terrestrial biodiversity, AIS and fire management measures provided.</b> |

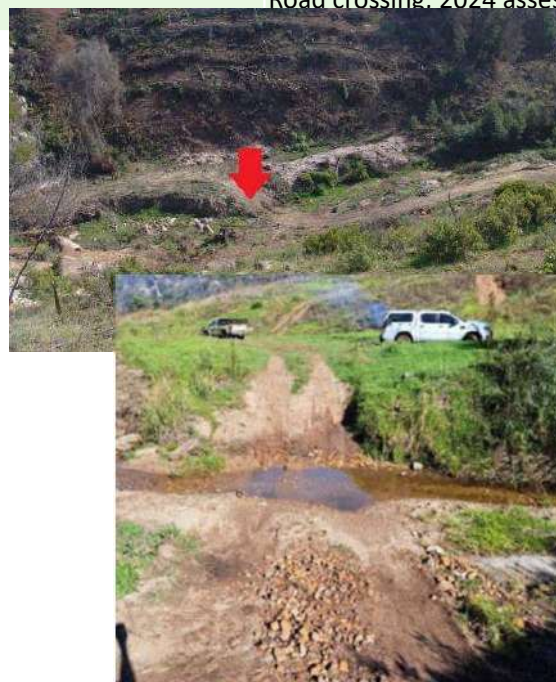
2019 assessment, the infilling area is marked with a red arrow. Note the cleared Blackwattle area above the arrow. The *Pelargonium* cf. *capitatum* plants are the three green shrubs to the right of the arrow. (2019 assessment)

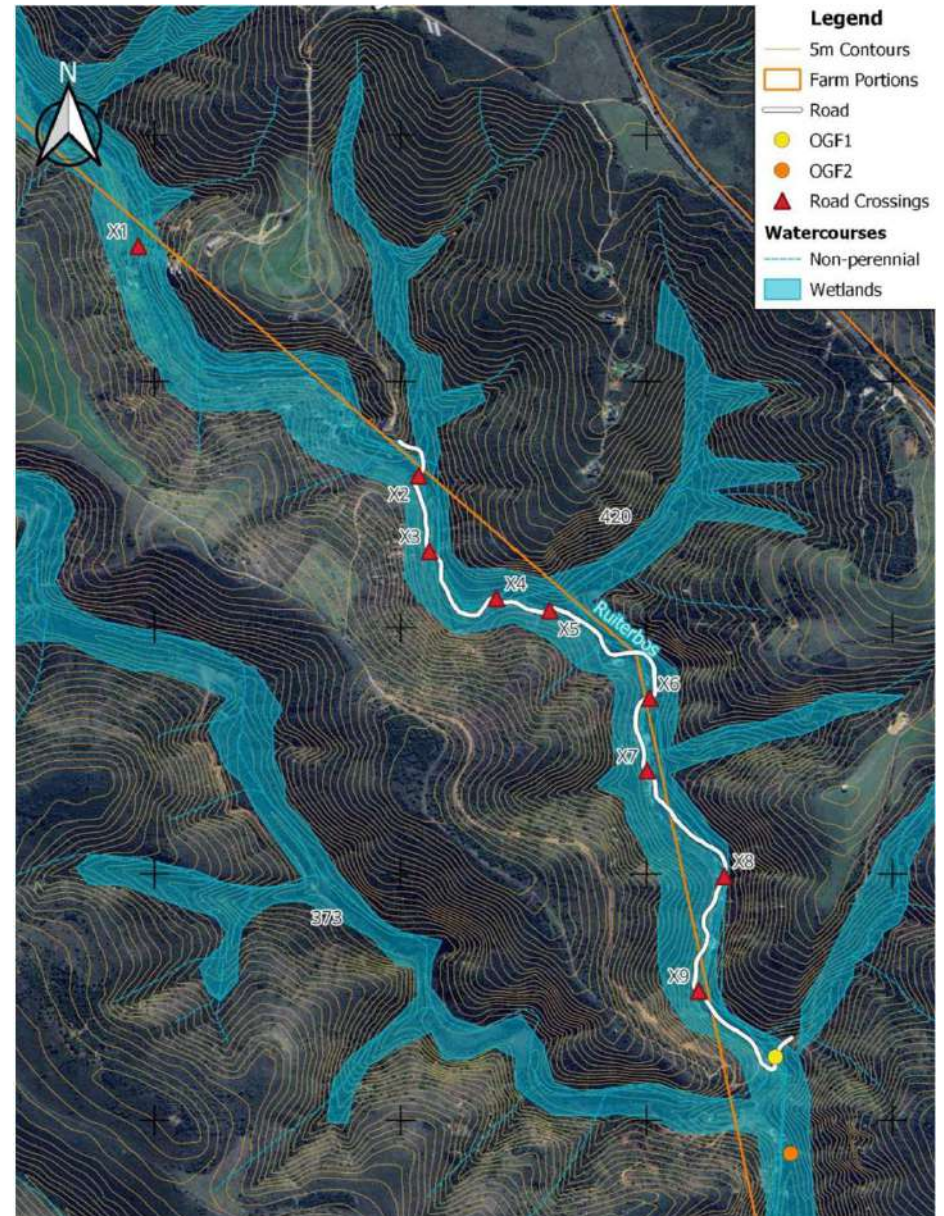
X3 - accumulation of woody debris from AIS clearing; obstruction of eastern bank and resultant erosion on opposite side

X7 and X9- multiple entry/exit points to/from the river have resulted in unnecessary additional disturbance to the riverbank. No signs of erosion were observed at road crossing points.

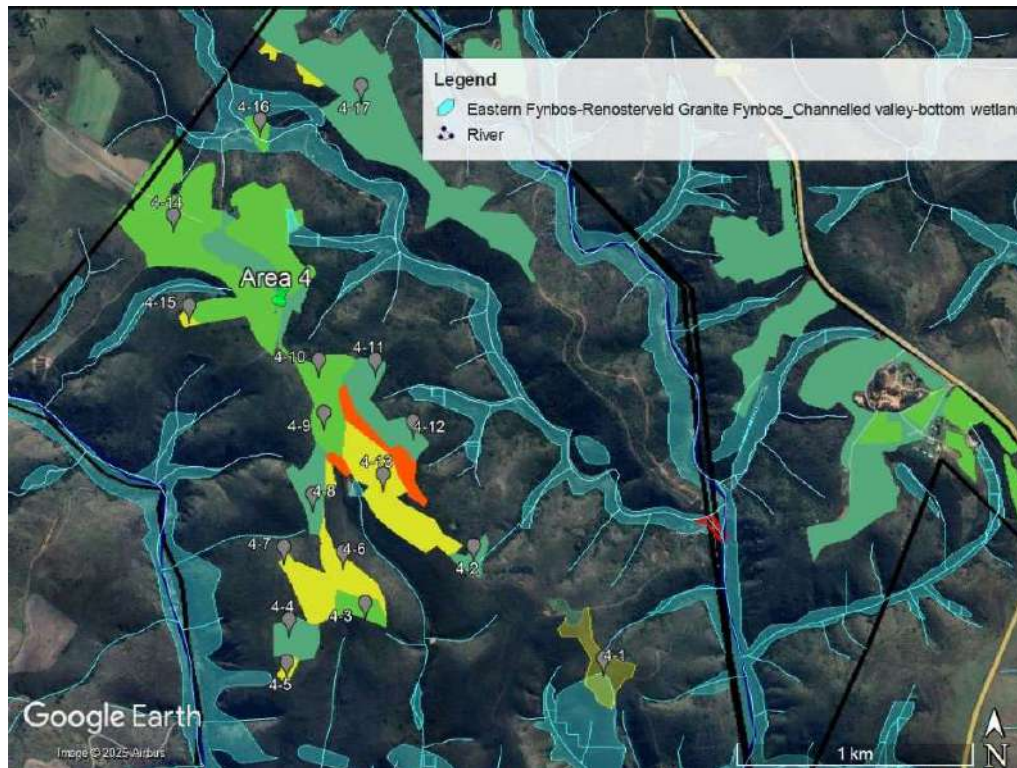
All agricultural areas are outside of the aquatic systems with exception of Areas 4-1 and 4-16 which are not recommended. The road crossing and dammed area at 4-16 needs to be addressed. This area (0.89ha) is in a valley area and is recommended to be rehabilitated with thicket / riverine/ wetland vegetation. The existing road crossing was already in place by 2005; however, no dammed area is visible in historical imagery from that period. At the road crossing, no culvert, bridge, or formal channel is visible to facilitate hydrological flow, and the obstruction of natural drainage has the potential to contribute to ecological degradation. This location intersects a mapped non-perennial drainage line (DWS) and falls within a NFEPA-designated channelled valley-bottom wetland system. A proper hydrological flow path (e.g. culvert or low water crossing) must be installed at the road crossing. This road is anticipated to be retained long-term due to its role in accessing recommended agricultural areas 4-15 and 4-17. The operational management measures need to be implemented to ensure ongoing removal of AIS within the drainage line areas on the property. These measures should in the long term, increase the amount of water that can be captured by the proposed OGF2 dam during storm events.

**Area 4 showing drainage lines (light blue), Ruiterbos and Palmiet Rivers and channelled valley bottom wetland mapped in terms of the NFEPA**
