## **Annexure M2: S24G application – Impact assessment**

**Activities carried out on Portion 12 of the Farm Ongegunde Vryheid No 746, Cape st Francis**

**Kouga Local Municipality, Sarah Baartman District Municipality  
Eastern Cape**

**DEDEAT reference: SBROB#2021-05-21**

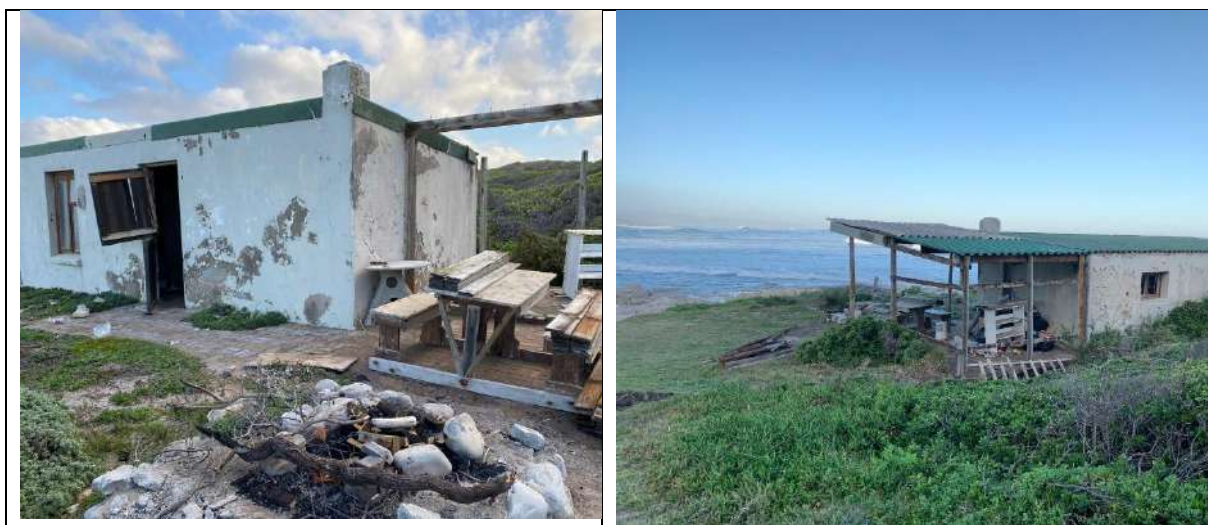
*Figure 1: Old dwelling (prior to 2021) (courtesy of registered IAP, 2025 – refer to PP and CRR in Annexure )*

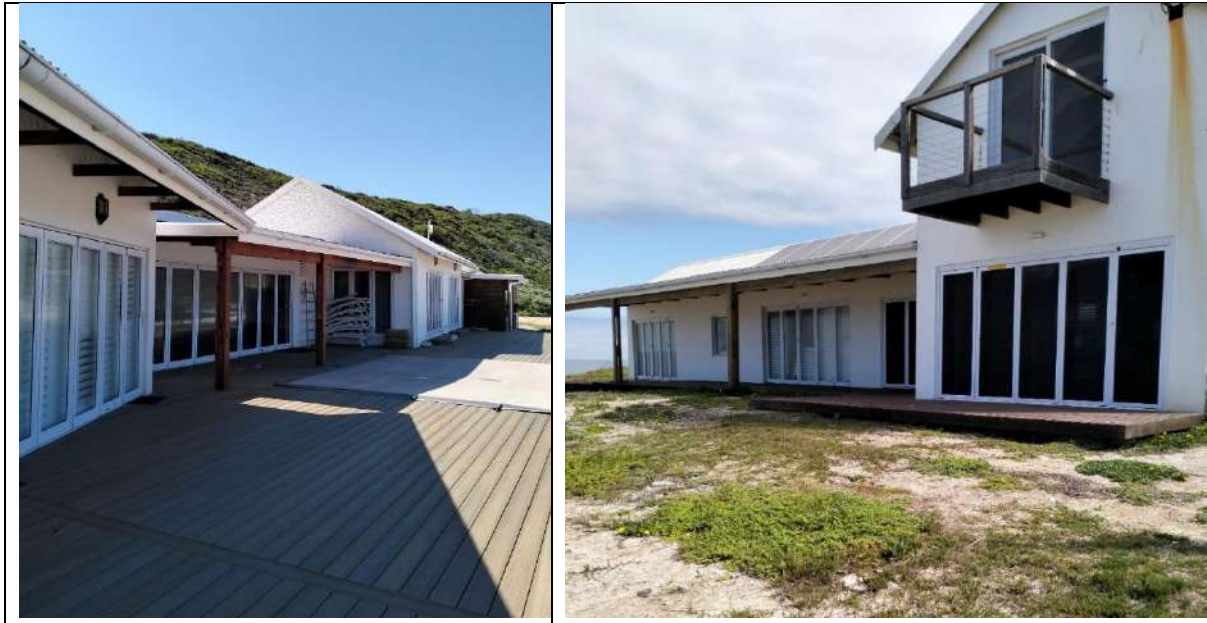
Figure 2: Left - Dwelling 1; Right dwelling 2 (current)

- Renovated / expanded footprints post 2021:
- Dwelling 1 – 390 m2 (original footprint: 265m2 – expanded by 125m2))
- Section of access road rerouted behind dwelling - 260m2
- Dwelling 2 – 105m2 (original footprint: 60m2 - expanded by 45m2)
- Road between dwellings (existing): 300 m2
- Total footprint: 1055m2

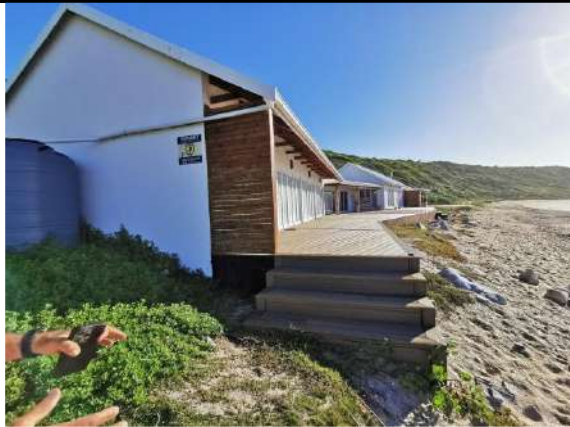
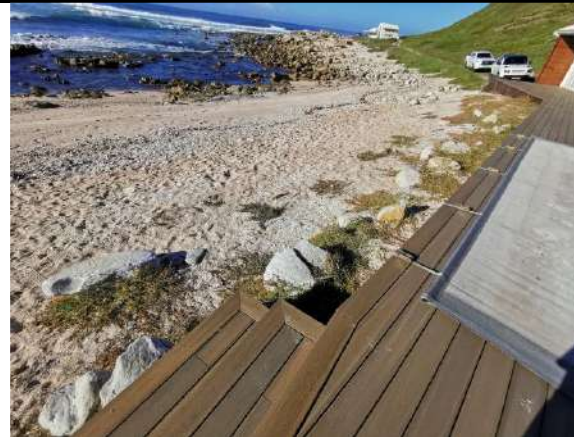
Figure 4: Front deck on edge of historically disturbed access road footprint

Intactness of vegetation for the site and footprint is Very Low. Intactness of indigenous for the broader site outside of the footprint is Moderate to High. Alien invasion for the site and footprint is Low. Invasion for the broader site outside of the footprint is Low to High (localised dense clumps and scattered trees). The entire site footprint has a low sensitivity. The unaffected area surrounding the site footprint would be designated a Moderate to High sensitivity but is not affected by the activity. No-go areas are not identified but no further mechanical clearing of natural vegetation should occur on the vegetated dune behind the dwelling or within the littoral active zone.

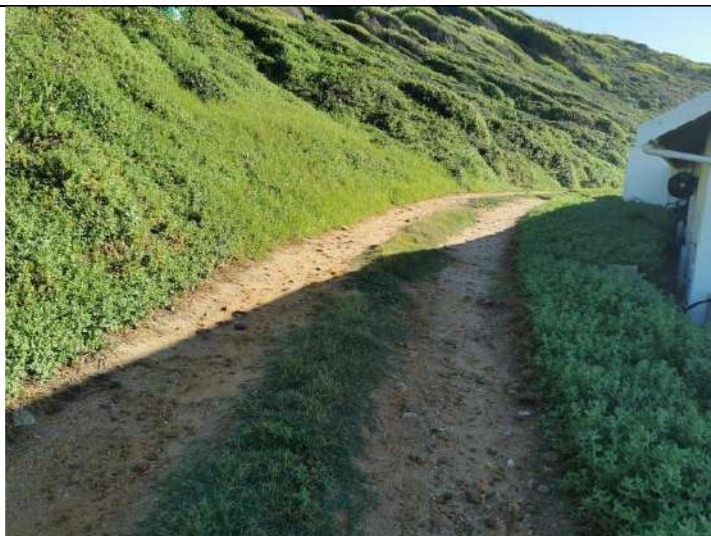
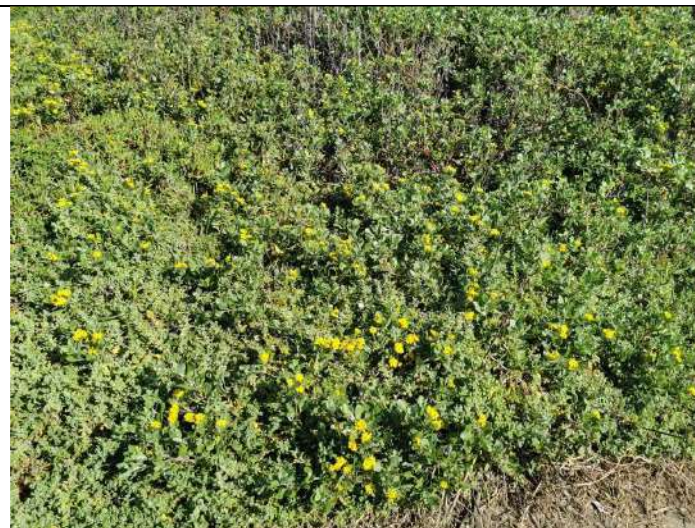
Figure 5: Rear access road within historically disturbed cut and fill area (left); Typically, weedy secondary thicket vegetation (right)
