GEOTECHNICAL SOIL TEST REPORT

Client: Dr Marx c/o Eco Route Environmental Consultancy

Project: Erf 1510, Sea Vista, St Francis Bay

Date of test: 21.7.2022

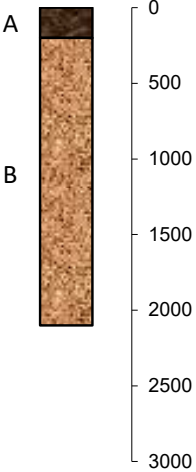
TP 3		Datum:	Co-ords:	Dynamic Cone Penetrometer (DCP)		Photo of Test Pit
		NGL	25 Y0014556 X3783473

(0 to 200)	Moist, dark brown, very loose, intact, SILTY SAND & ROOTLETS , aeolian.

(200 to 2100)	Moist, light brown, loose to medium dense at base, intact, SILTY SAND & ROOTLETS , aeolian.				
Sidewalls collapsed No Water

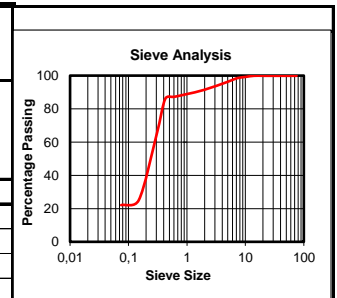
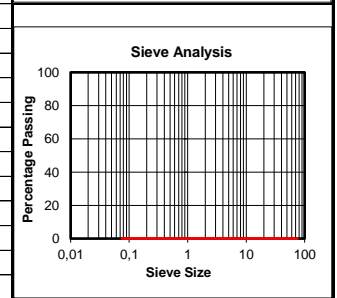
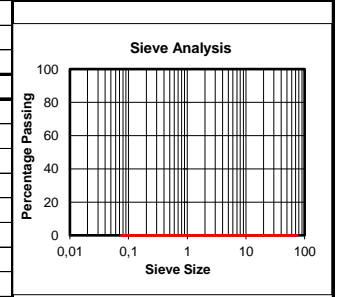
Sample Position (SV)	TP 1				
Depth (mm)	200-2300				
Sample No	16259				
Description	Source	Test Pit			
	Colour	Light Brown			
	Soil Type	Silty Sand with Roots			
	Classification	Unknown

Material Indicators - (SANS 3001 Method AG1,PR5*,GR20)		
Percentage Passing	75.0mm	100
	63.0mm	100
	50.0mm	100
	37.5mm	100
	28.0mm	100
	20.0mm	100
	14.0mm	100
	10.0mm	99
	7.1mm	98
	5.0mm	96
	2.0mm	92
	1.0mm	89
	0.600mm	87
	0.425mm	86
	0.300mm	64
	0.150mm	25
	0.075mm	22,1
Fineness Modulus		1,5

Atterberg Limits - (SANS 3001 Method GR10)		
Liquid Limit	0	
Plasticity Index 0,425mm (%)	NP	
Plasticity Index 0,075mm (%)		
Linear Shrinkage (%)	0
