Erosion Control Plan

**Short term measures to remedy adverse effects of the unlawful dam
construction at 17/232 Redford Farm**

Prepared by Dr. Jackie Dabrowski of Confluent Environmental (Pty) Ltd

August 2021

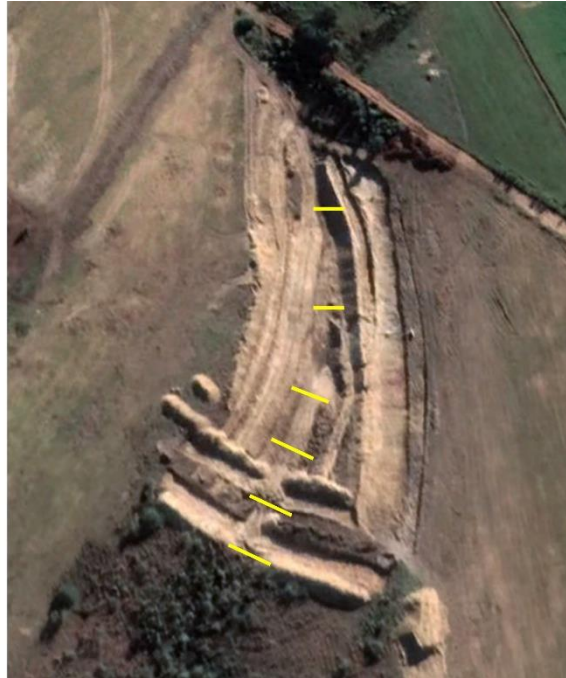
Figure 3. Proposed location of 6 hay bale check dams along the watercourse bed.

It is therefore recommended that erosion control measures be focussed on the bed of the original watercourse through a series of hay bale check dams. These are relatively cost-effective and easy to install. At least one check dam should be installed under supervision of an Environmental Control Officer (ECO) or an Aquatic Specialist. This should be the lowest check dam as it is the most important intervention. Supervision must also cover the on-site location of additional sites for each of the upstream check dams. A theoretical layout of the location of each check dam is provided in Figure 3.
