## Coastal Stability Assessment at Featherbed Nature Reserve

By Inanda Port and Coastal Engineers (Pty) Ltd

For Phambi Properties (Pty) (Ltd)

Document No: 04125-IND-M-RPT  
Revision : A

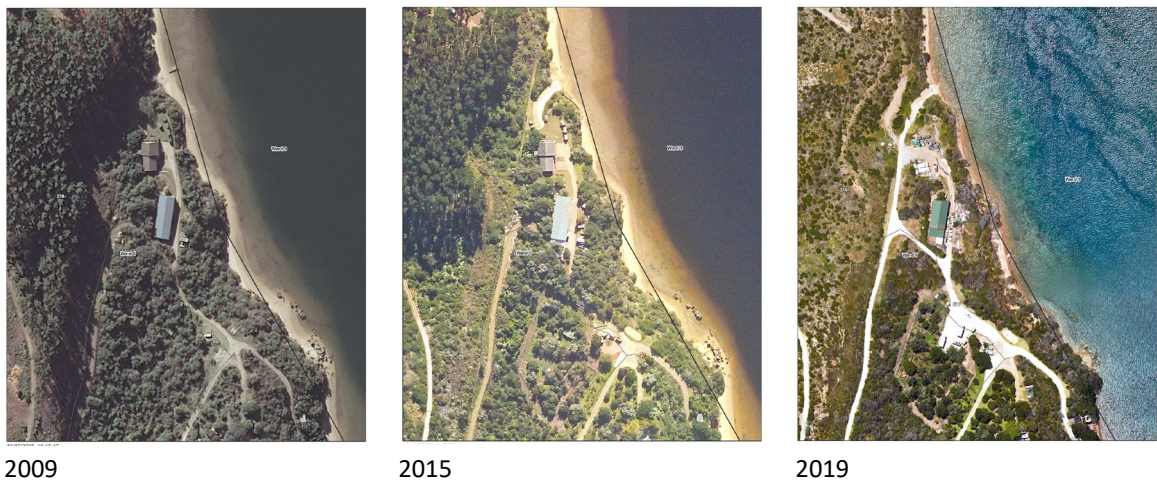
Figure 3: Aerial Imagery utilised in the study (ESRI)

An assessment of the three historical images was undertaken. The findings of the assessment are presented graphically in Figure 4.
