**WATER USE LICENSE APPLICATION FOR PORTION 17 AND 19 OF  
AVONTUUR 166, HOEKWIL, WESTERN CAPE**

**Technical Report**

**Prepared for Turvey Broers (Pty) Ltd**

**Confluent Environmental**

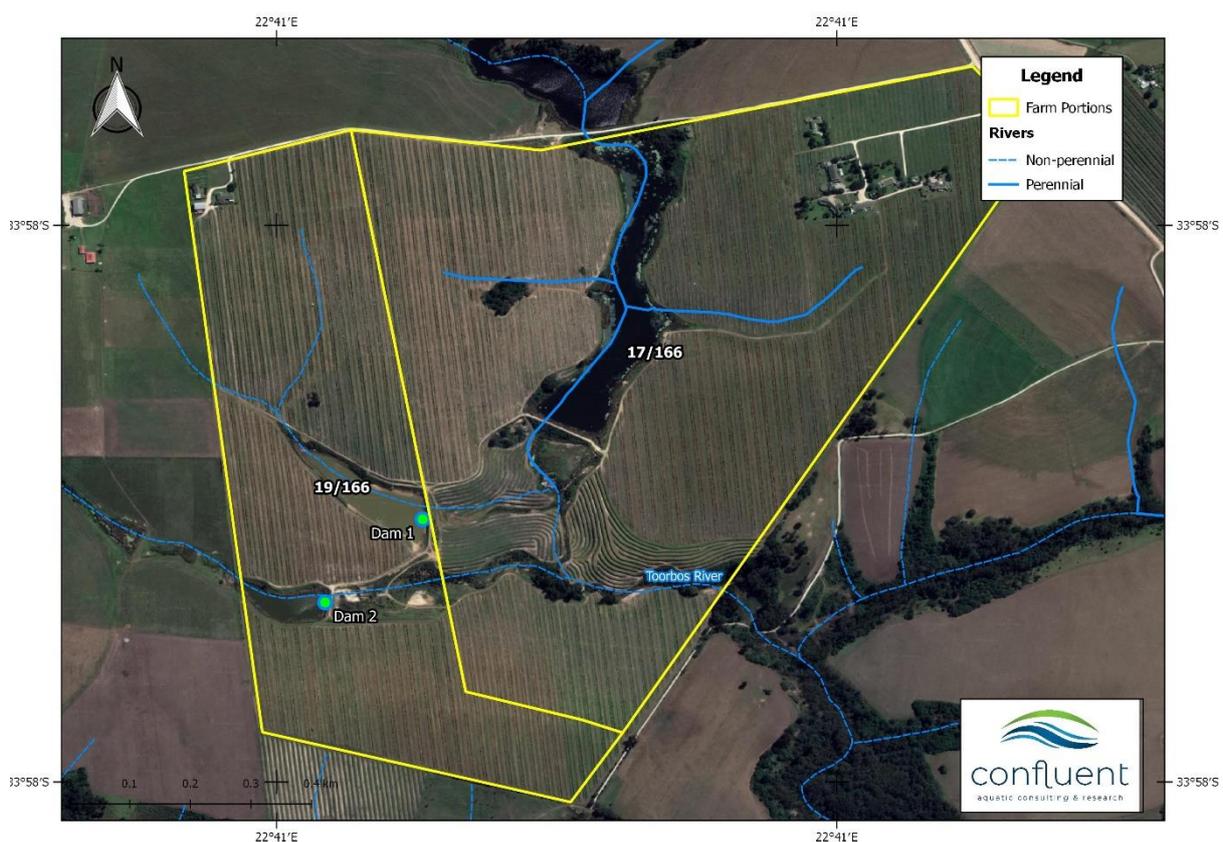
Figure 1: Map indicating farm portions and the location of Dam 1 and Dam 2.

Turvey Broers (Pty) Ltd (hereafter referred to as the applicant) enlarged an existing instream dam (Dam 1) on Portion 19 of Avontuur 166 without acquiring the necessary environmental or water use authorisation (Figure 1). The dam has been enlarged, increasing its footprint and water storage capacity from approximately 25 000 m<sup>3</sup> up to 75 000 m<sup>3</sup> (see APPENDIX A for dam survey drawings). Water passing through the spillway of Dam 1 is diverted via a channel into the adjacent Dam 2 (also located on Portion 19 of Avontuur 166). In its current configuration, no water therefore flows from Dam 1 into the drainage line below the dam. The design specifications of Dam 1 are described in detail in APPENDIX B. The storage capacity of Dam 2 is approximately 20 000 m<sup>3</sup> and has not been modified since before 1998.

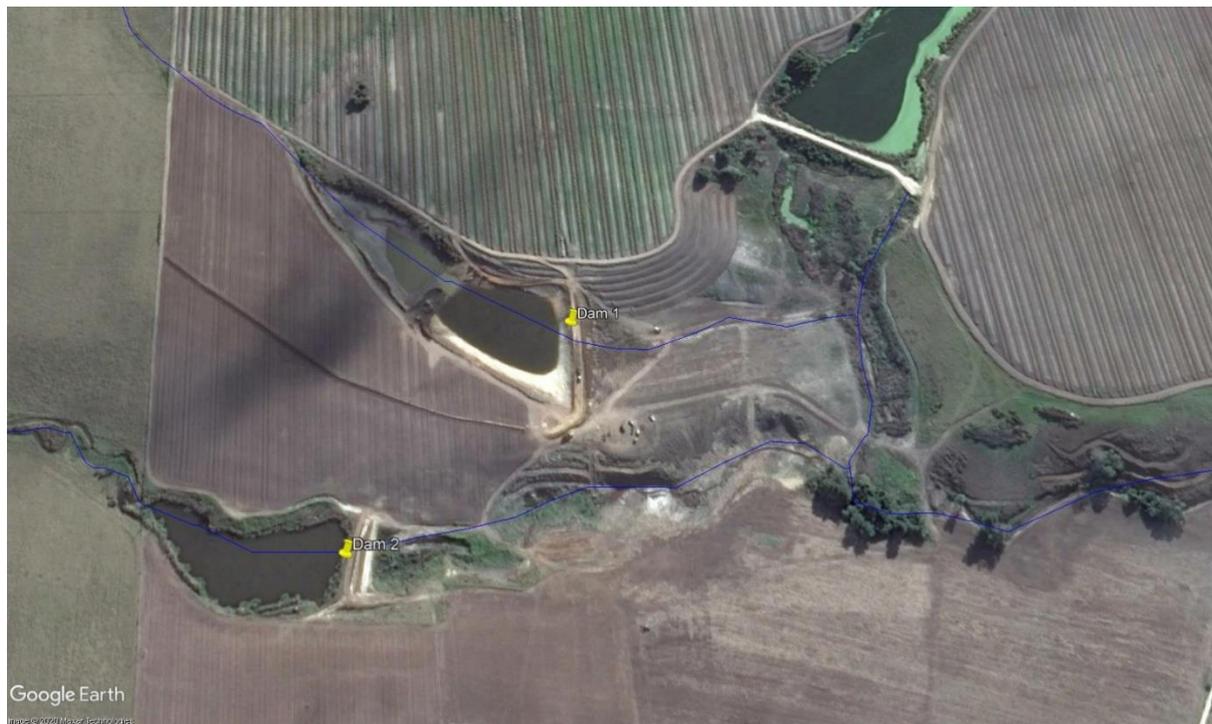
Figure 2: Aerial image indicating the enlargement of Dam 1 and clearing of vegetation downstream of Dam 1 and Dam 2.

In addition, the applicant cleared a large amount of natural and alien invasive vegetation (approximately 10 ha) in watercourses (drainage lines and wetlands) located downstream of Dam 1 and Dam 2, which fall within Portion 19 and 17 of Avontuur 166 (Figure 2). Excavation and infilling of parts of the wetland area occurred and has resulted in channel straightening, modification of the watercourses bed and banks, and removal of wetland habitat. The clearing of vegetation was done to expand the area of macadamia orchards, mainly on Portion 17. Further details of the affected watercourses can be viewed in APPENDIX C.

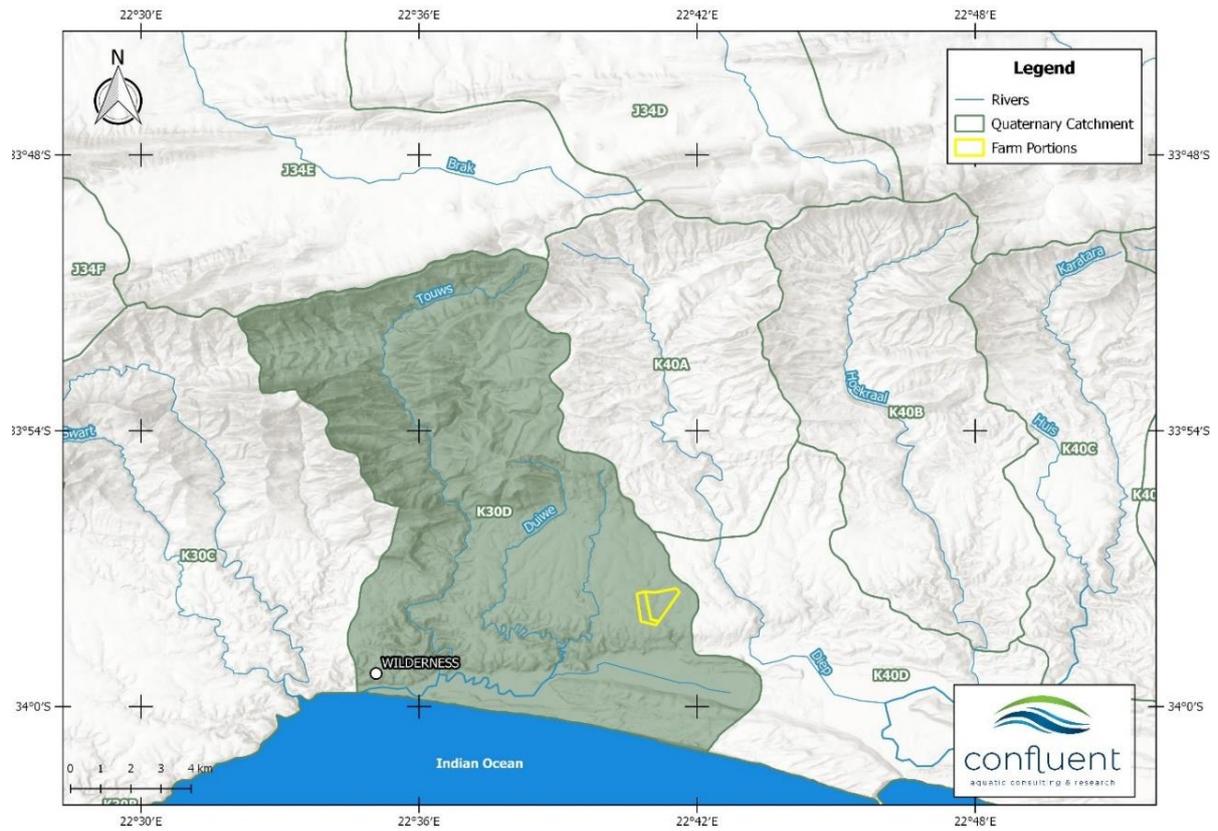
Figure 3: Location of Portion 17 and 19 of Avonturr 166 in quaternary catchment K30D.

The affected properties are located in quaternary catchment K30D (Figure 3) which falls in the Breede-Gouritz Water Management Area (WMA). The site is situated within a River FEPA (Figure 4). The enlarged dam (Dam 1) and a smaller dam (Dam 2) are both located within non-perennial drainage lines, which flow into the Toorbos River, a tributary of the Bo-Langvlei System. The Toorbos River flows into Bo-Langvlei approximately 2 km downstream from the site.

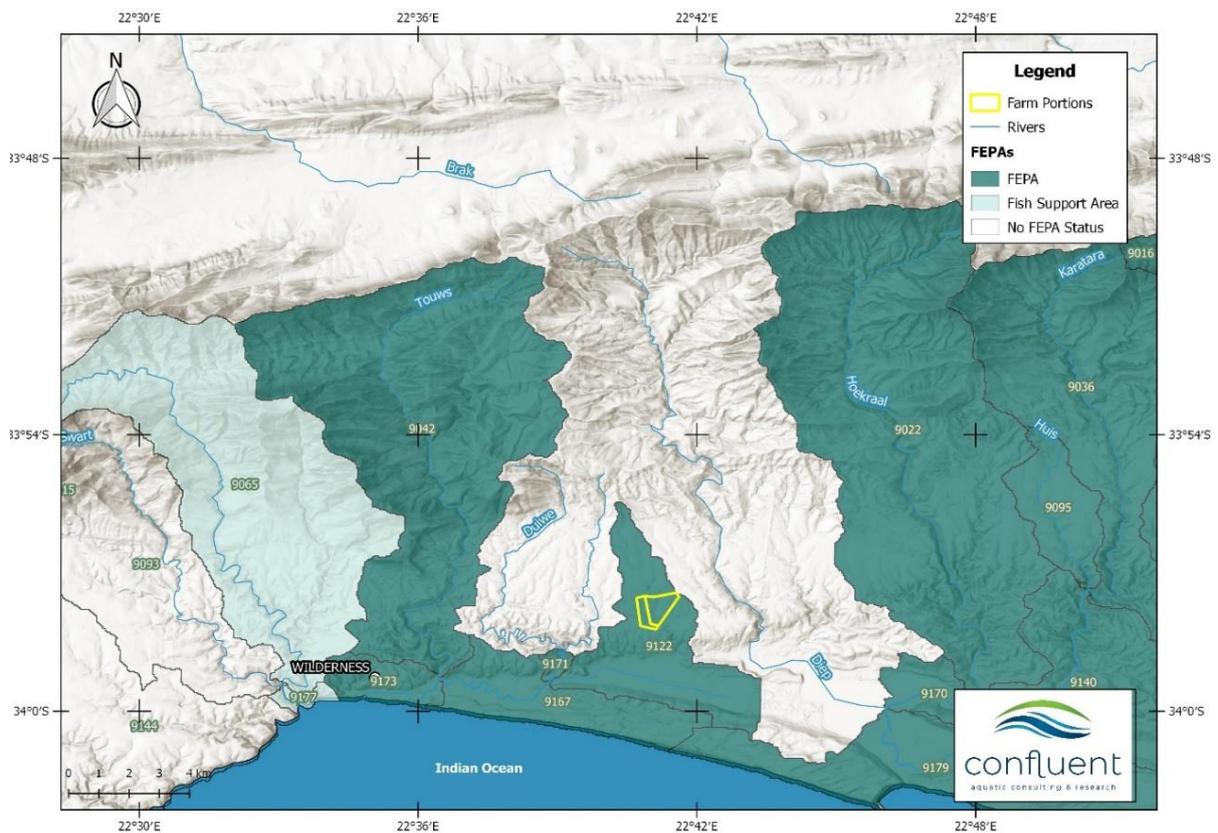
Figure 4: National Freshwater Ecosystem Priority Atlas

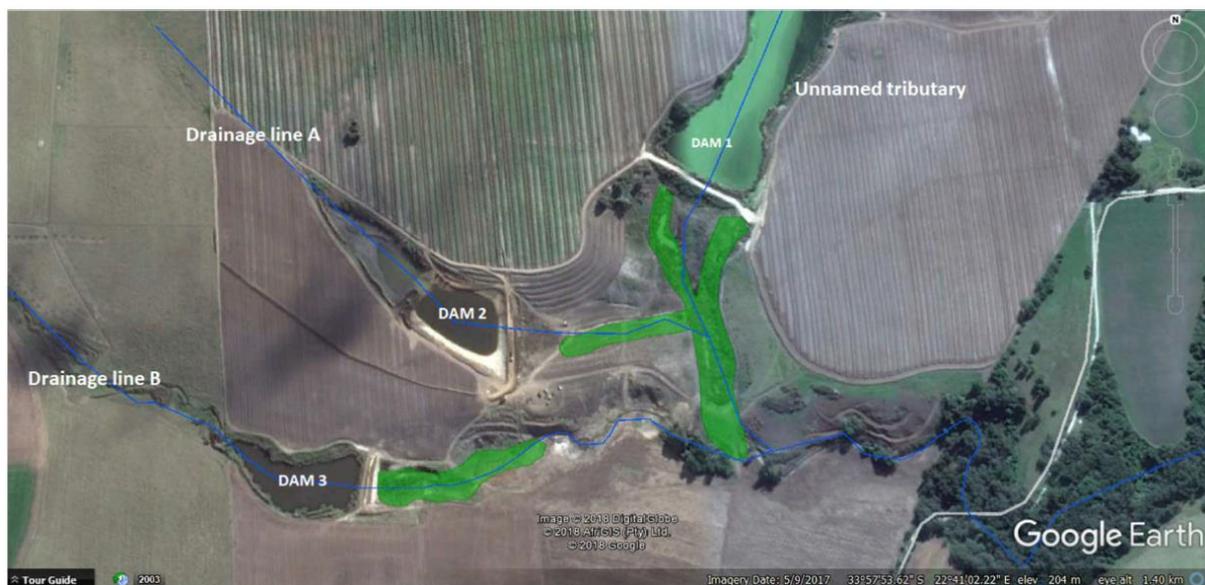
Figure 5: Map from the freshwater assessment indicating freshwater features affected by the unlawful activities (Note: Dam 1 and Dam 2 were referred to as Dam 2 and Dam 3 in the Freshwater Assessment Report).

Main freshwater features impacted on by the unlawful activity include the Toorbos River and two associated tributaries/drainage lines located downstream of Dams 1 and 2, as well as a broader wetland area associated with the confluence of the Toorbos River with the two tributaries (Figure 5). The main area where unlawful activity took place falls within the confluence of these three streams and has seriously to critically modified the state of these freshwater features.

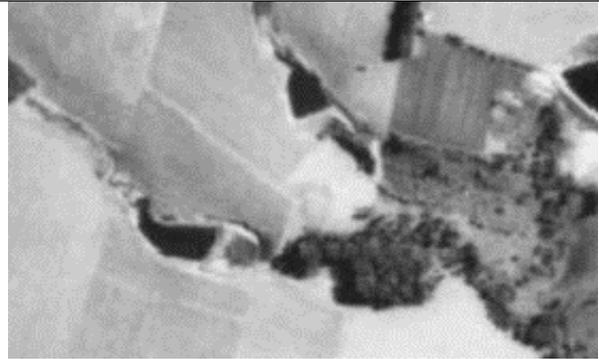
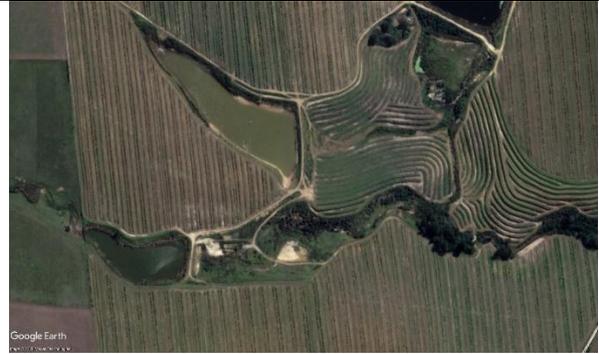
Table 2: Historical imagery of Dam 1 and Dam 2.

<b>1991</b>

<b>2020</b>
